**CONSENT ORDER
ISSUED UNDER THE
WATER POLLUTION CONTROL ACT
WEST VIRGINIA CODE CHAPTER 22, ARTICLE 11**

ORDER NO.: 10260

1. Horus West Virginia 1, LLC is conducting land disturbance activity associated with the Blake Solar Project in Jefferson County, West Virginia. Horus West Virginia 1, LLC was issued WV/NPDES Water Pollution Control Permit No. WV0115924, Registration No. WVR111837, on August 12, 2022.
2. On May 15, 2023, West Virginia Department of Environmental Protection (WVDEP) personnel conducted an inspection of the facility. During the inspection, violations of the following sections of the WV/NPDES permit were observed and documented:
 - a. Section II.H.1.d. – Horus West Virginia 1, LLC failed to provide an adequate stone access entrance/exit to reduce the tracking of sediment onto public or private roads.

Horus West Virginia 1, LLC, WVR111839, Blake Solar Project, 7/18/2023

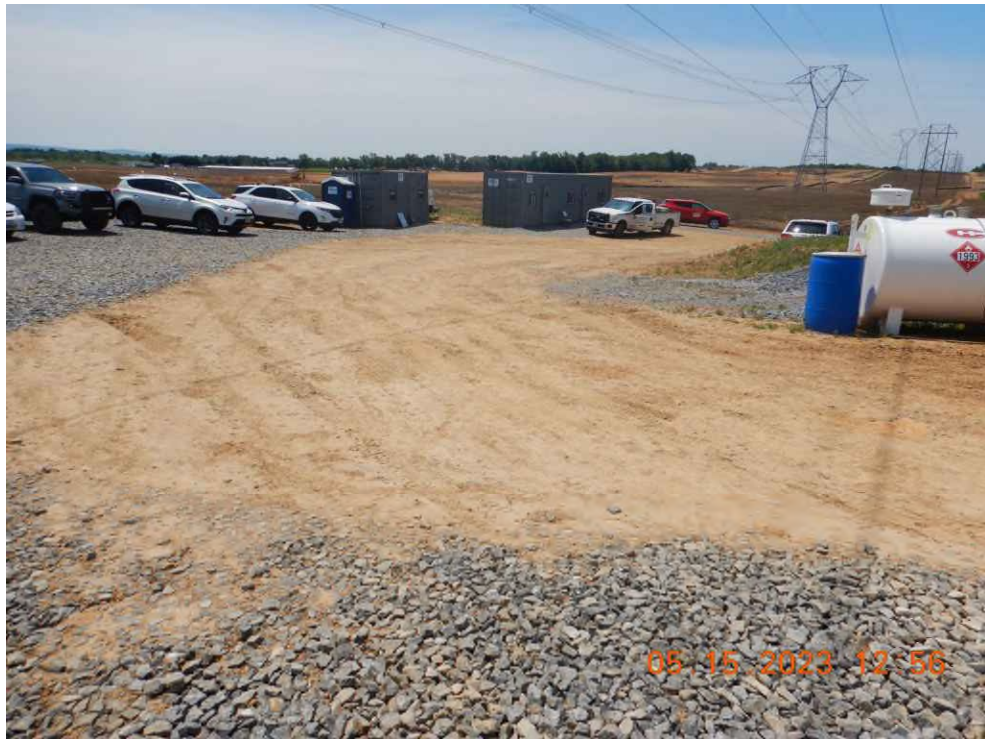
Unstabilized construction entrance.

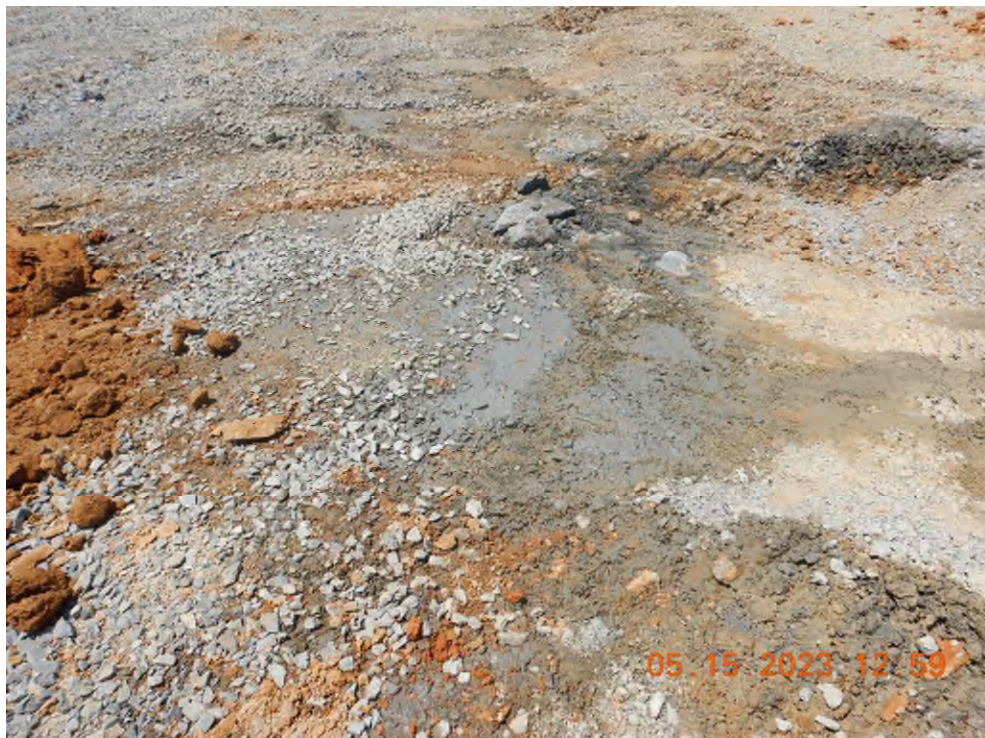
Concrete washout is not being used properly.

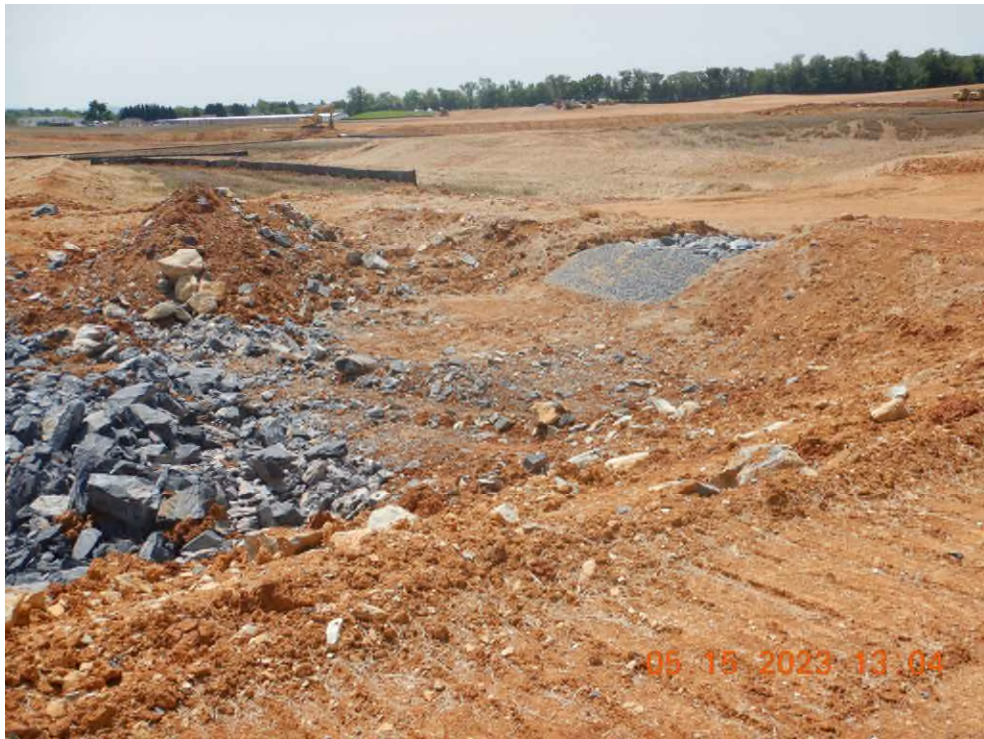
Sediment Trap 11 has no inlet, outlet marker, or Super Silt fence.

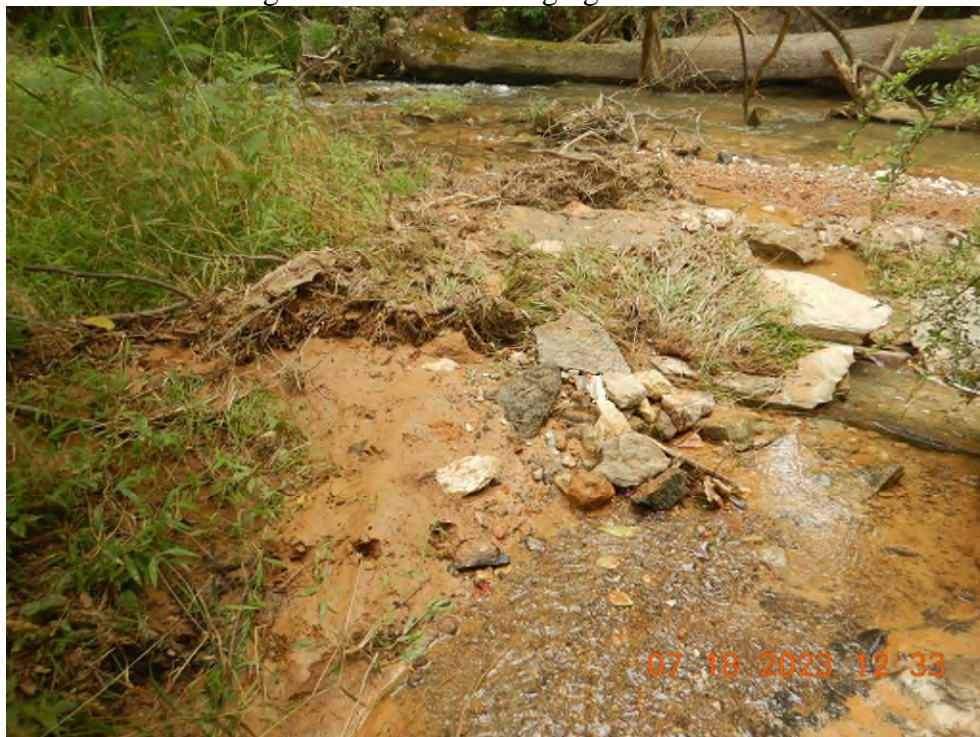
Sediment laden water that has caused conditions not allowable in Evitts Run.

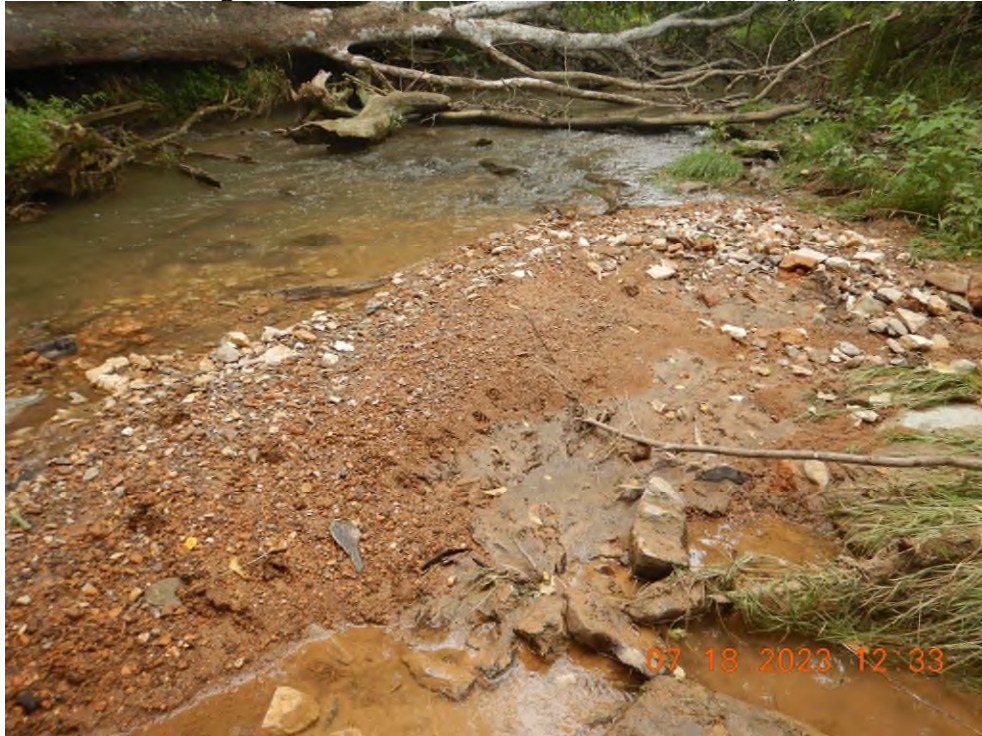
Sediment in Evitts Run.

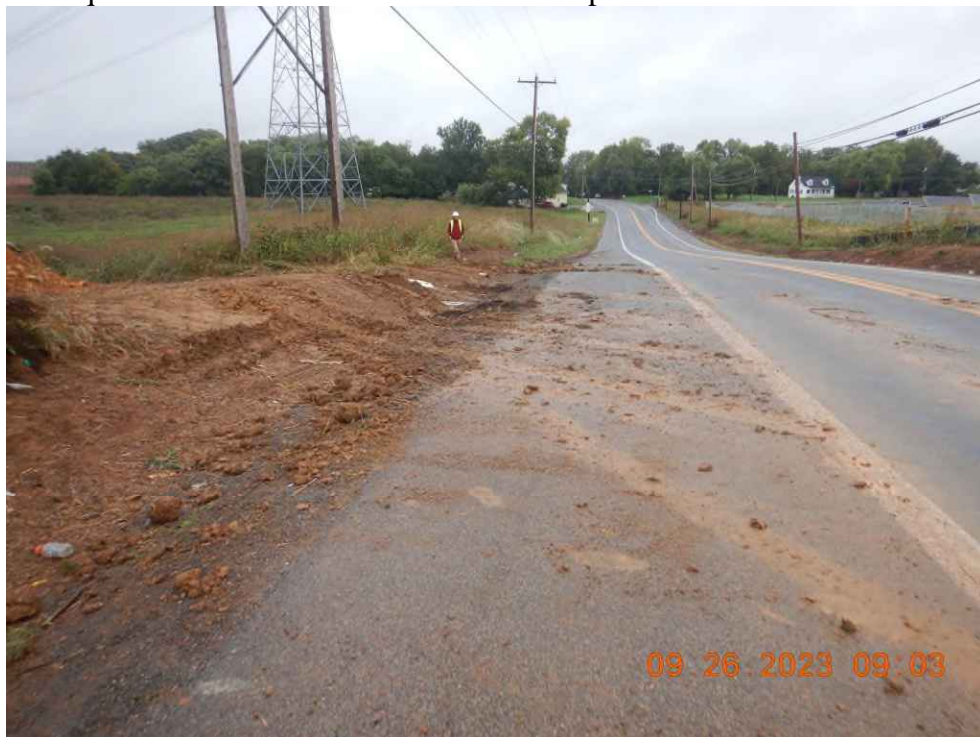
Unstabilized construction entrance.

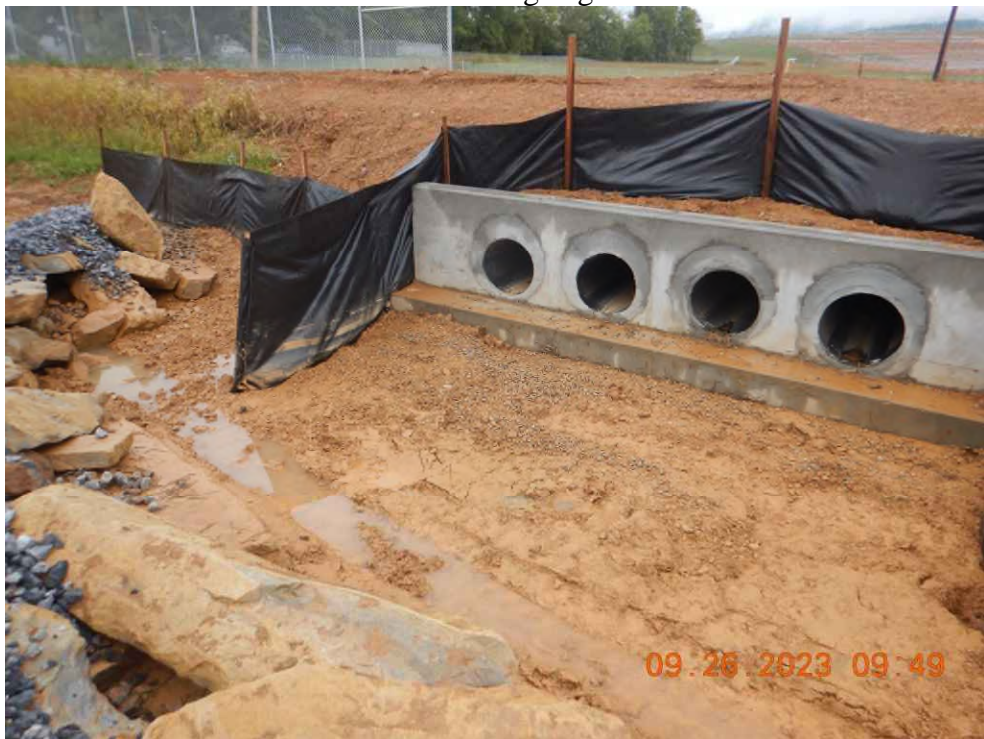
Outlet for stormwater pond 14 has been installed. Sediment laden water leaving site through outlet.

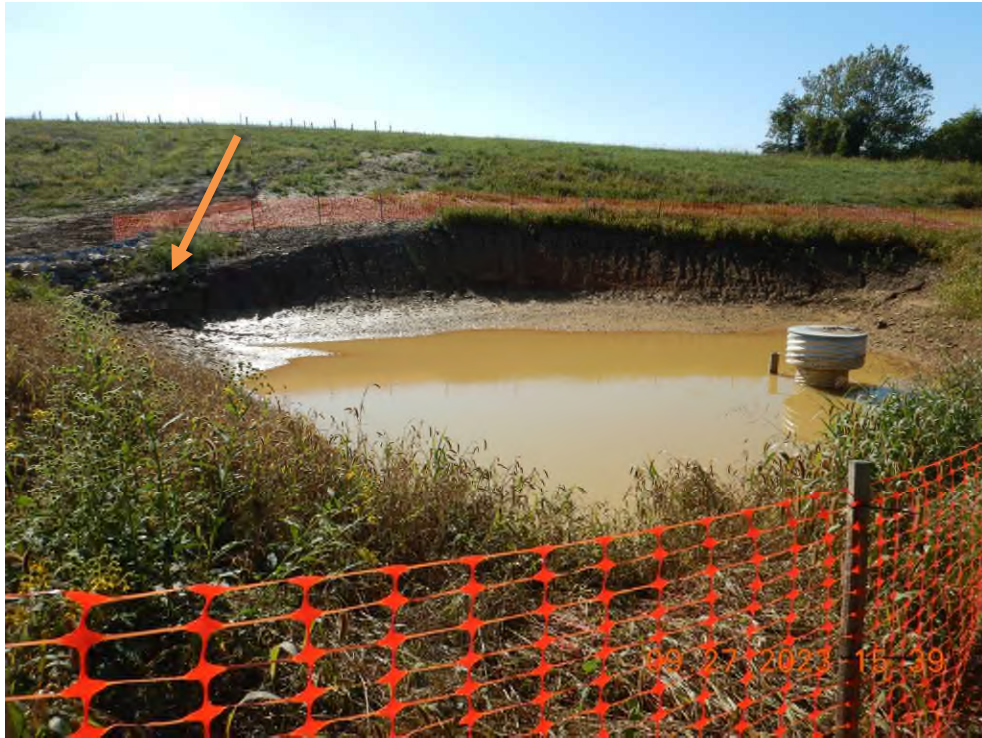
- h. Section II.H.3.b.13. – Horus West Virginia 1, LLC failed to protect the inlet of a sediment trapping structure against erosion by using an appropriate material. The inlets for Sediment Ponds 5 and 6 were not properly armored.

Sediment Pond 6 has unstable inlet.

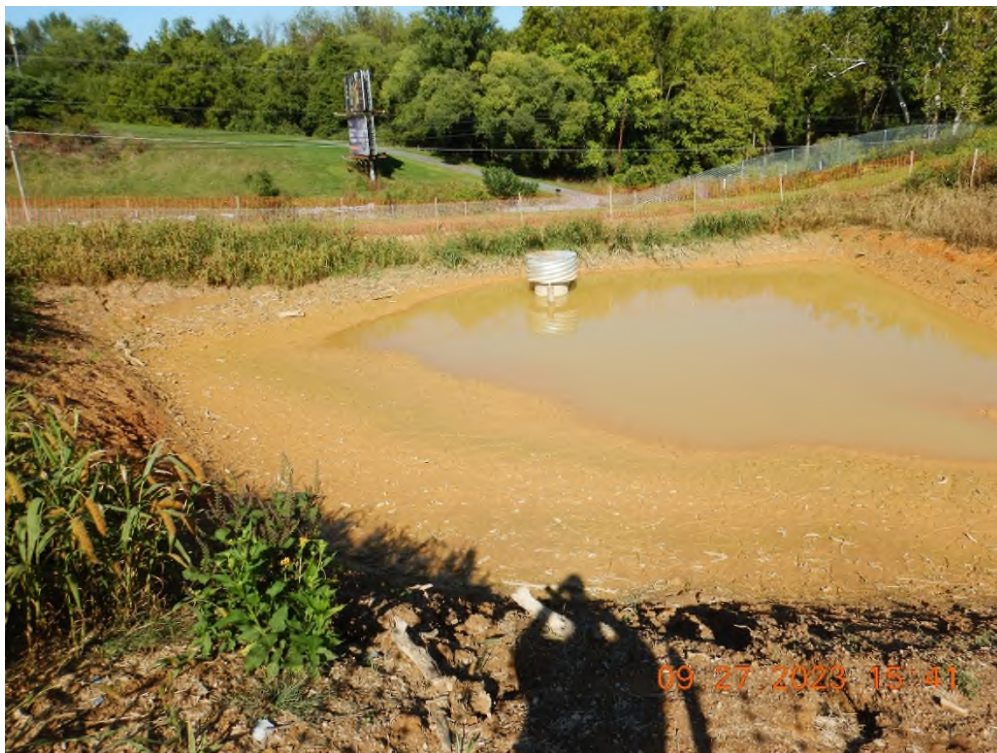
- i. Appendix B.I.1. – Horus West Virginia 1, LLC failed to properly operate and maintain all activities and installed BMPs. Sediment Basin 6 had accumulated

- deposits that were greater than 50% of the wet storage capacity, and maintenance had not been conducted.
- j. 47CSR2 Section 3.2.b. – Horus West Virginia 1, LLC caused conditions not allowable in waters of the State by creating sediment deposits on the bottom of an ephemeral UNT of Evitts Run (39° 15' 33.3189" X -77° 49' 30.6042") and Evitts Run (39° 15' 17.2288" X -77° 49' 26.9350").

Sediment Basin 6 with accumulated deposits.

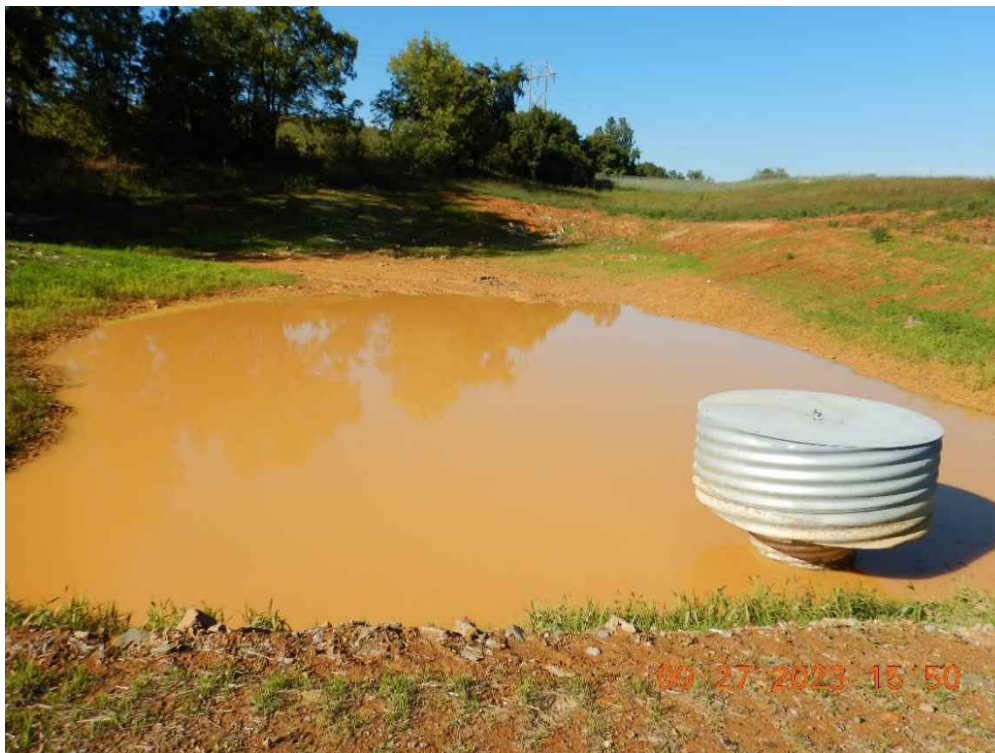
Sediment Pond 5, showing the lack of a stabilized inlet.

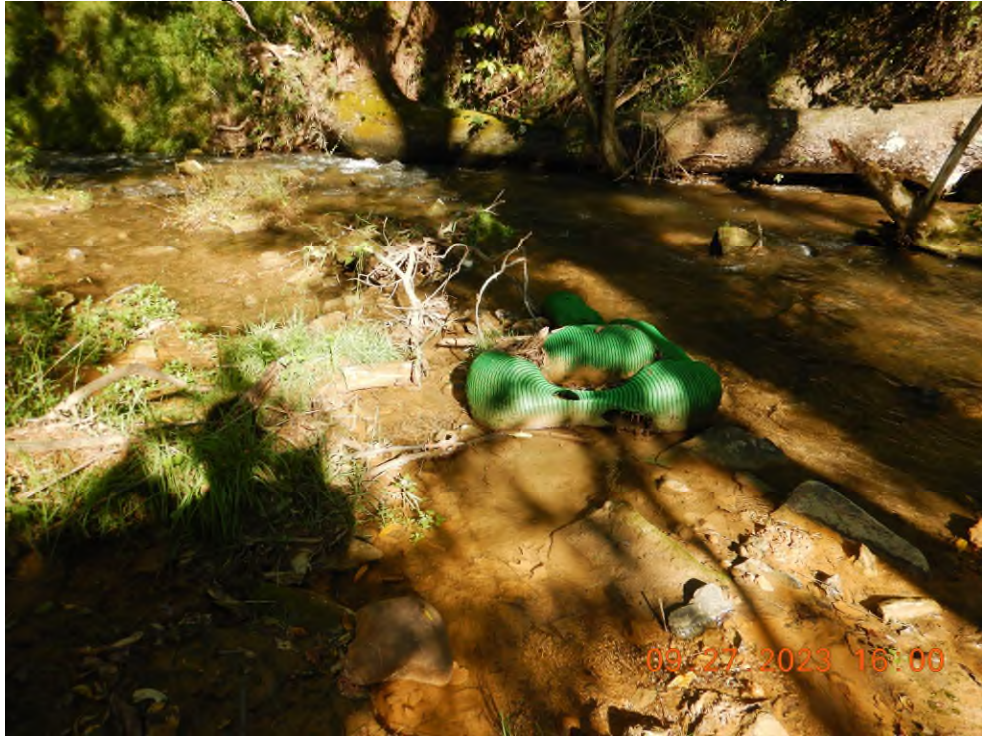
Conditions not allowable - deposits in Evitts Run (39° 15' 17.2288" X -77° 49' 26.9350") from Sediment Basin 5. Filter sock laying in creek.

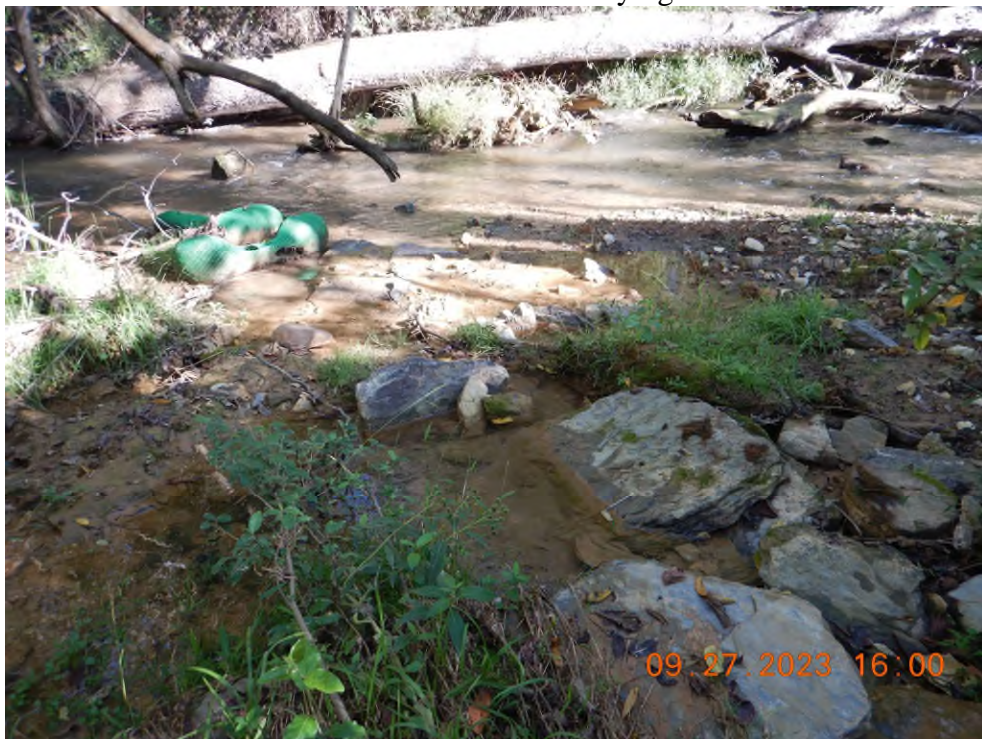
Conditions not allowable - deposits in Evitts Run (39° 15' 17.2288" X -77° 49' 26.9350") from Sediment Basin 5.

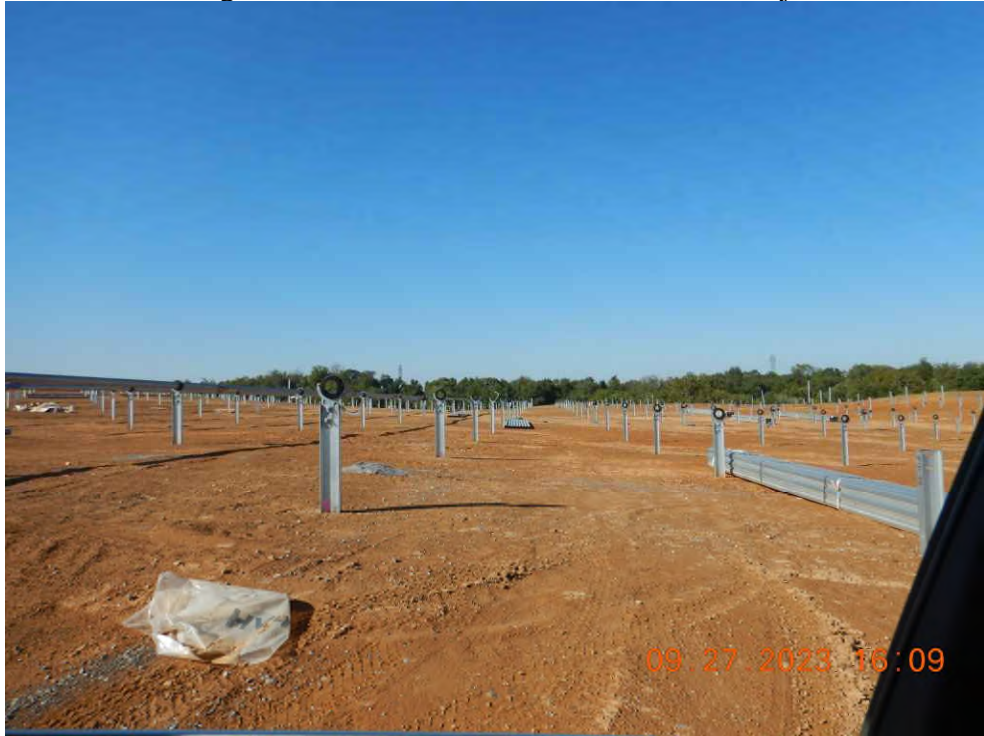
Unstabilized area of project. Temporary or permanent stabilization has not been started.

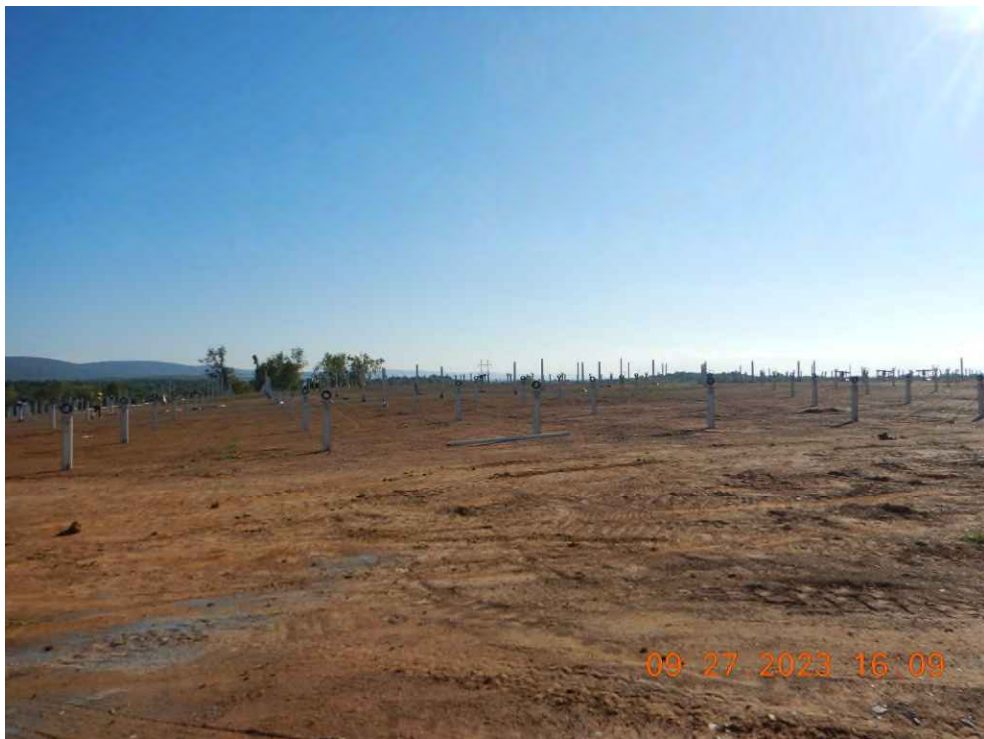
Unstabilized area of project. Temporary or permanent stabilization has not been started.

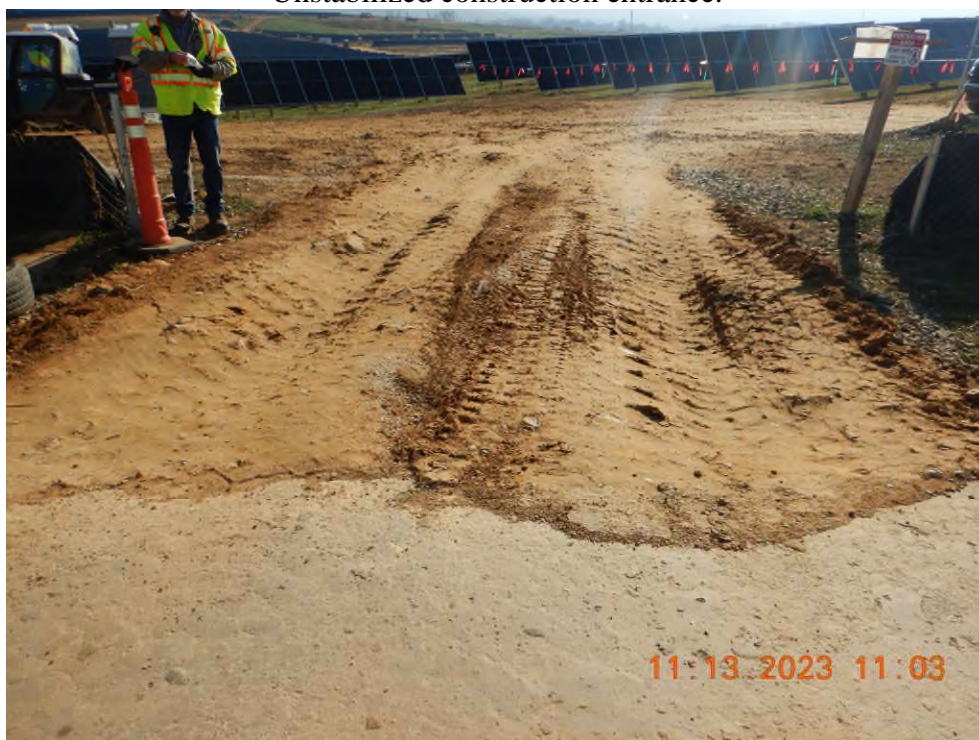
Unstabilized construction entrance.

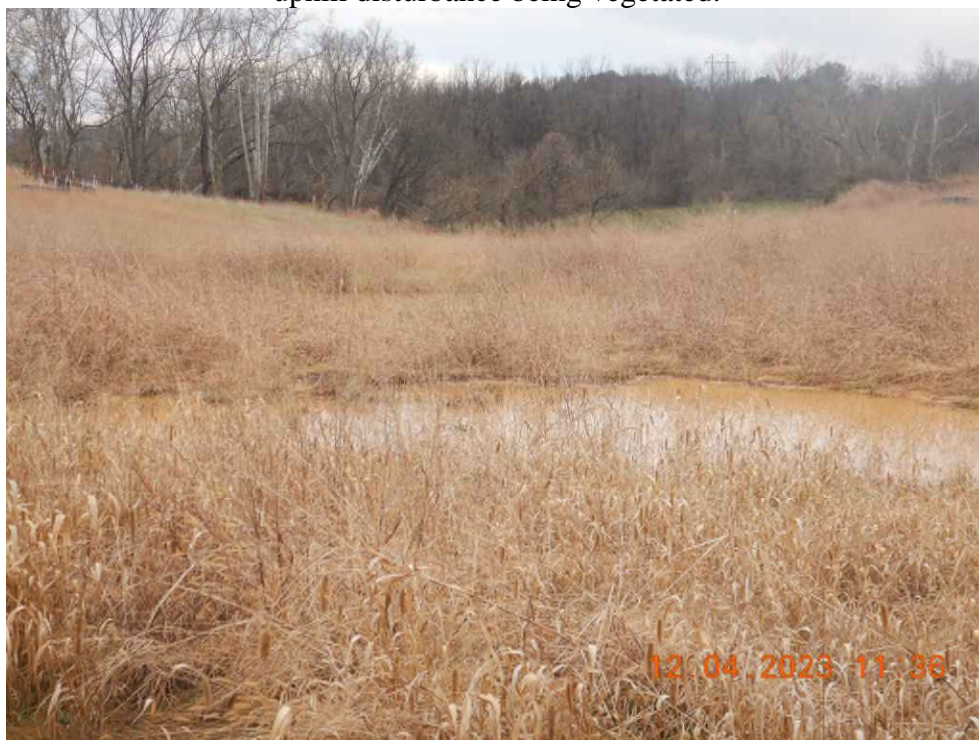
Sediment laden discharge from Sediment Basin 13 into Evitts Run.

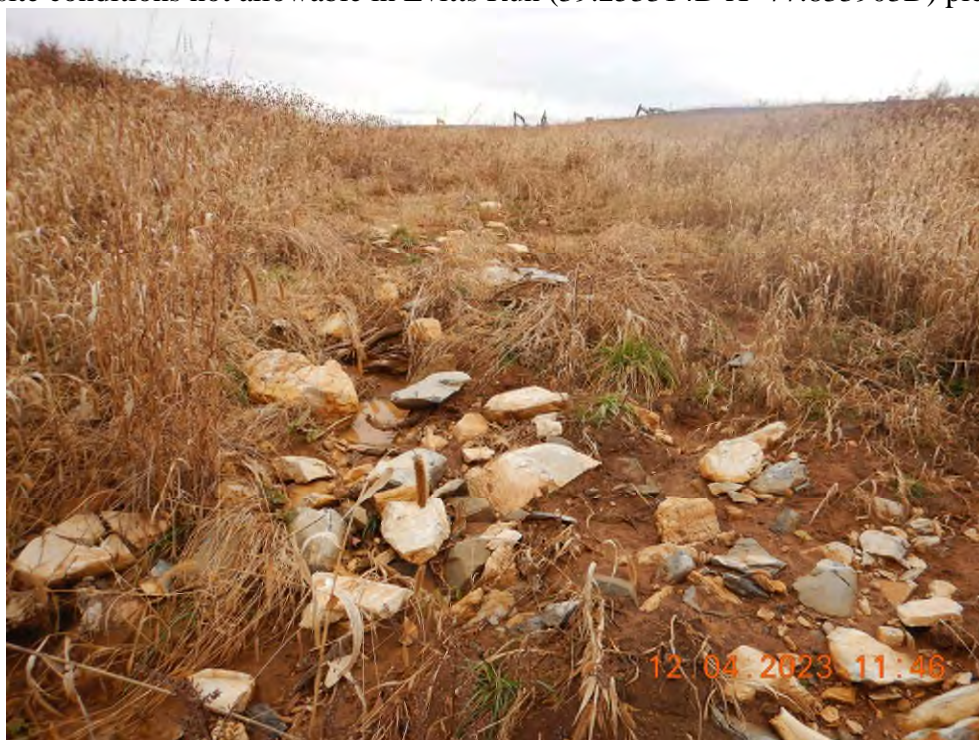
Sediment laden discharge from Sediment Basin 13 into Evitts Run.
Offsite conditions not allowable in Evitts Run (39.253314D X -77.833903D) pictured.

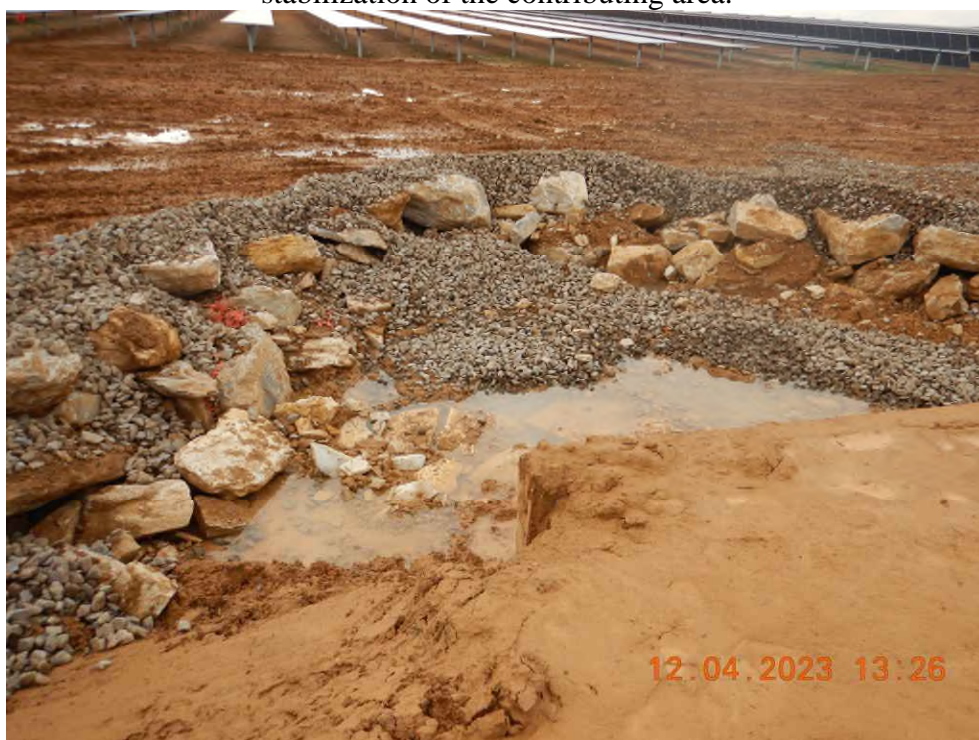
Sediment basin SB-11 (Pond 2B redline) that has been converted to stormwater retention prior to stabilization of the contributing area. Outlet pictured.

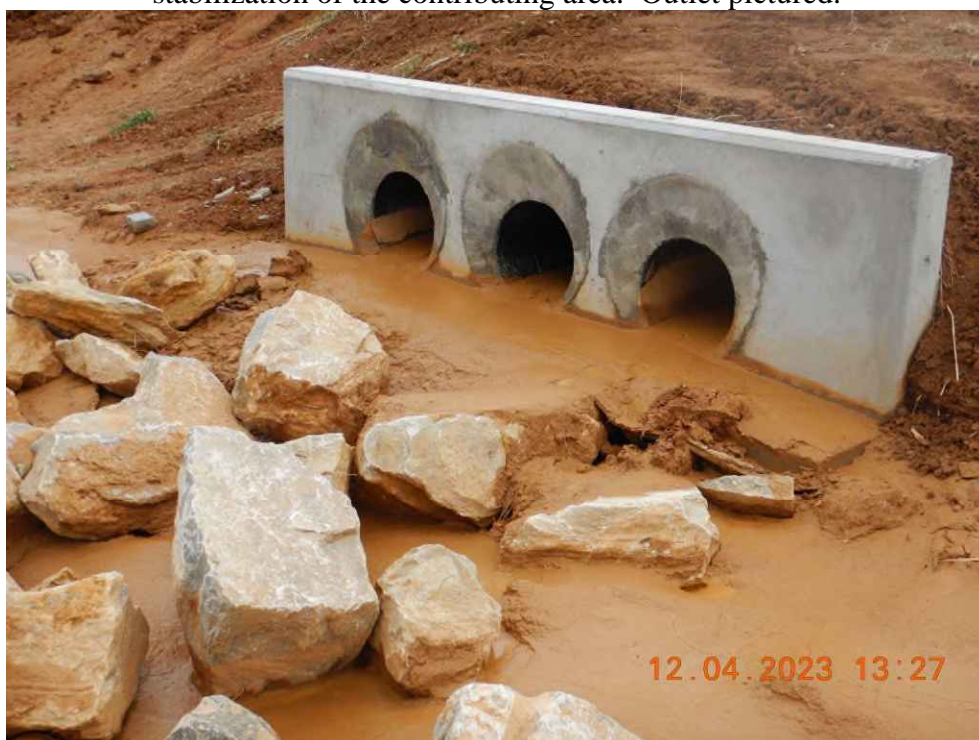
Sediment basin SB-11 (Pond 2B redline) that has been converted to stormwater retention prior to stabilization of the contributing area. Outlet showing sediment laden discharge pictured.

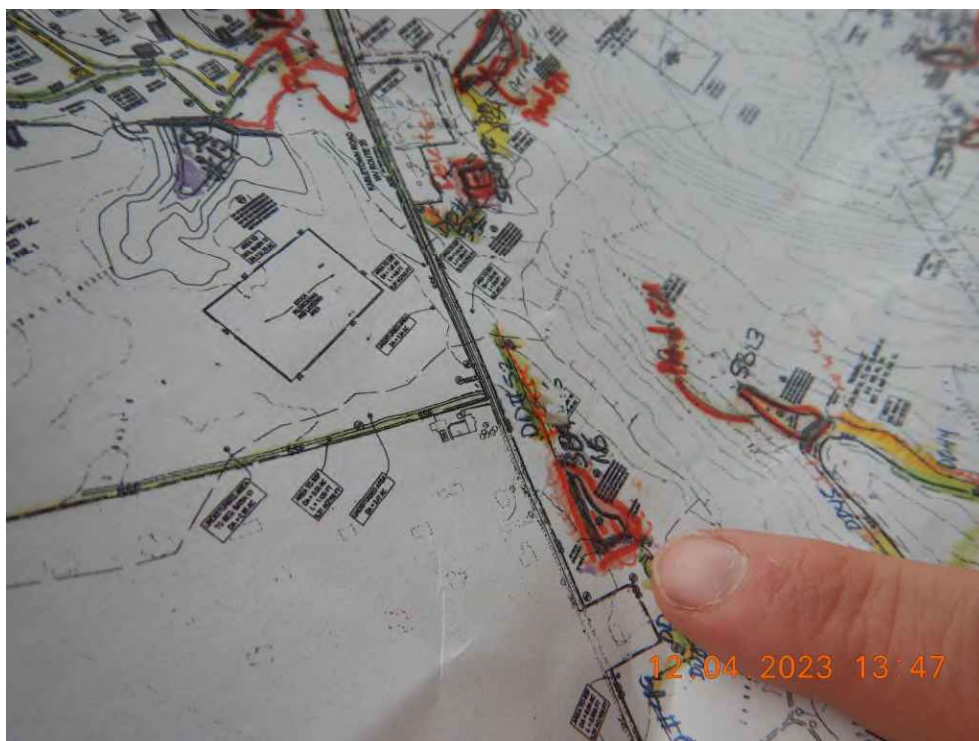
Sediment Basins 12 and 15 have been deleted prior to all uphill disturbance being vegetated.

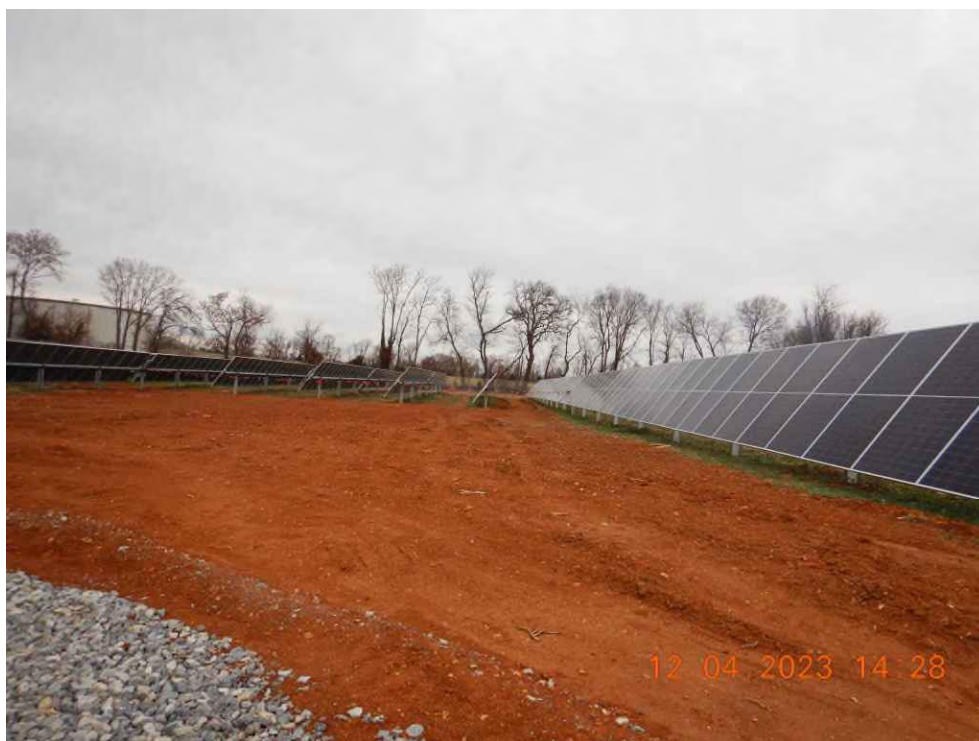
Area where Sediment Trap 5 should be installed.

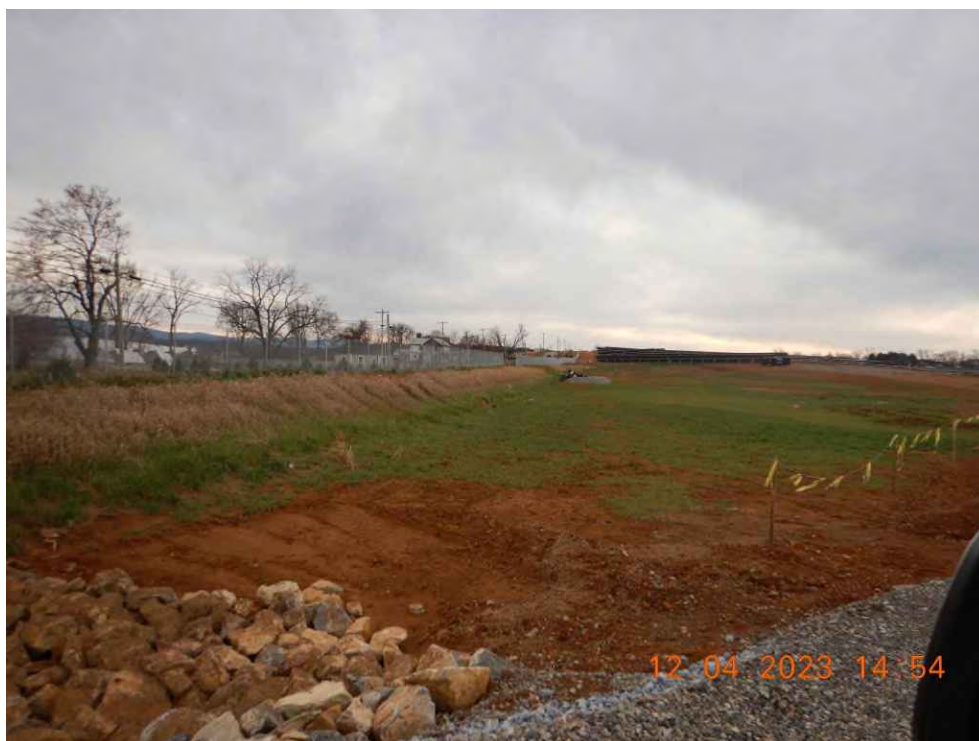
Pond 14A

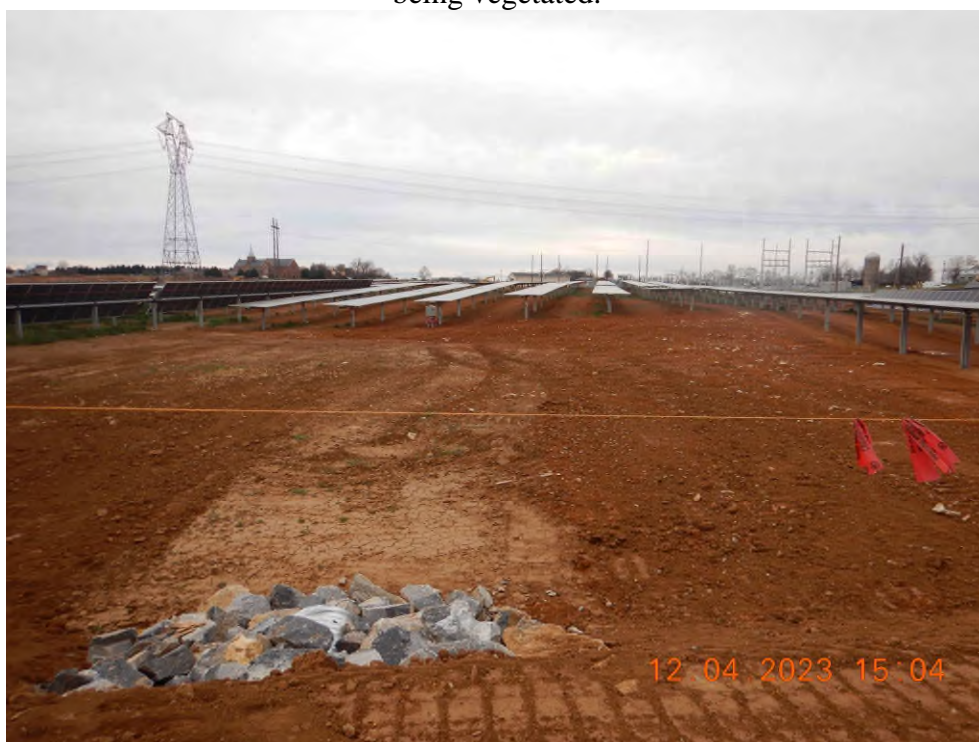
Unstabilized area above Pond 14A.

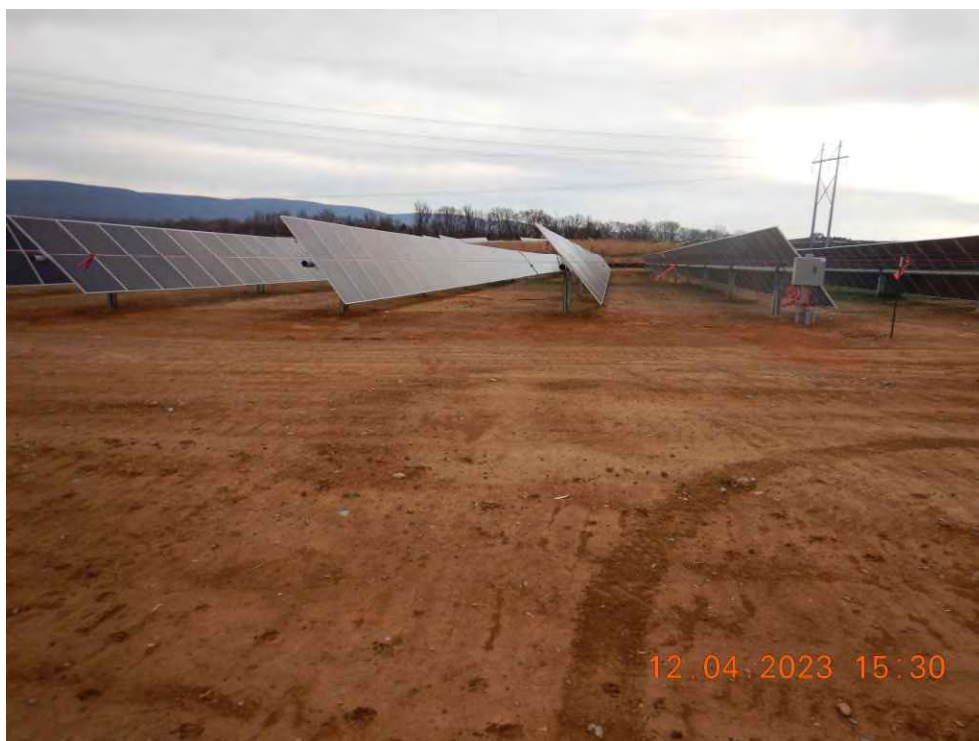
Area that has not been worked within the past 14 days and has not been stabilized.

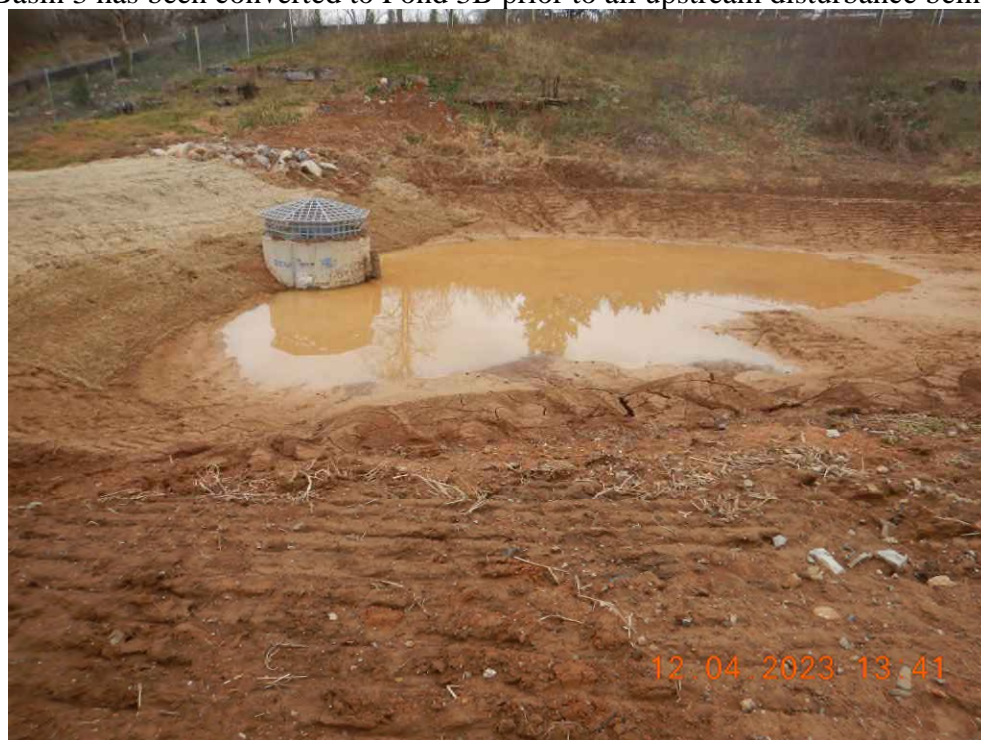
Sediment Basin 15 has been converted to Pond 1 prior to all upstream disturbance being vegetated.

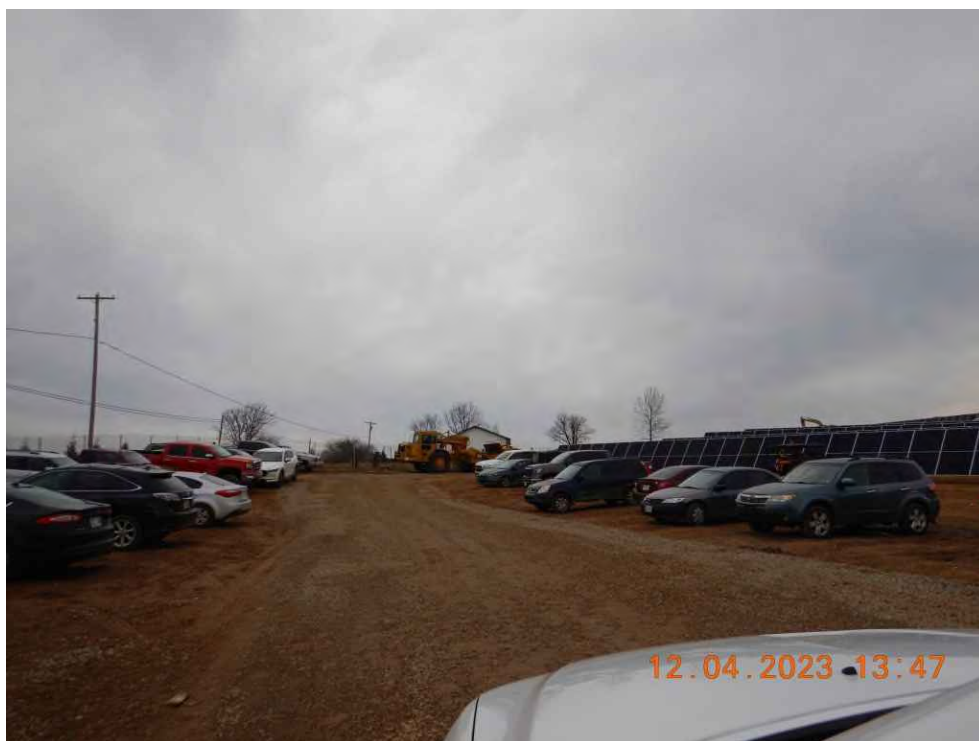
Sediment Basin 16 has been removed prior to all upstream disturbance being vegetated.

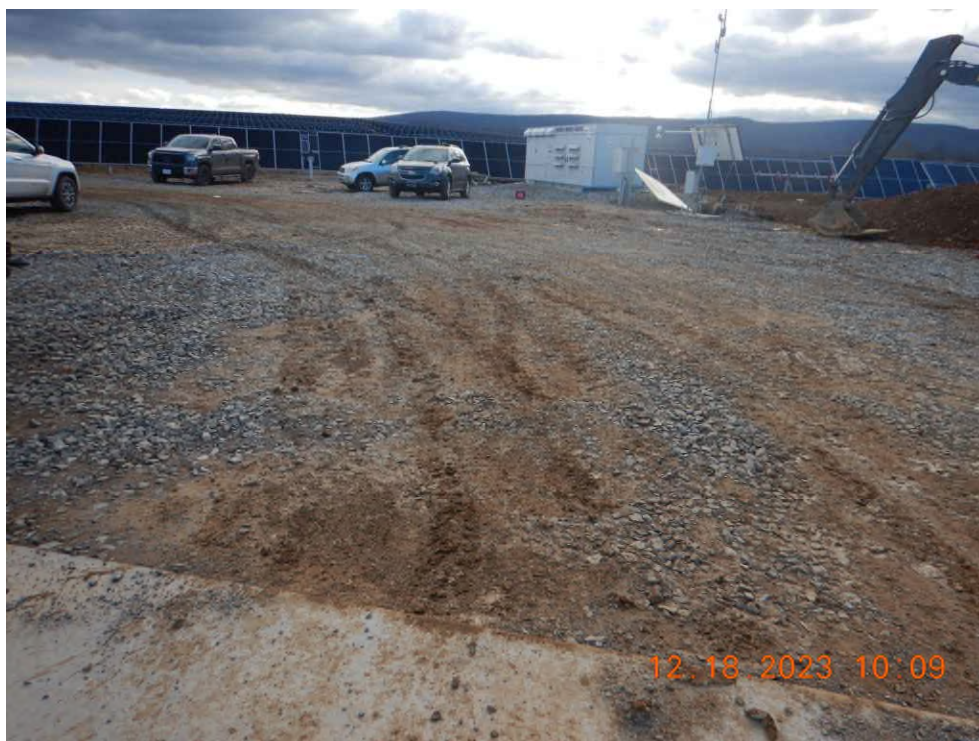
Construction entrance needs stabilized

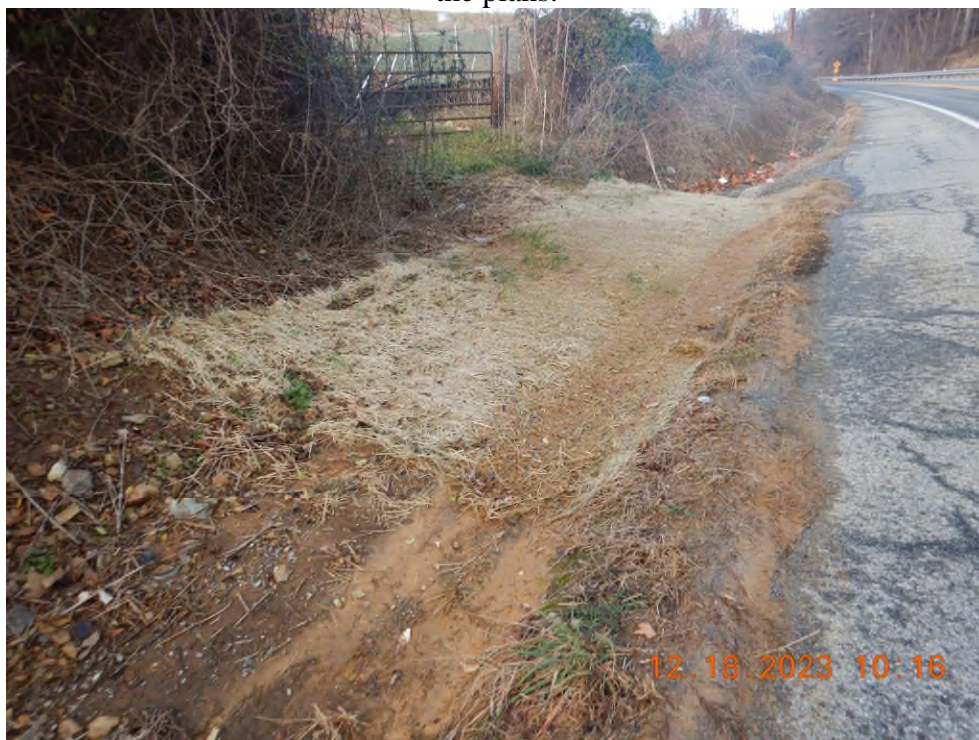
Sediment laden water leaving site via outlet of Sediment Basin 6.

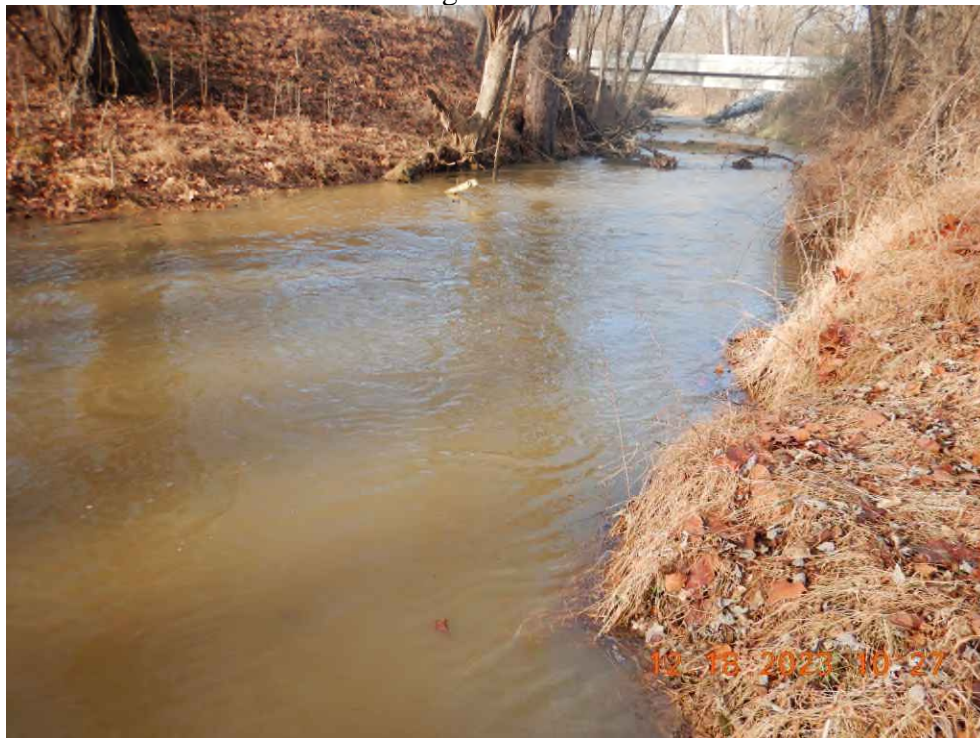
Sediment leaving site in Evitts Run causing conditions not allowable.

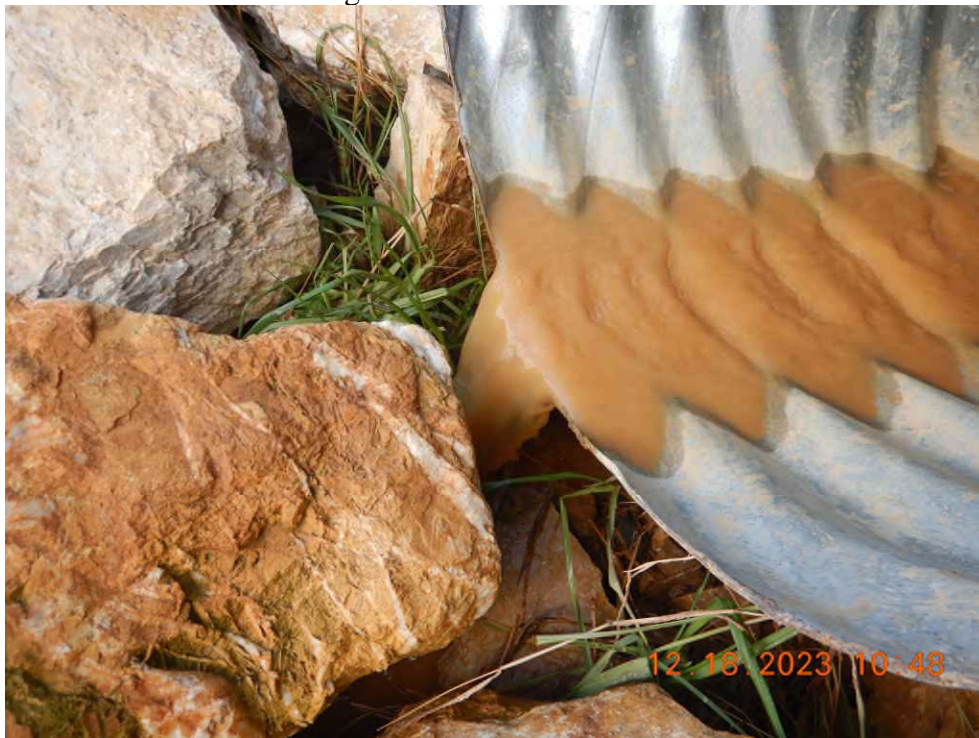
Sediment laden water leaving outlet of Sediment Basin 5.
