**CONSENT ORDER
ISSUED UNDER THE
WATER POLLUTION CONTROL ACT
WEST VIRGINIA CODE CHAPTER 22, ARTICLE 11**

ORDER NO.: 10260

1. Horus West Virginia 1, LLC is conducting land disturbance activity associated with the Blake Solar Project in Jefferson County, West Virginia. Horus West Virginia 1, LLC was issued WV/NPDES Water Pollution Control Permit No. WV0115924, Registration No. WVR111837, on August 12, 2022.
2. On May 15, 2023, West Virginia Department of Environmental Protection (WVDEP) personnel conducted an inspection of the facility. During the inspection, violations of the following sections of the WV/NPDES permit were observed and documented:
 - a. Section II.H.1.d. – Horus West Virginia 1, LLC failed to provide an adequate stone access entrance/exit to reduce the tracking of sediment onto public or private roads.

Horus West Virginia 1, LLC, WVR111839, Blake Solar Project, 7/18/2023

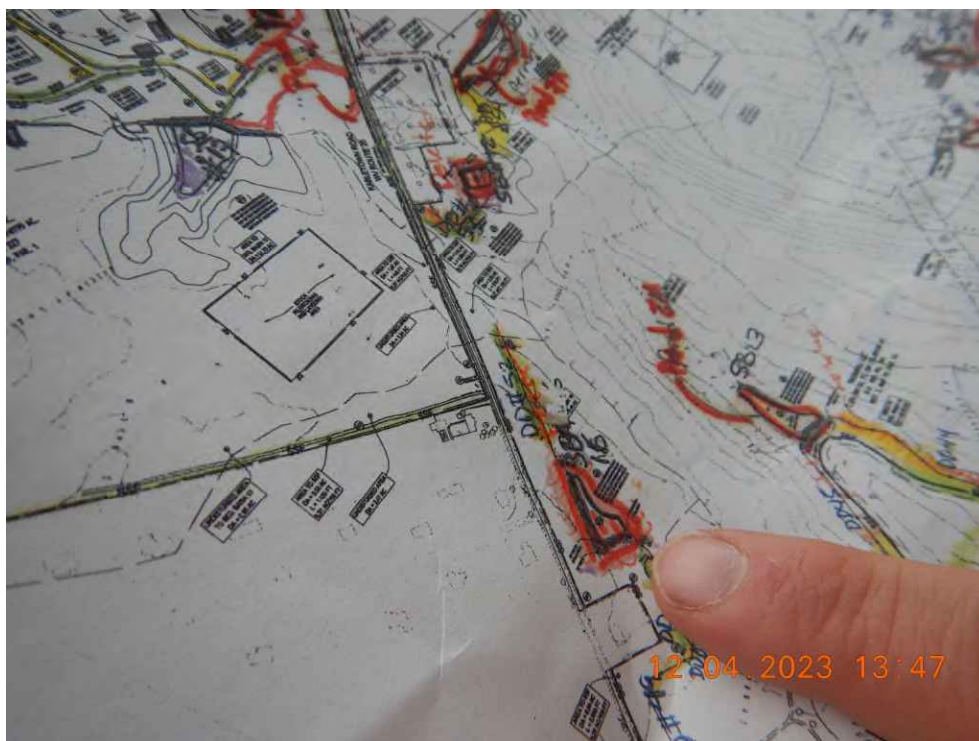
Sediment Basins 12 and 15 have been deleted prior to all uphill disturbance being vegetated.

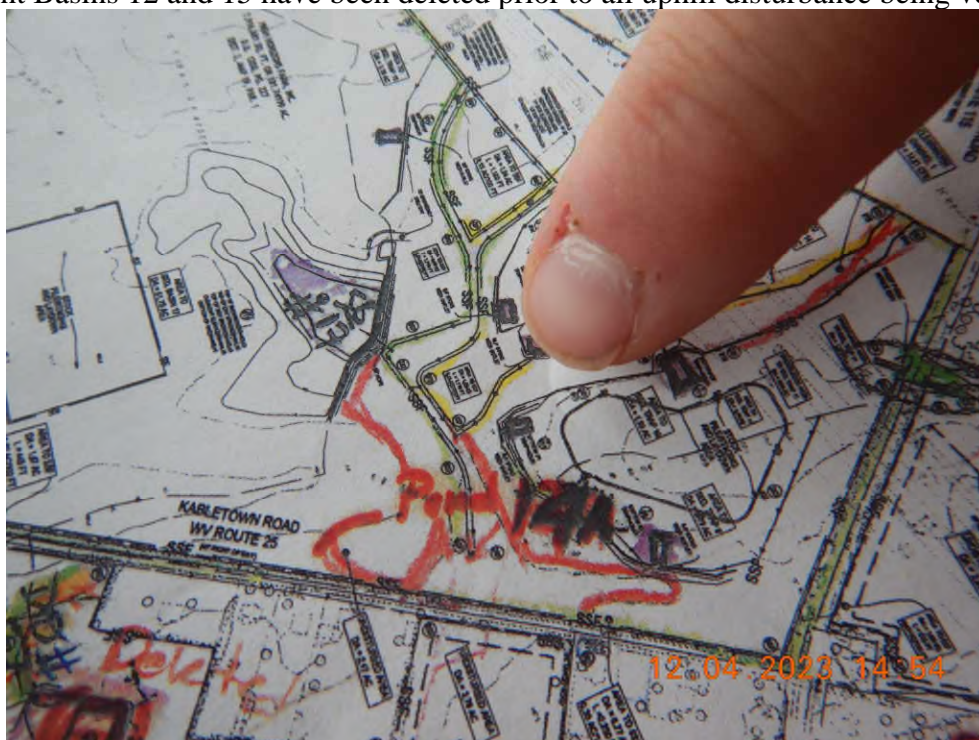
Pond 14A which is installed and not in the approved SWPPP.

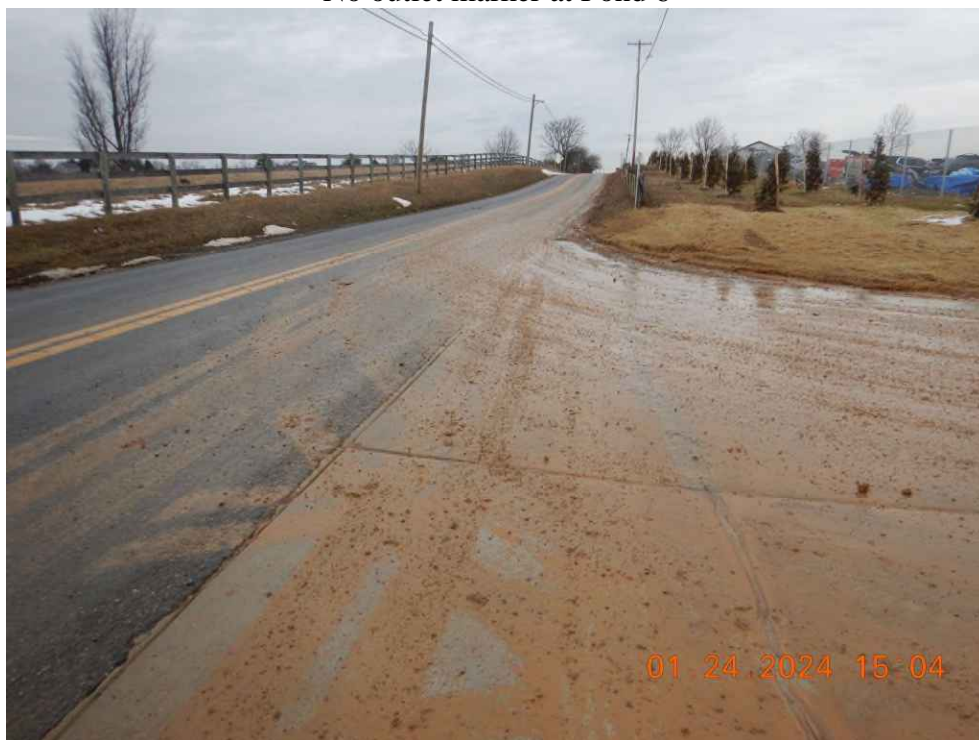
Track-out from Construction Entrance 2 that was not being cleaned during inspection.

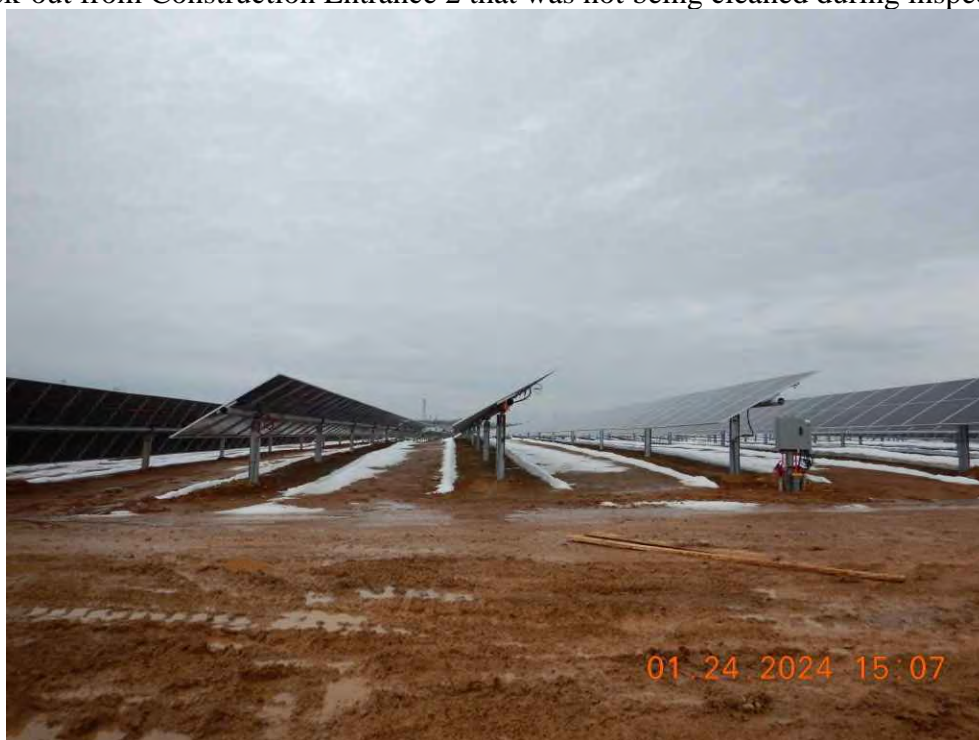
Unstabilized area that has not been worked within the past 14 days.

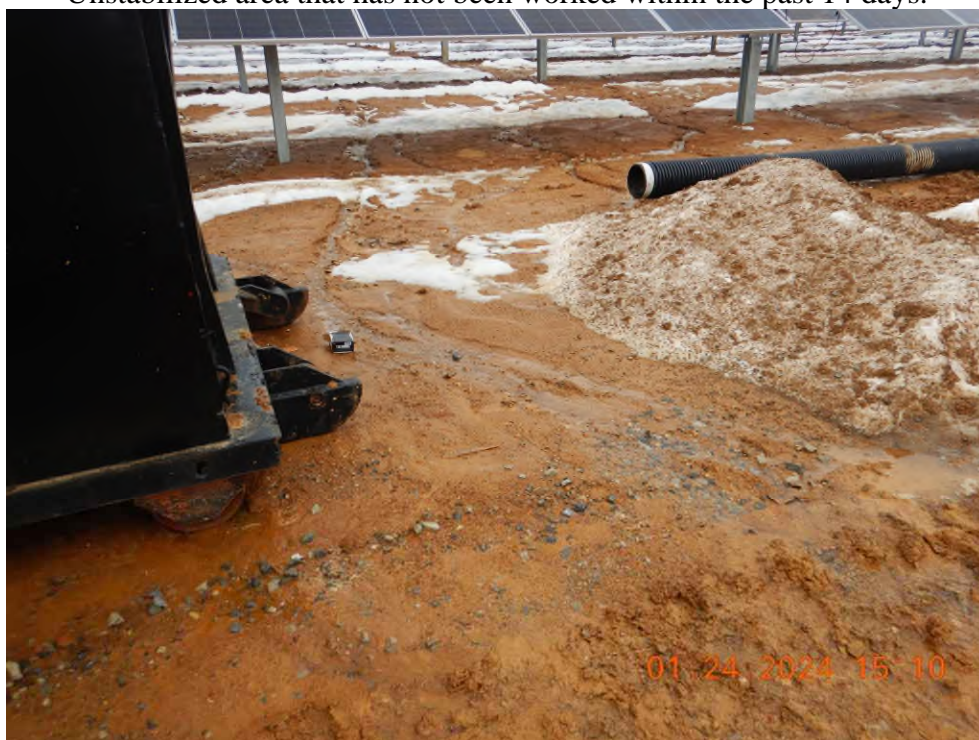
Erosion Rills that have formed above Basin 13. Area above has not been worked within the past 14 days.

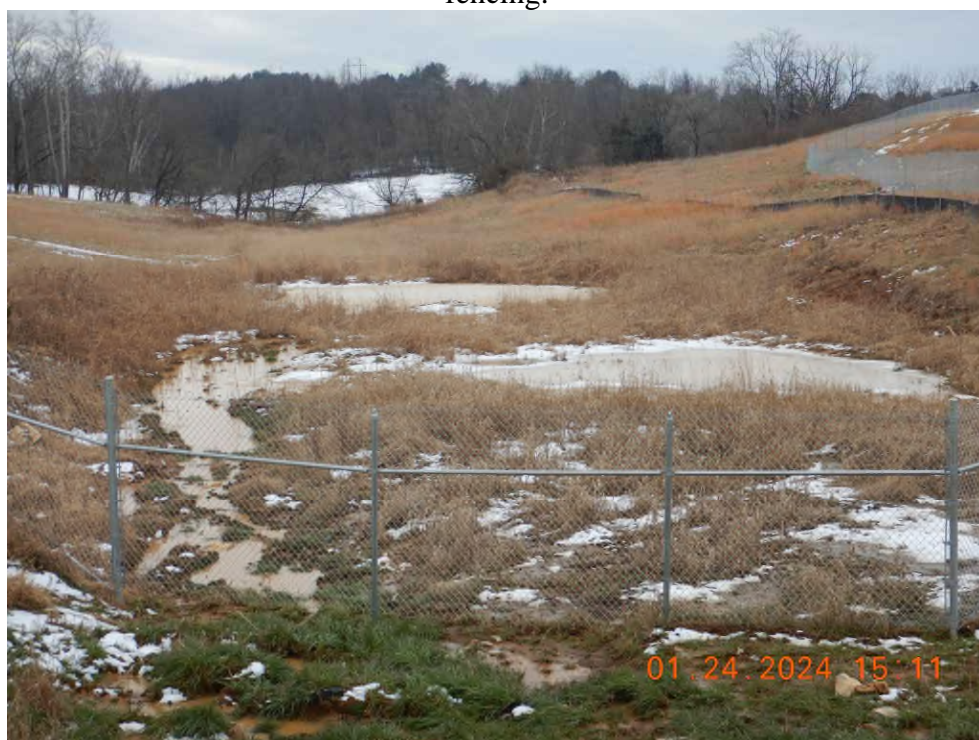
Sediment laden discharge into wetlands from Basin 13. Leading to Evitts Run.

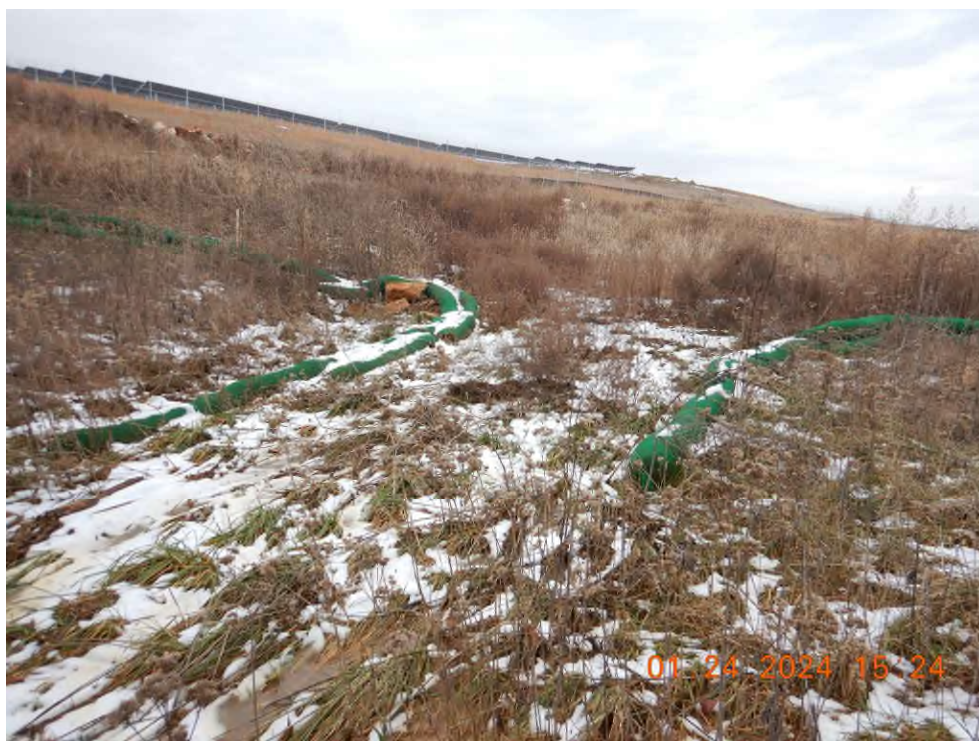
Sediment laden water leaving site downslope of Basin 13.

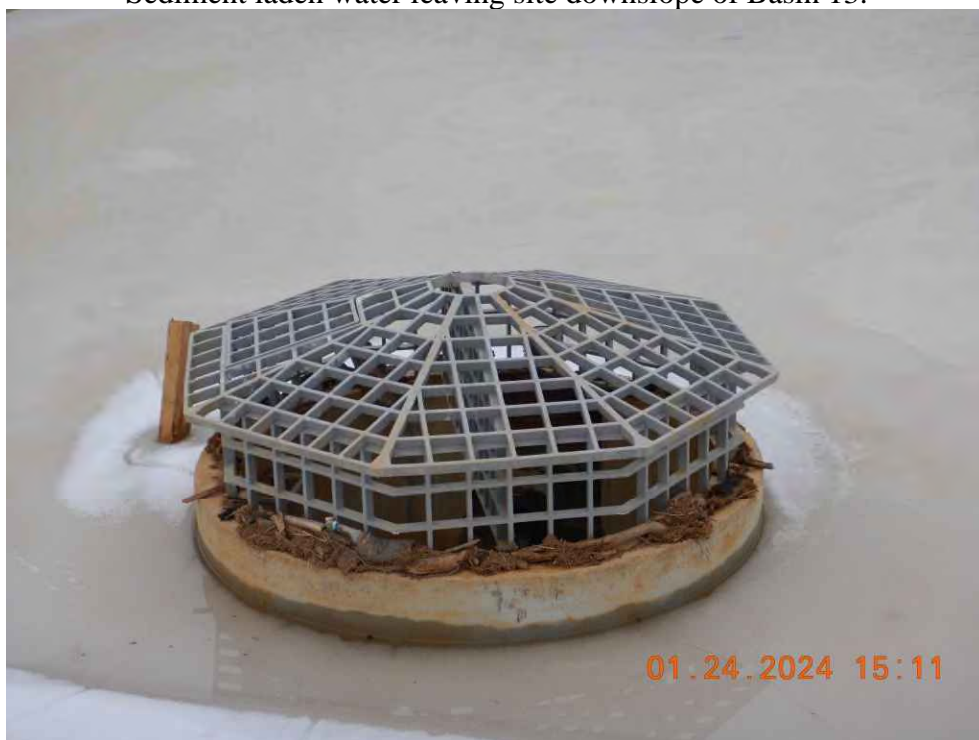
Riser for Basin 13 installed for the final stormwater pond.

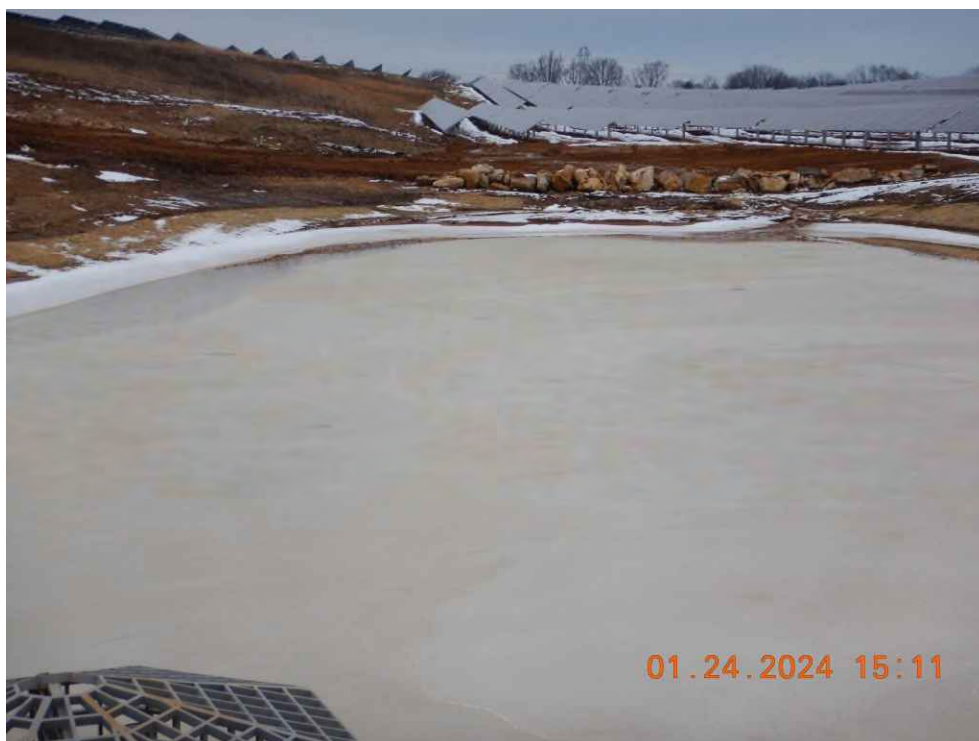
Area above Basin 13 is unstabilized prior to installation of the final stormwater feature.

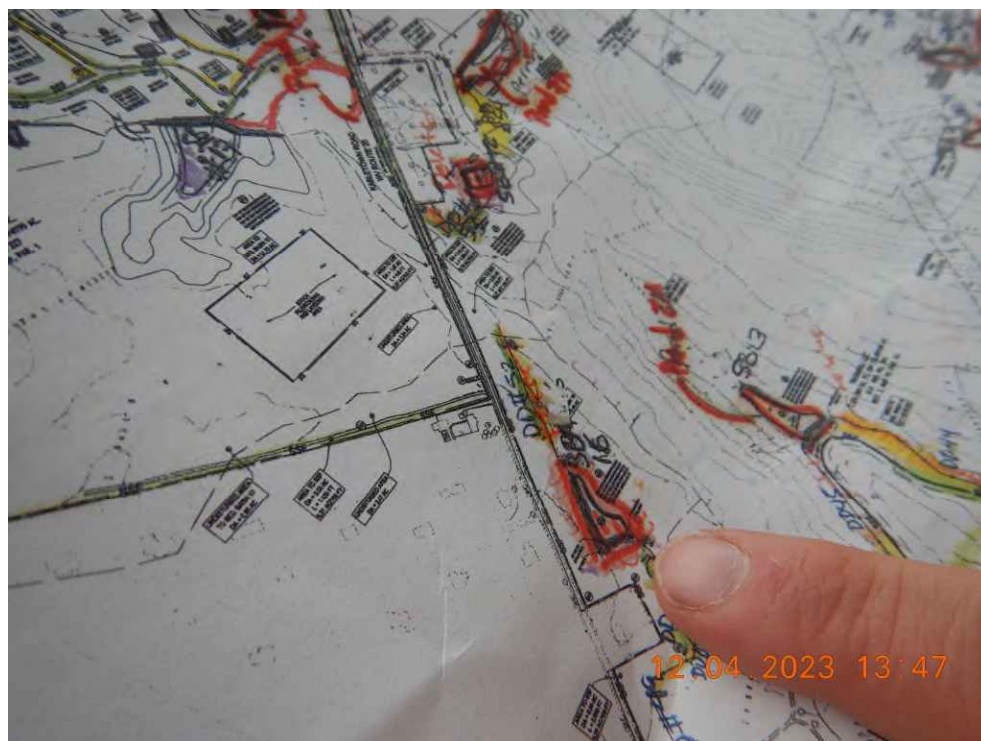
Sediment Basins 12 and 15 have been deleted prior to all uphill disturbance being vegetated.

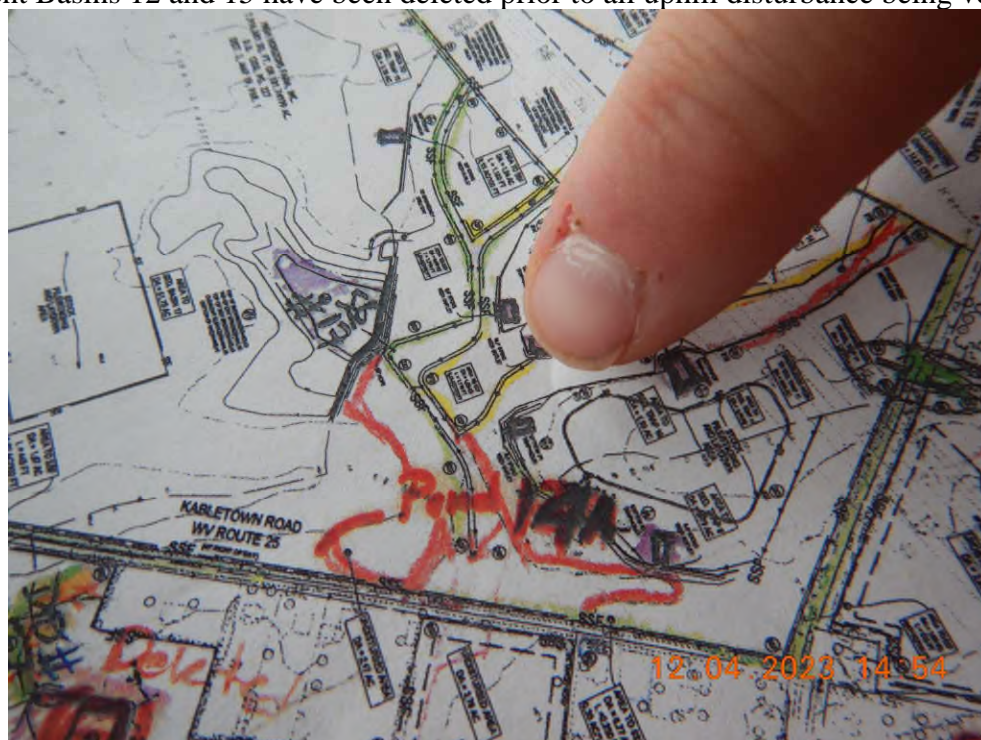
Pond 14A which is installed and not in the approved SWPPP.

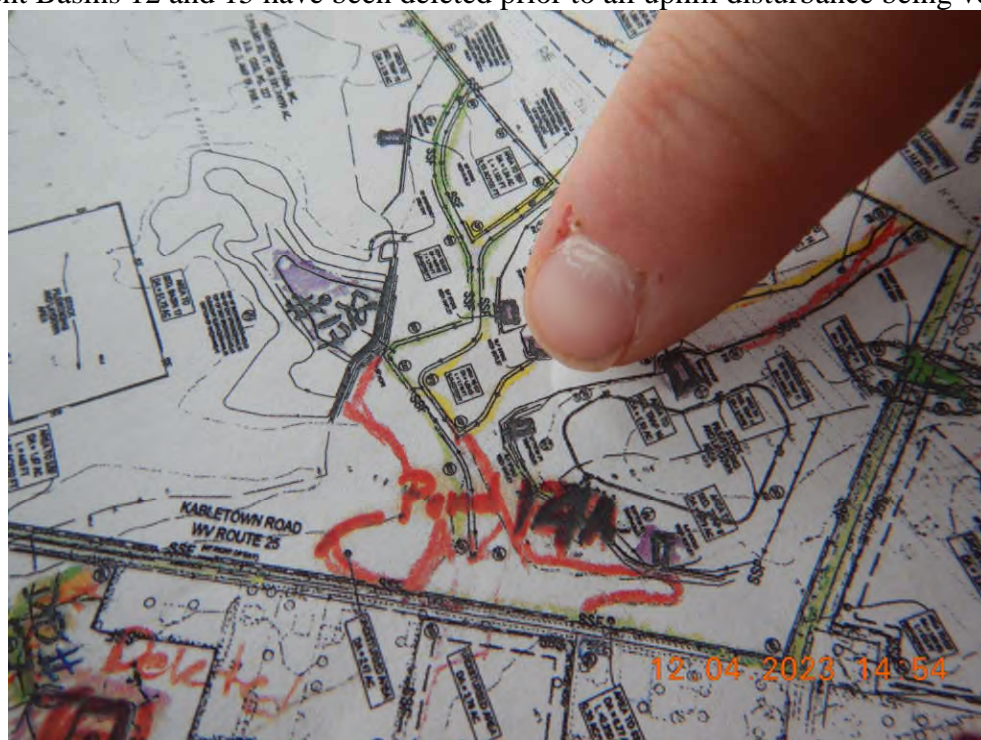
Pond 14A which is installed and not in the approved SWPPP.

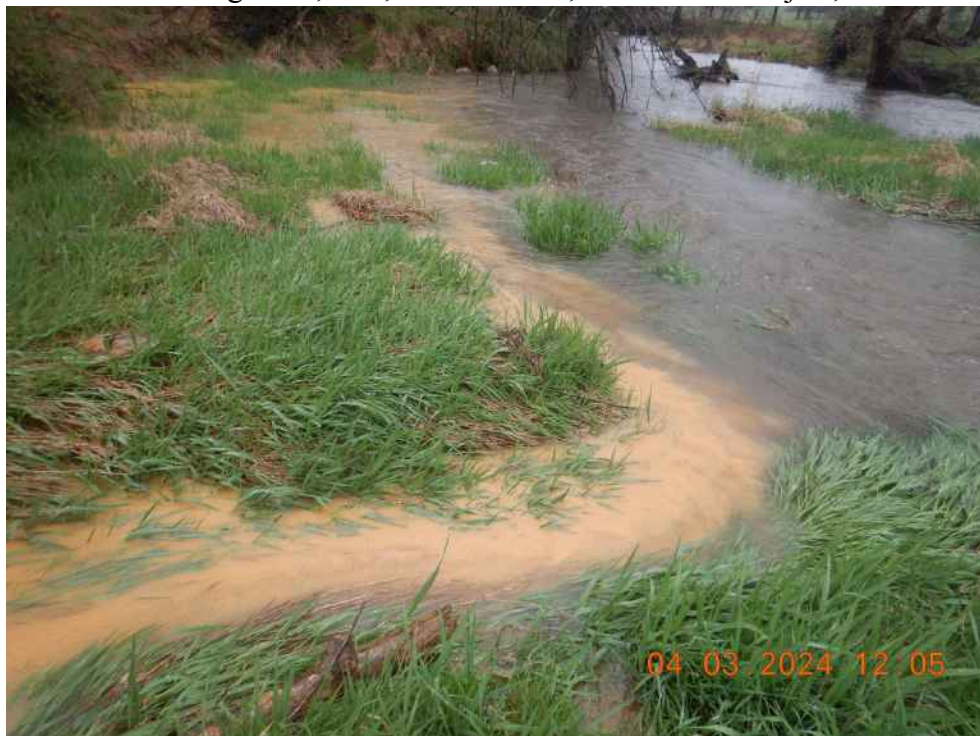
Outlet 2A discharging off site directly into Evitts Run. Causing Conditions not allowable.

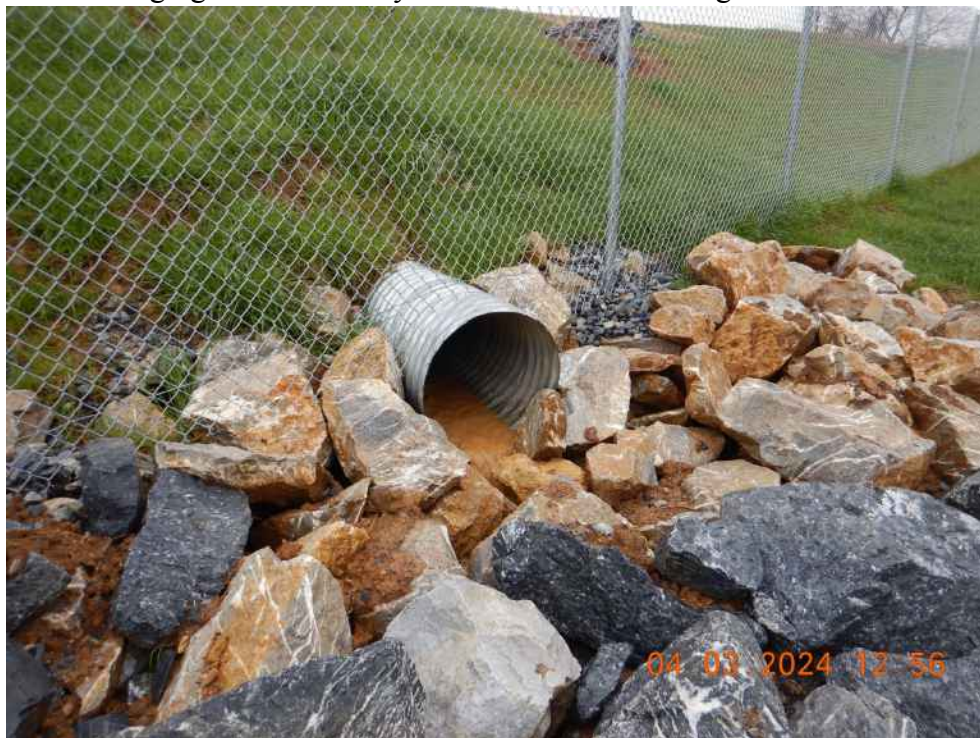
Outlet 6 discharging sediment laden water.

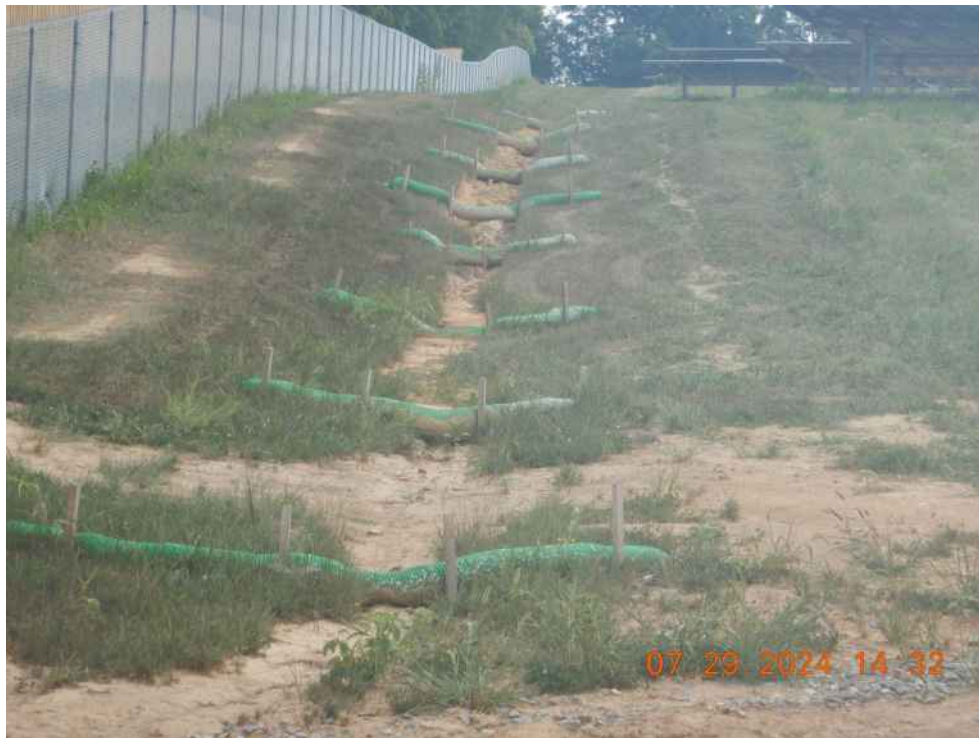
Diversion ditch checks that have been undermined and not repaired. Area of former access road below sediment basin 7.

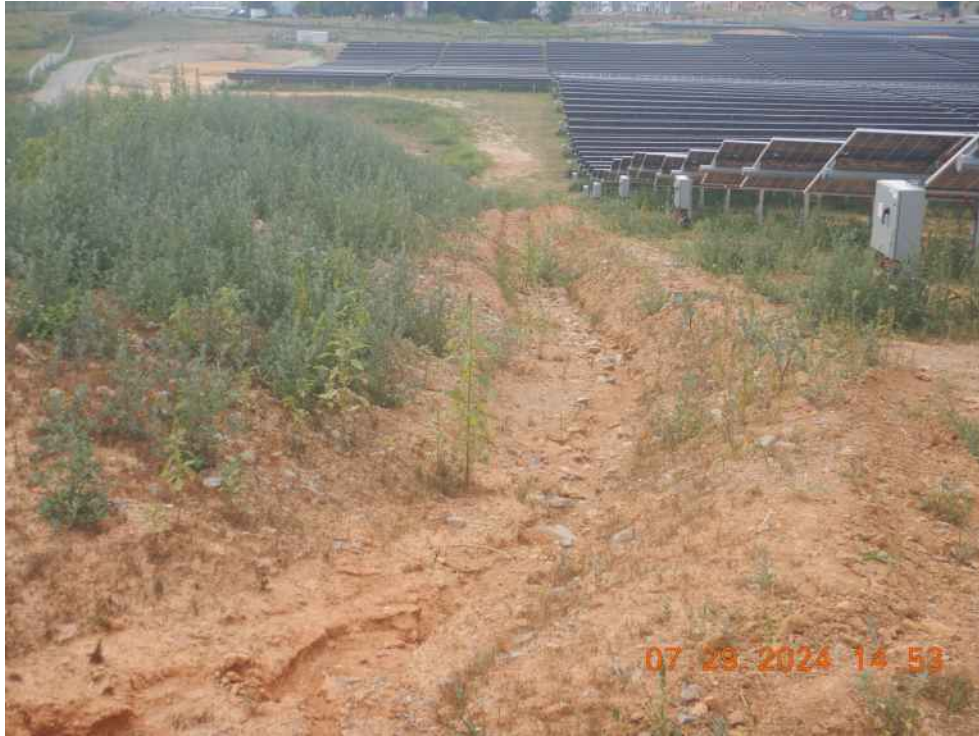
An unstabilized diversion that has not been repaired. Above sediment trap 2.

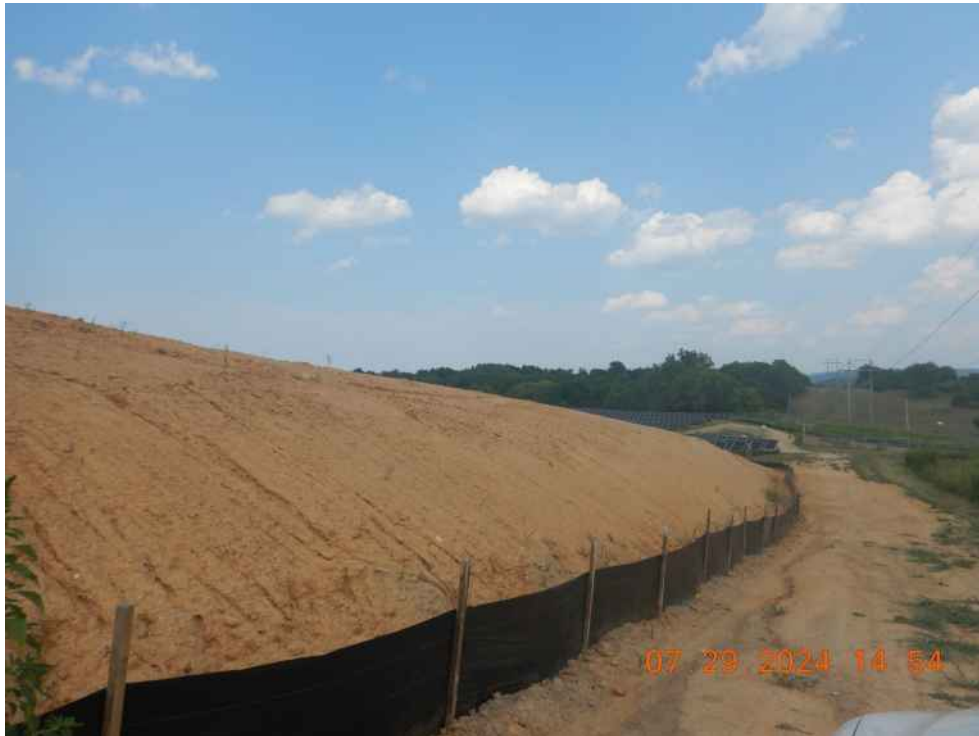
An unstabilized soil stockpile. Sediment trap 2 area.

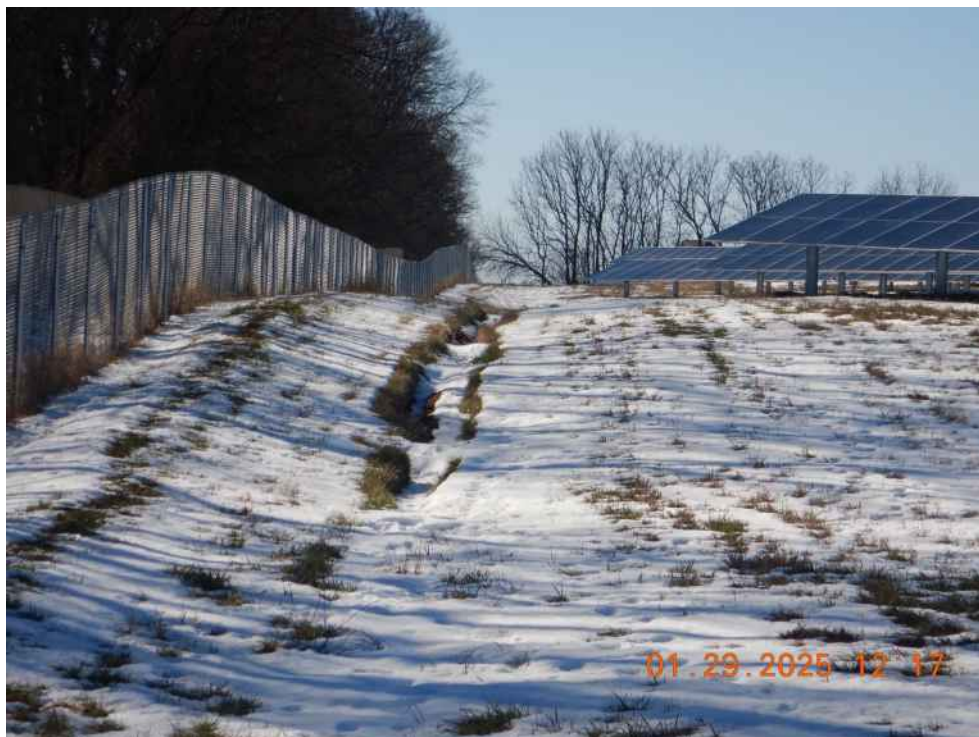
An unstabilized/washed out diversion channel.
