**CONSENT ORDER
ISSUED UNDER THE
WATER POLLUTION CONTROL ACT
WEST VIRGINIA CODE CHAPTER 22, ARTICLE 11**

ORDER NO.: 10260

1. Horus West Virginia 1, LLC is conducting land disturbance activity associated with the Blake Solar Project in Jefferson County, West Virginia. Horus West Virginia 1, LLC was issued WV/NPDES Water Pollution Control Permit No. WV0115924, Registration No. WVR111837, on August 12, 2022.
2. On May 15, 2023, West Virginia Department of Environmental Protection (WVDEP) personnel conducted an inspection of the facility. During the inspection, violations of the following sections of the WV/NPDES permit were observed and documented:
 - a. Section II.H.1.d. – Horus West Virginia 1, LLC failed to provide an adequate stone access entrance/exit to reduce the tracking of sediment onto public or private roads.

Horus West Virginia 1, LLC, WVR111839, Blake Solar Project, 7/18/2023

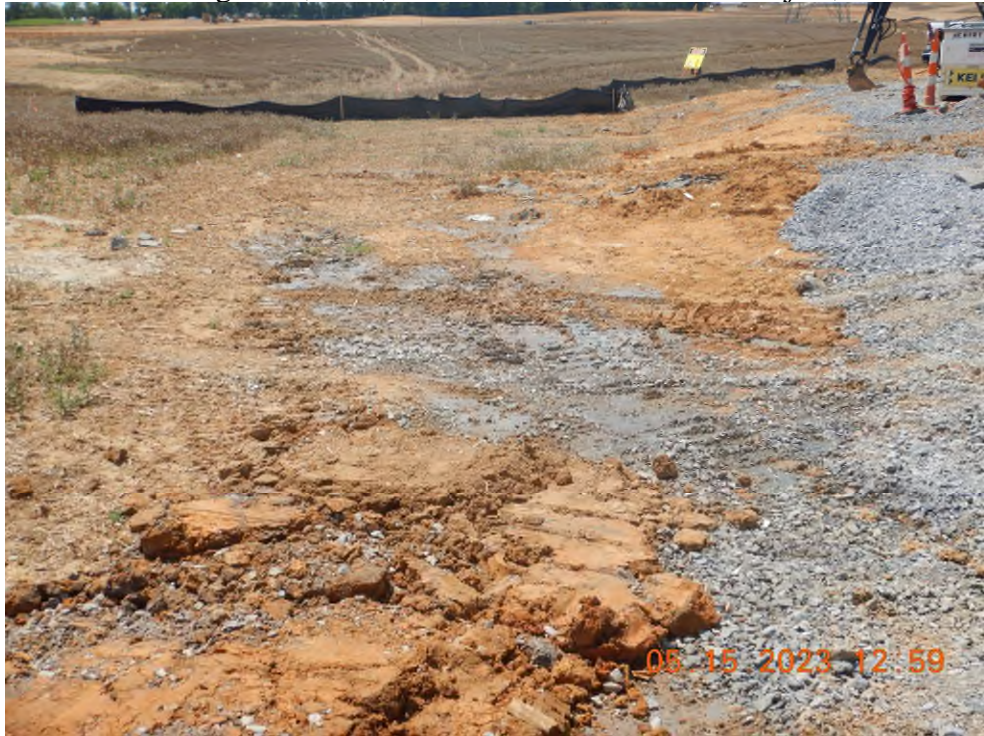
Concrete washout not being used.

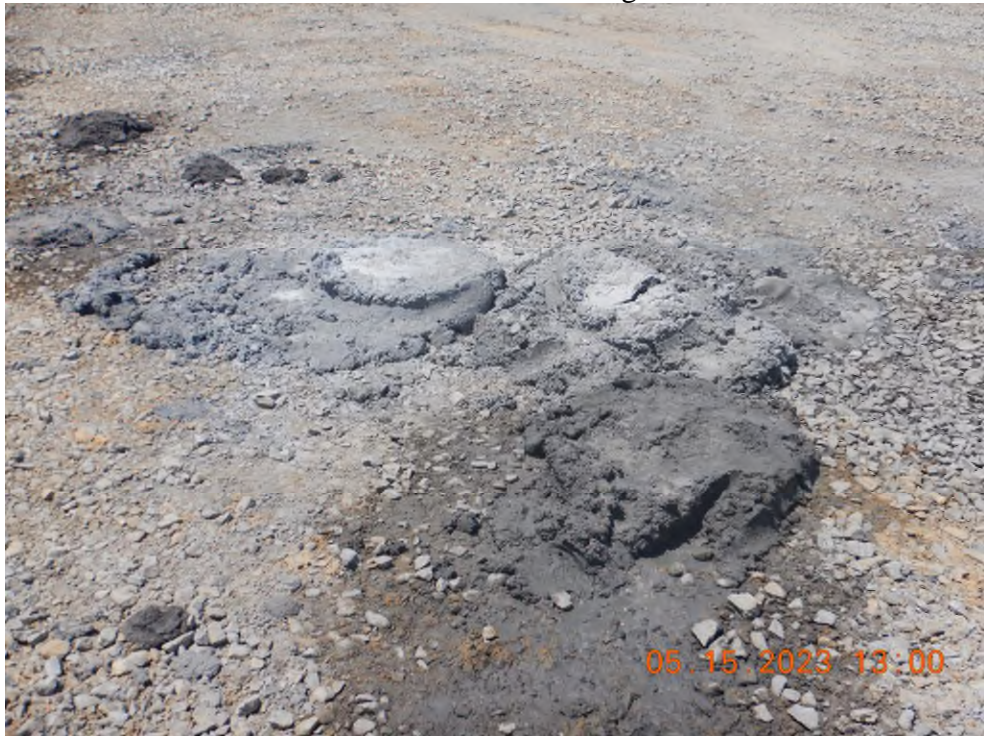
Concrete washout not being used.

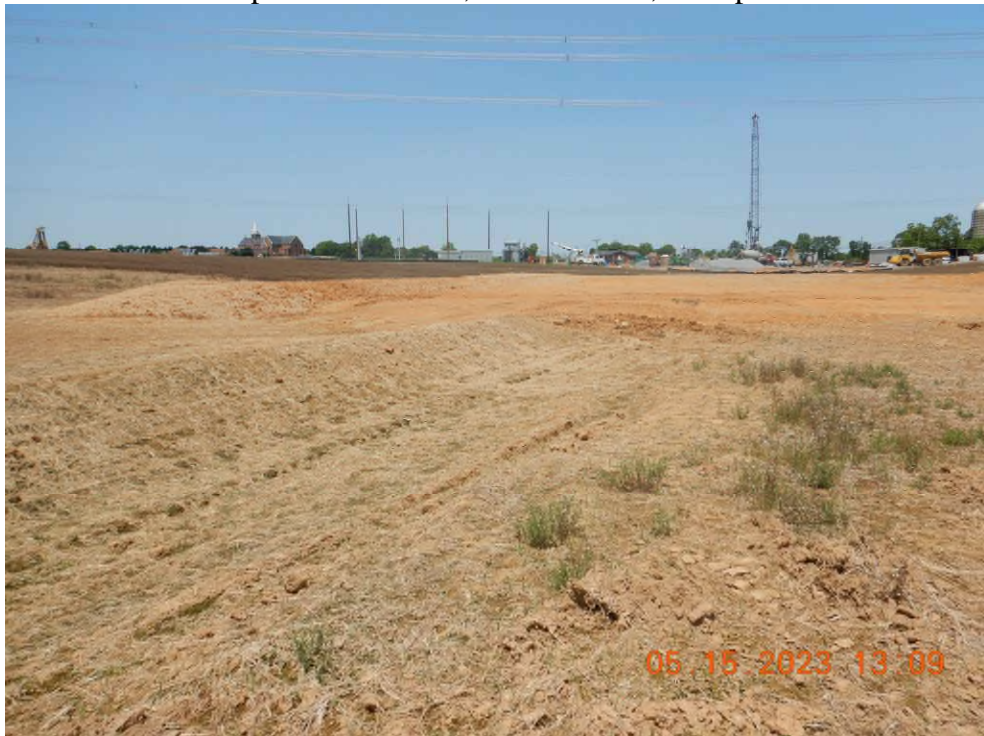
Clean water diversion is not vegetated prior to being put into use.

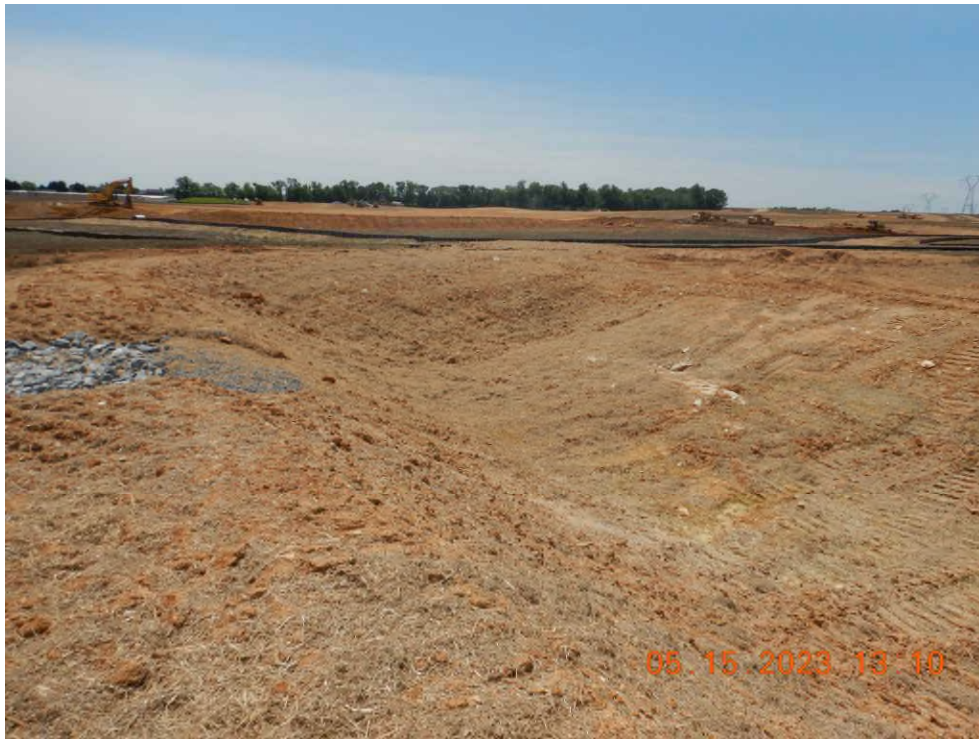
Sediment Trap 14 does not have a stabilized inlet.

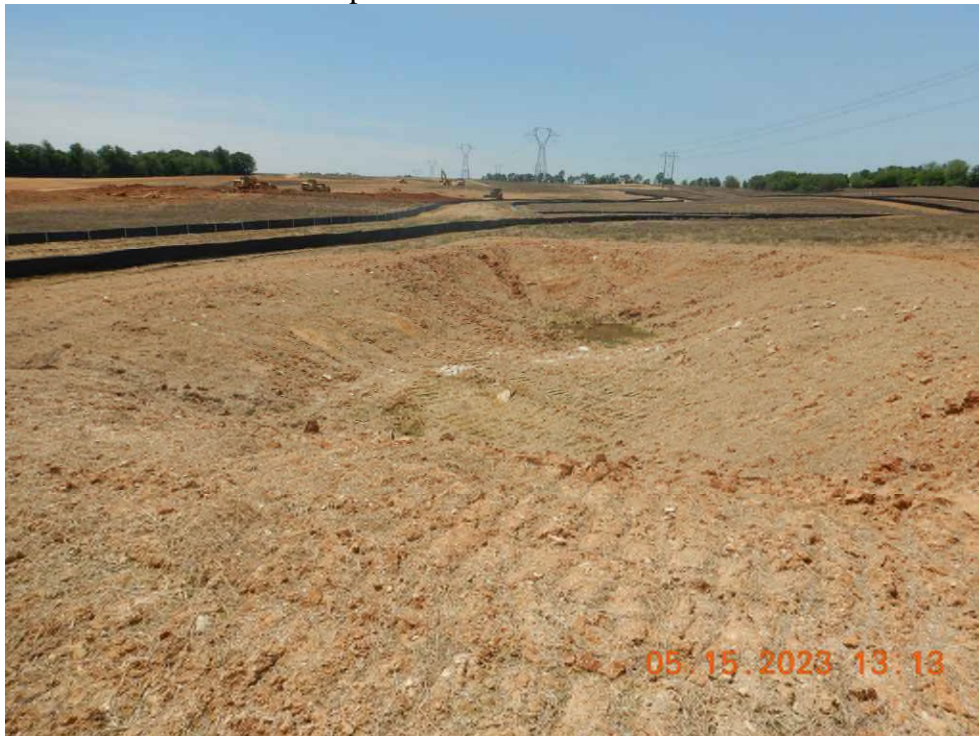
Sediment Trap 16 has no stabilized inlet or outlet.

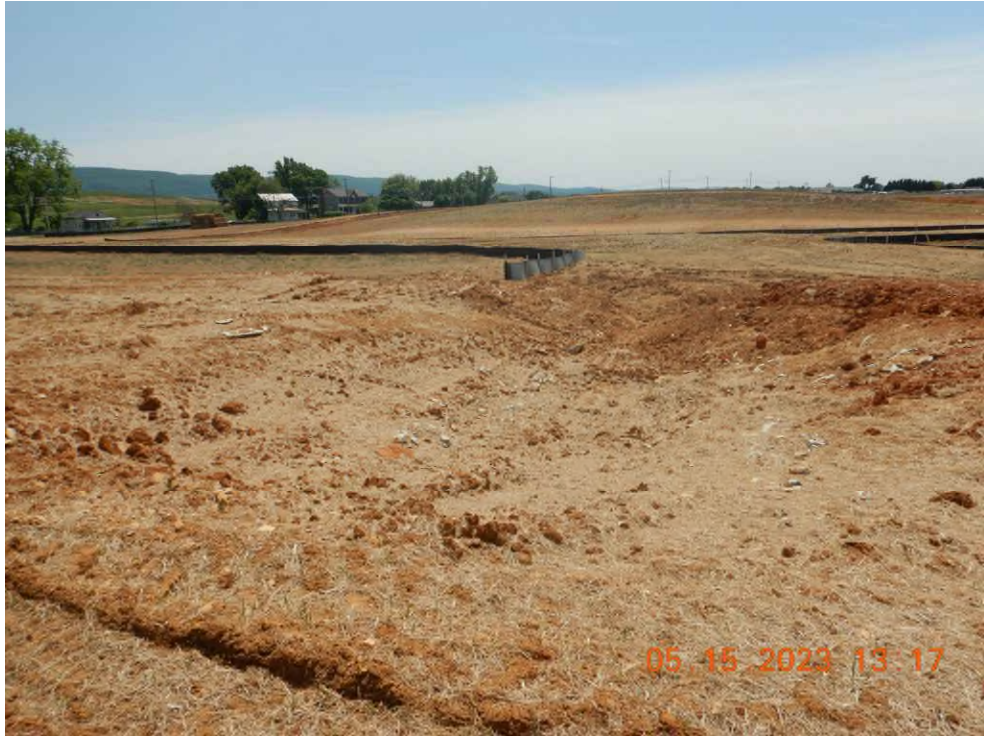
Sediment Trap 10 has no stabilized Inlet or Outlet.

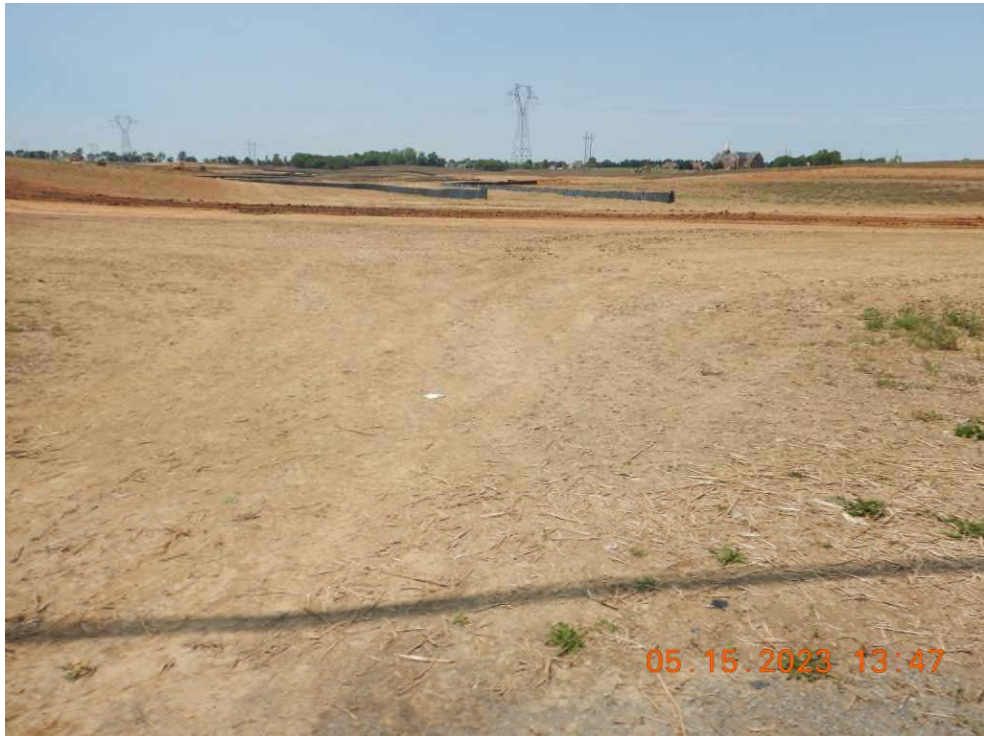
Construction entrance needs stabilization.

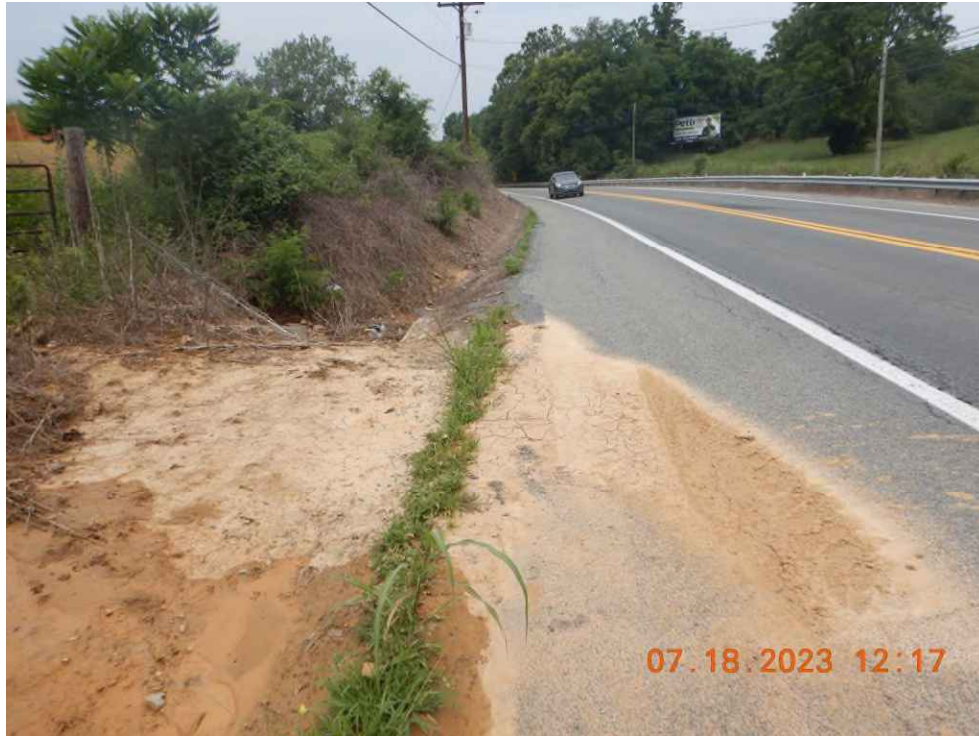
Outlet drainage area of Sediment Basin 6, discharging into WVDOH right of way

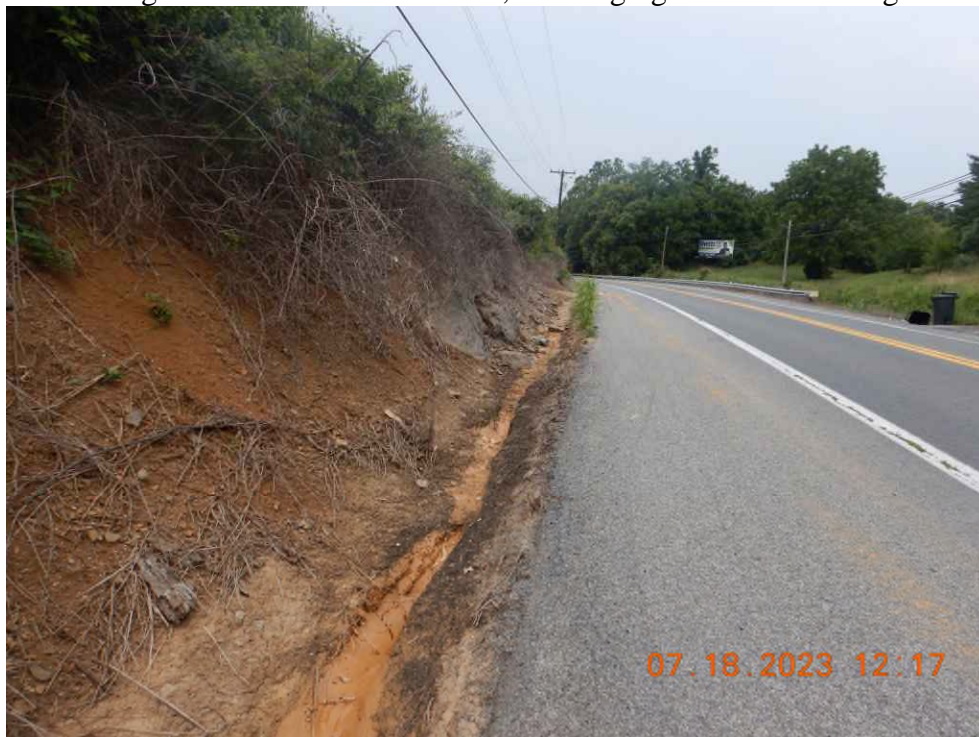
Sediment laden water leaving the project area through WVDOH right of way.

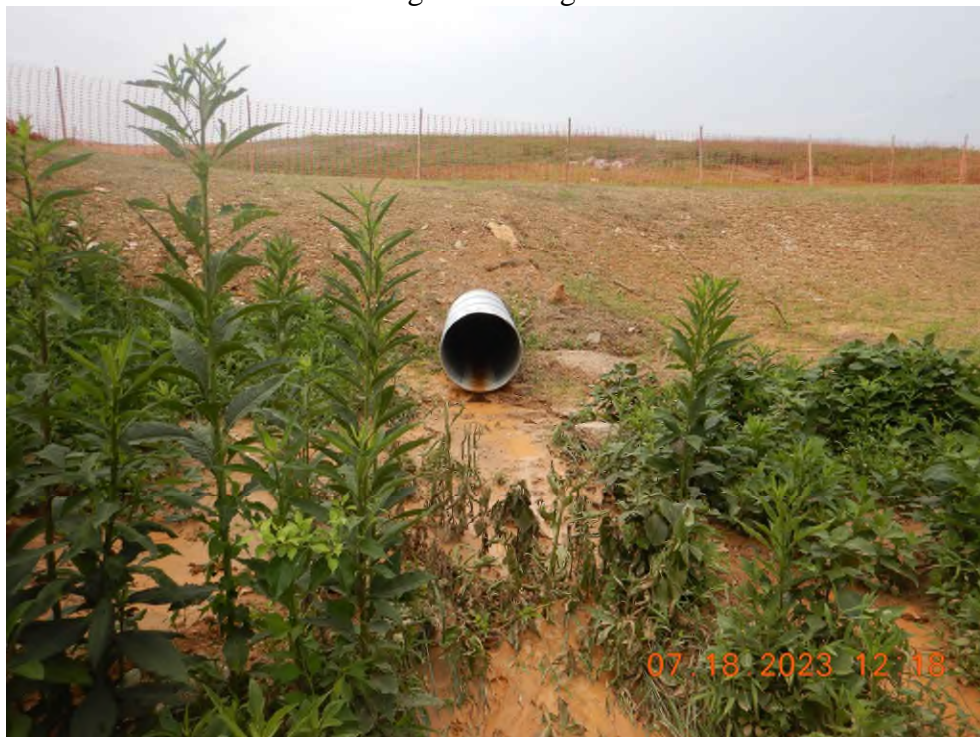
Outlet of Sediment Basin 6. No marker/sign for outlet.

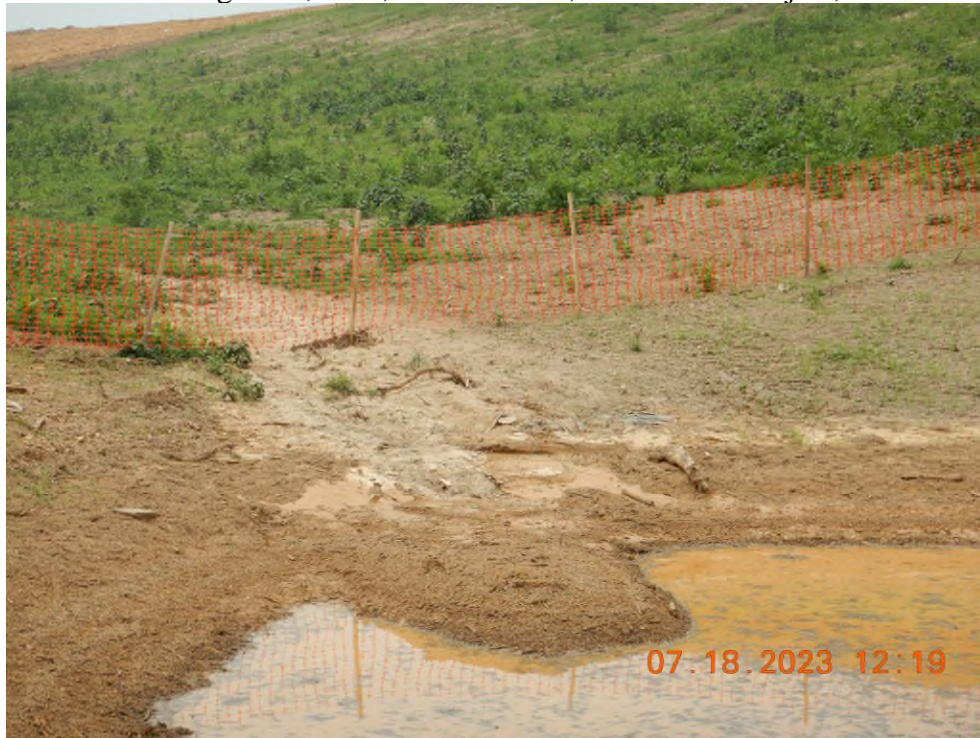
Unstable inlet to Sediment Basin 6.

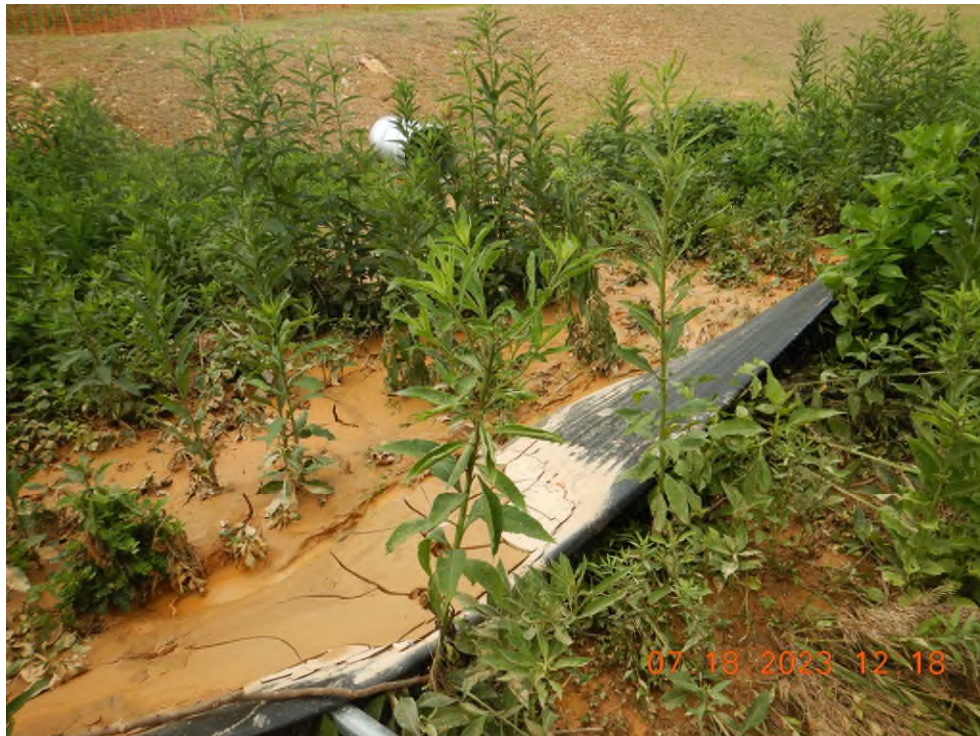
Super Silt fencing at lower end of outlet of Sediment Basin 6 needs maintenance

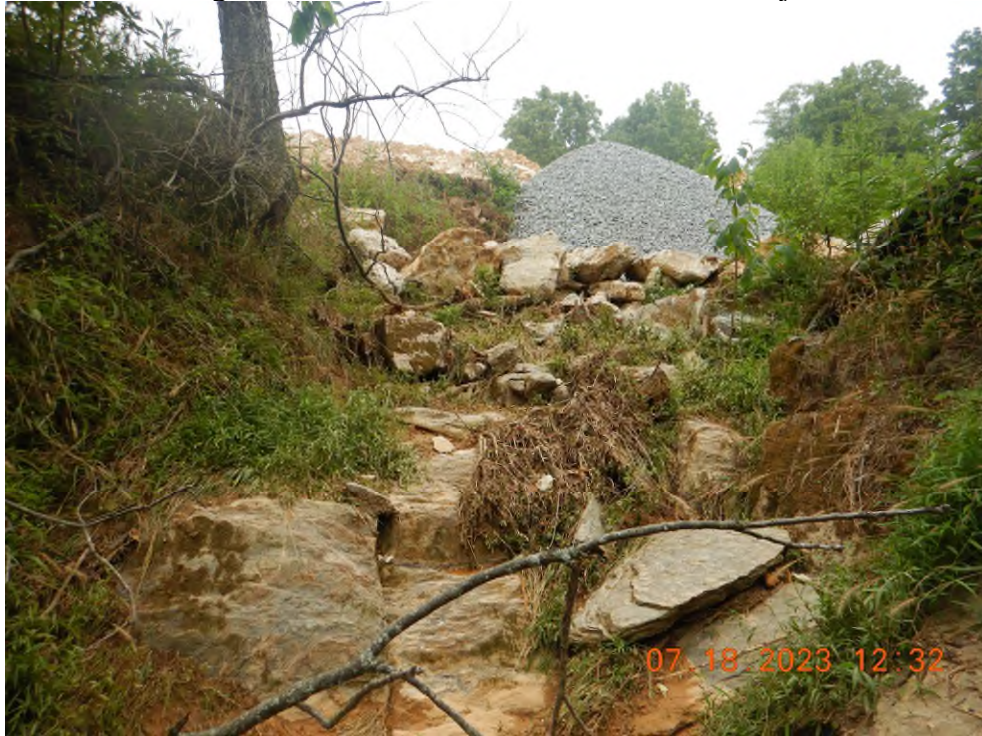
Sediment Basin 5 has not been installed per the approved SWPPP. Sediment laden water is leaving the area and discharging into Evitts Run.

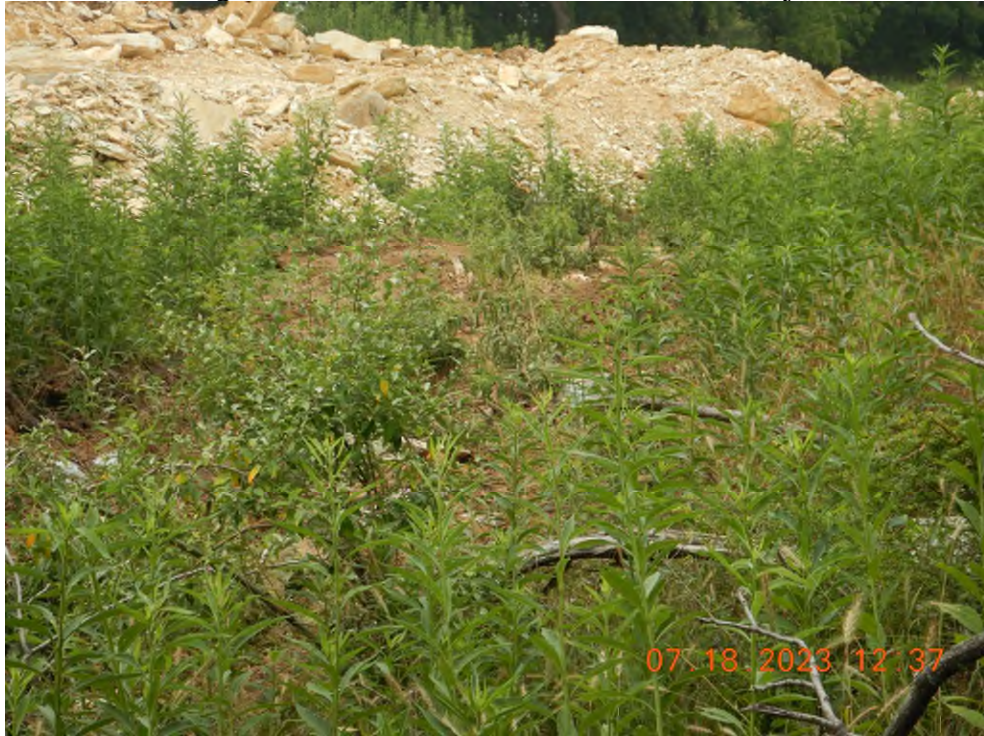
Area where Sediment Basin 5 should be installed and is not.

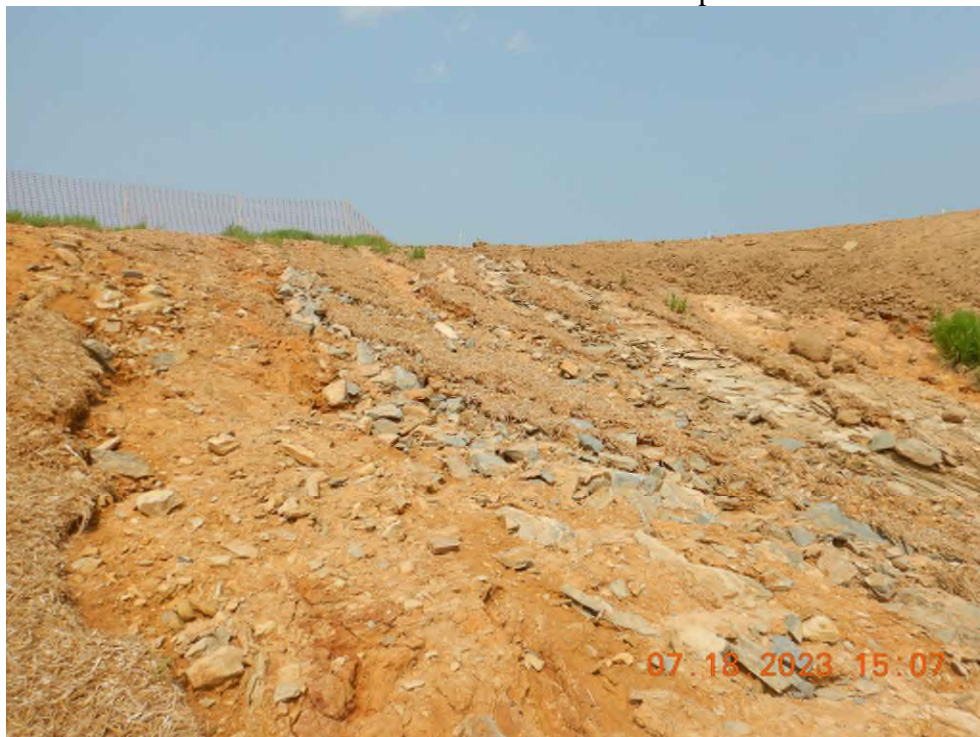
Erosion rills need stabilization.

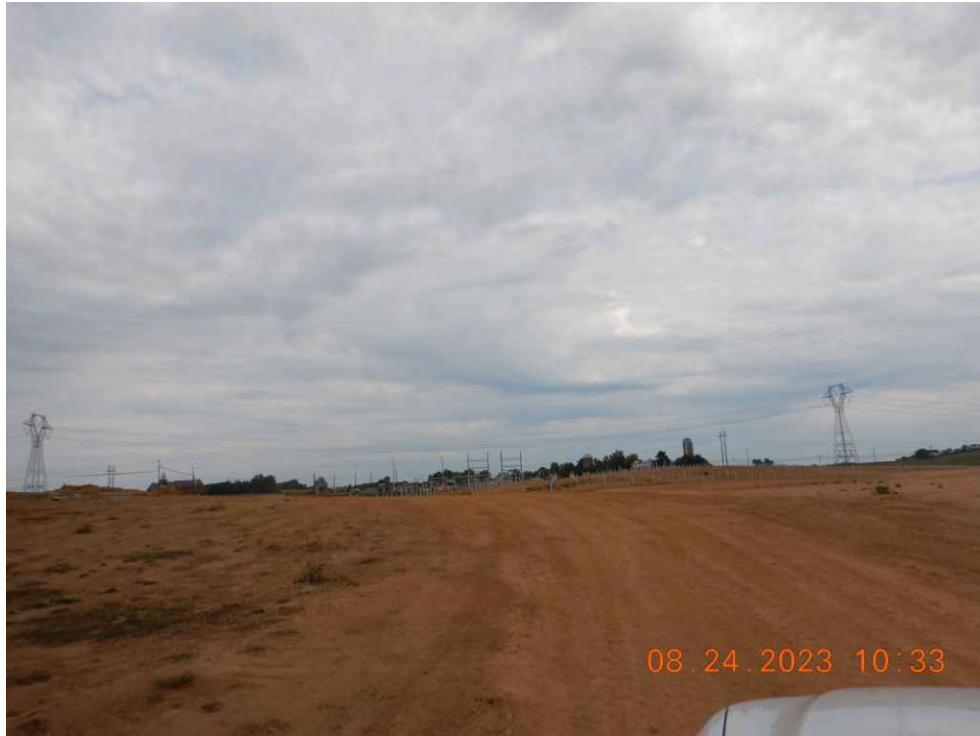
Area that has not been worked within the past 14 days and lacks temporary stabilization.

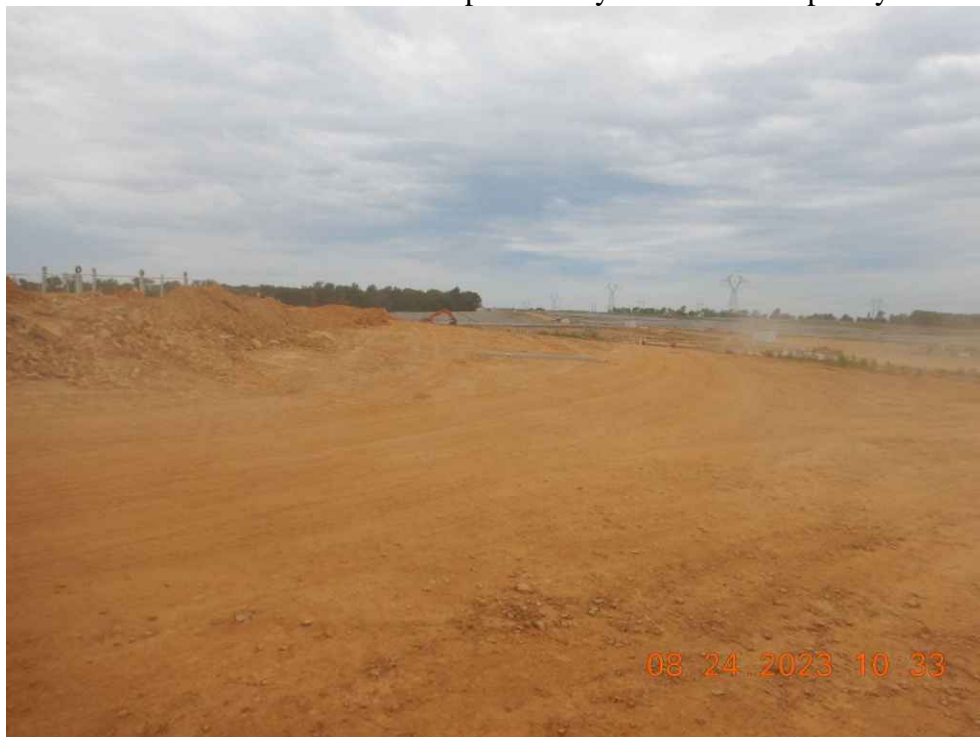
Area lacks temporary stabilization.

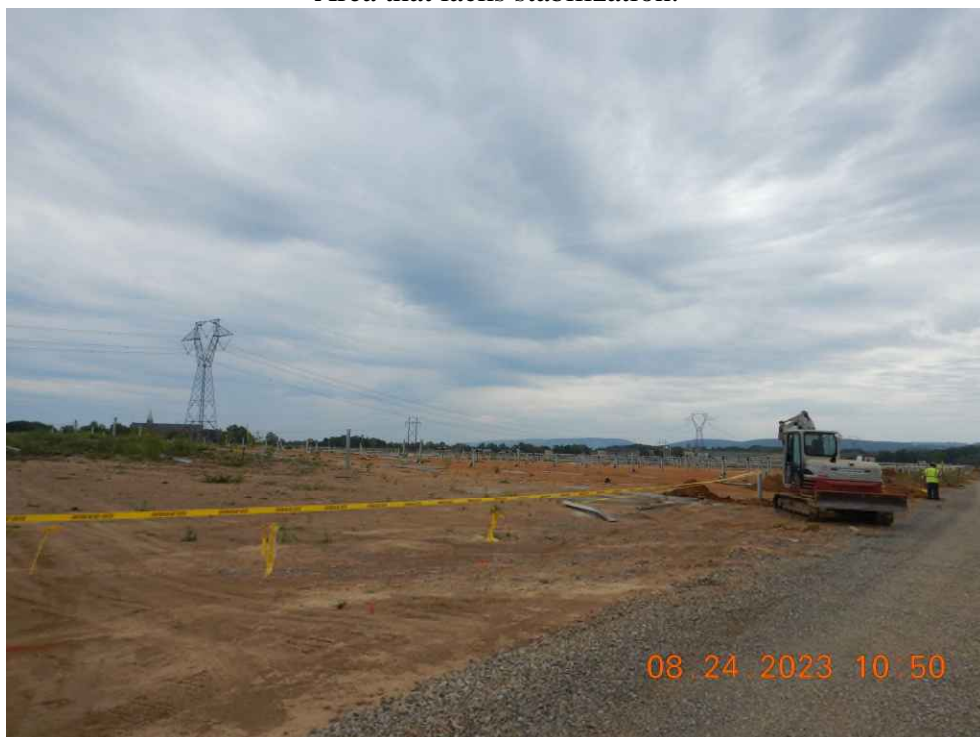
Area that lacks stabilization.

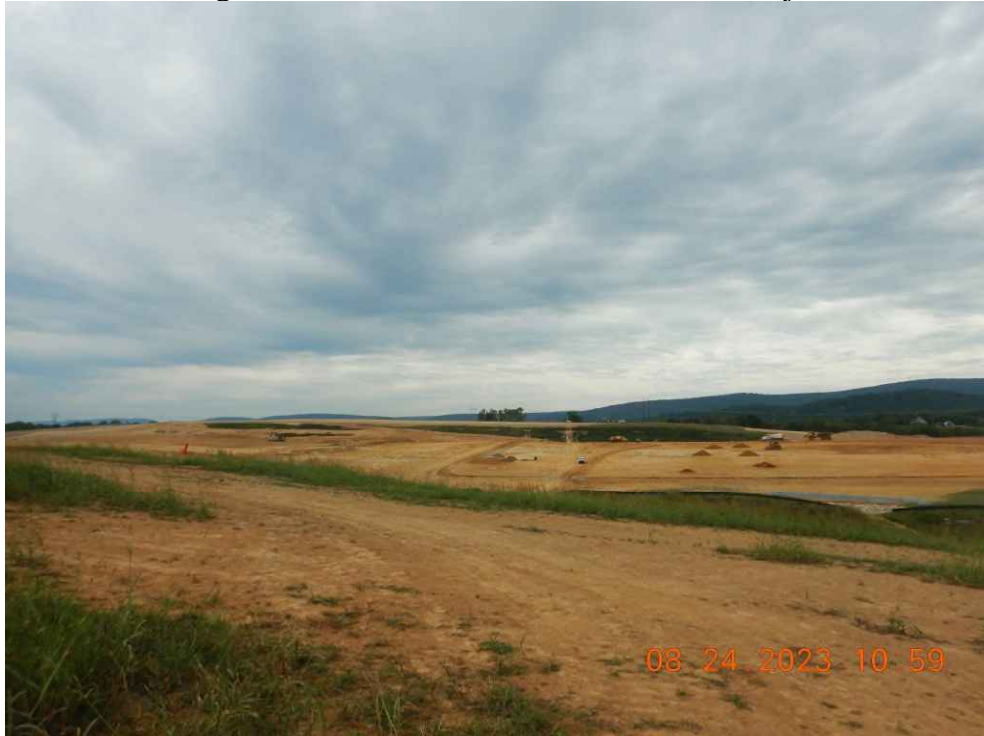
Area that lacks stabilization.

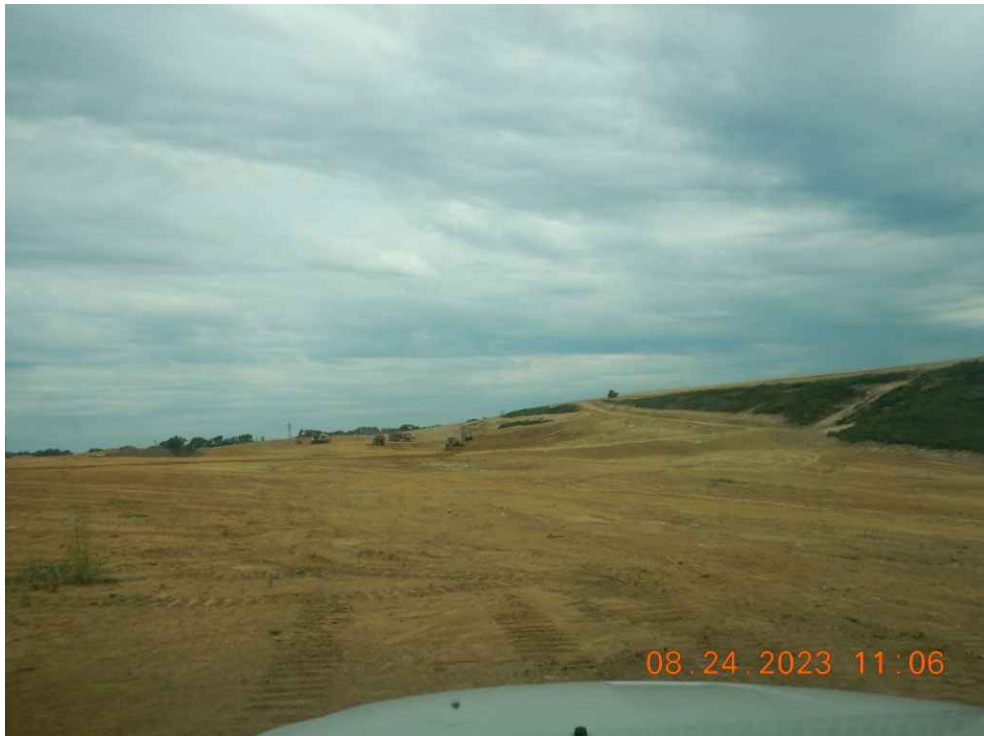
Area that lacks stabilization.

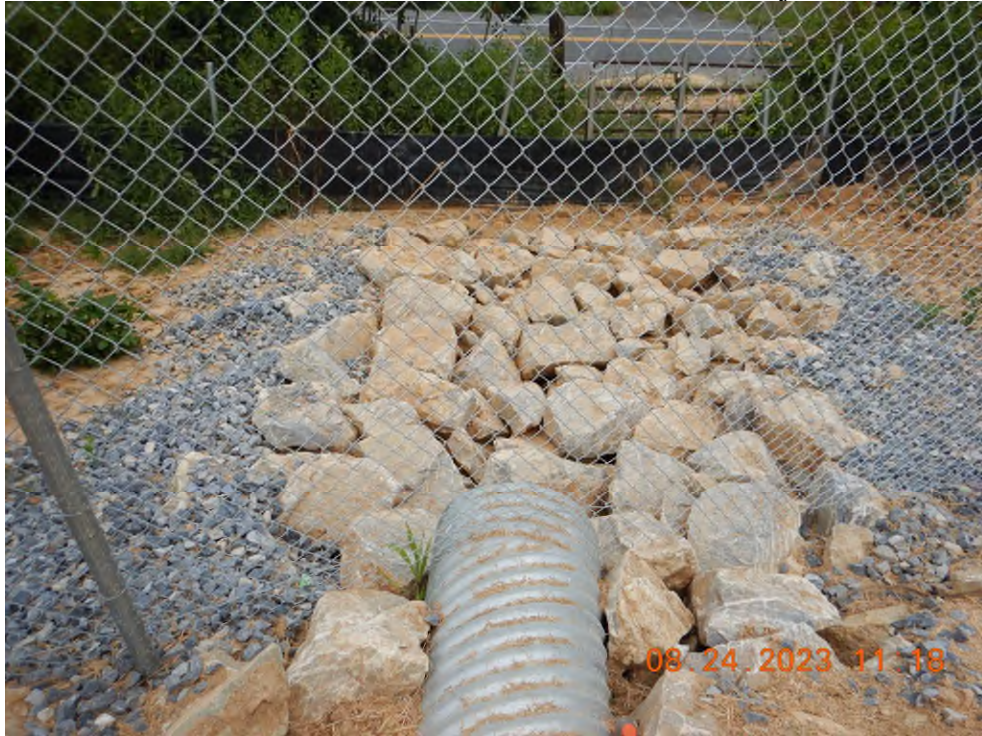
Area of Sediment Basin 6. No outlet marker has been installed.

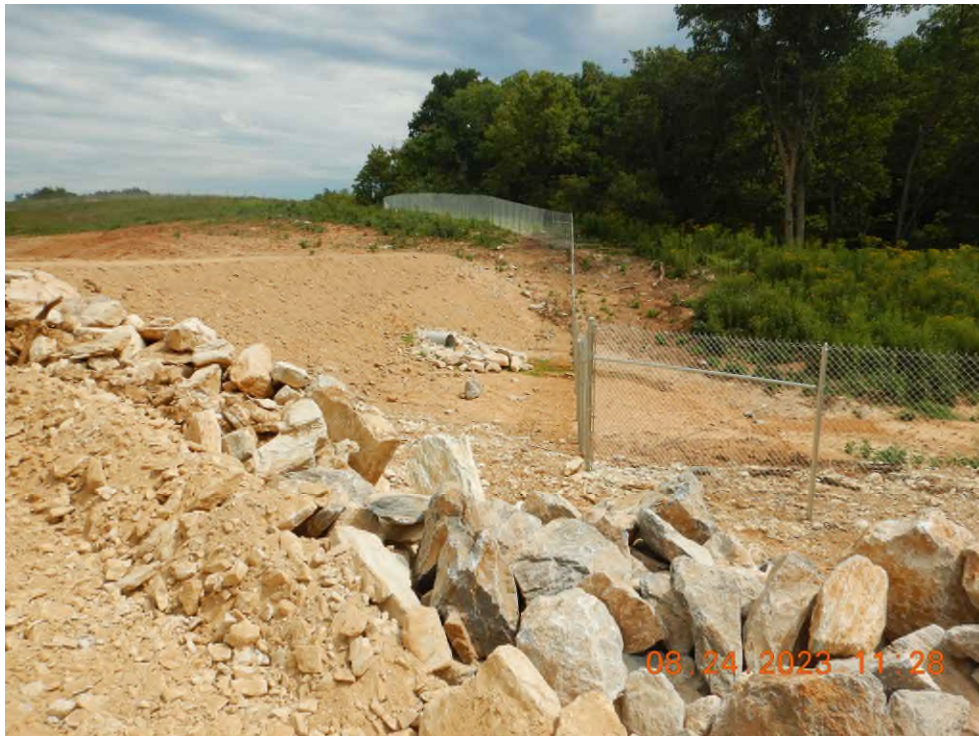
Area of Sediment Basin 5. Lacks stabilization and outlet marker.

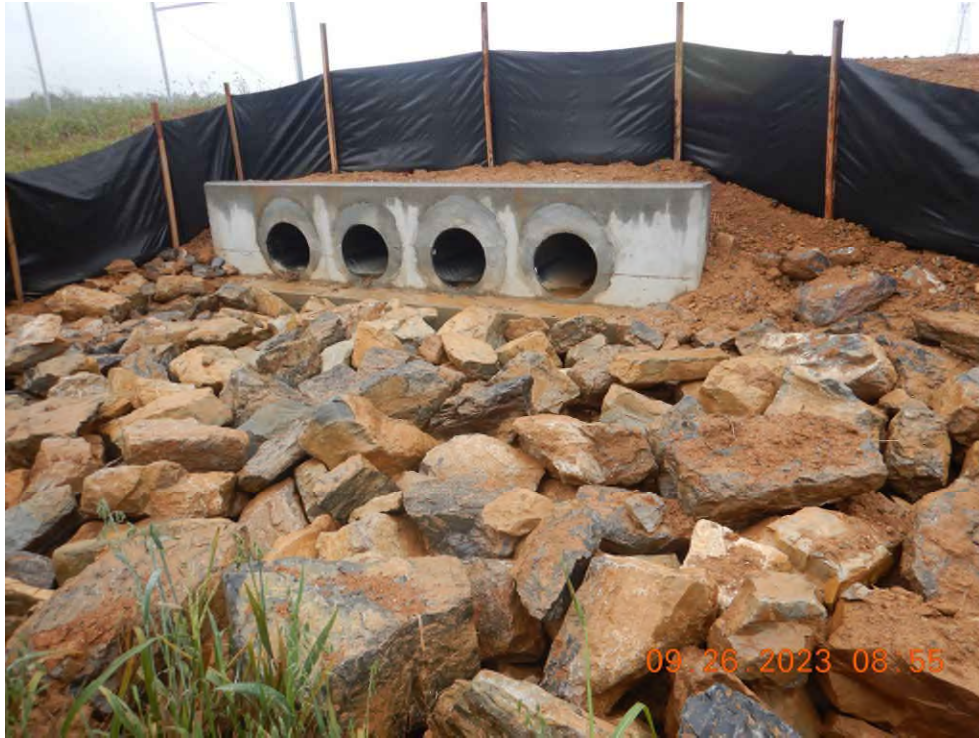
Outlet drainage area of Sediment Basin 14, discharging onto Kabletown Road

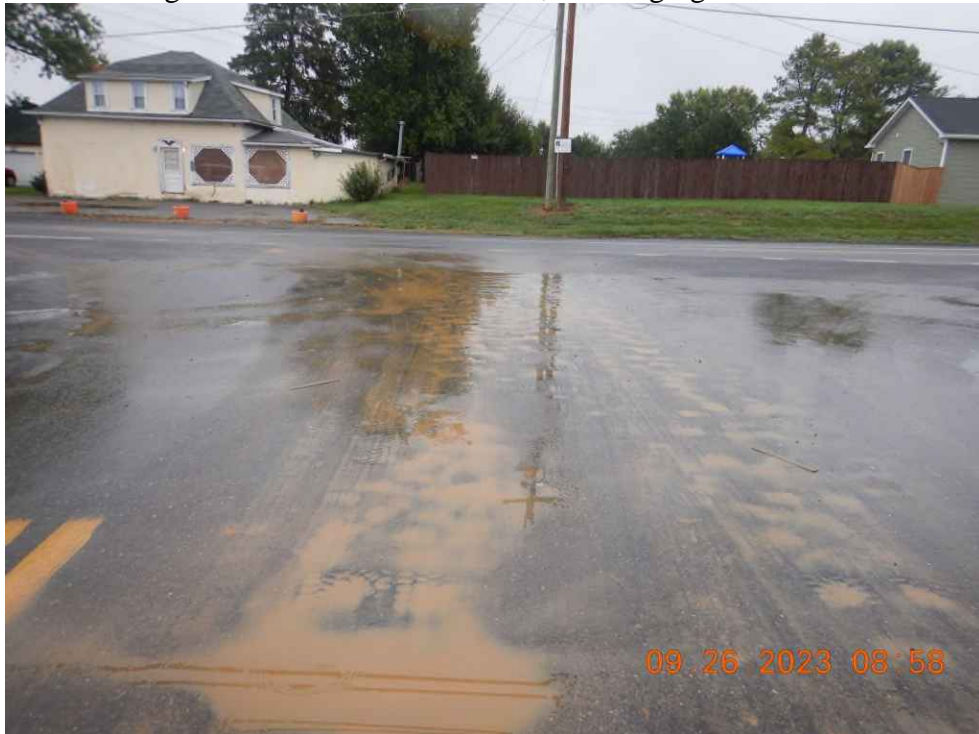
Sediment laden water in the road at the intersection of 115 and Kabletown Road.

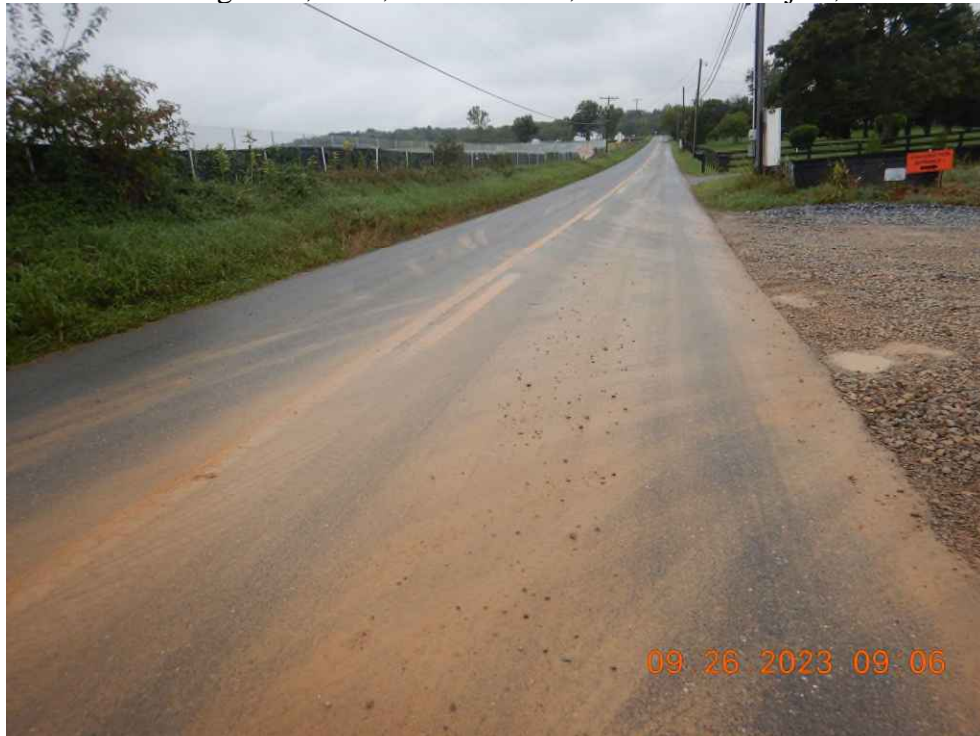
Track-out from the site on Kabletown Road.

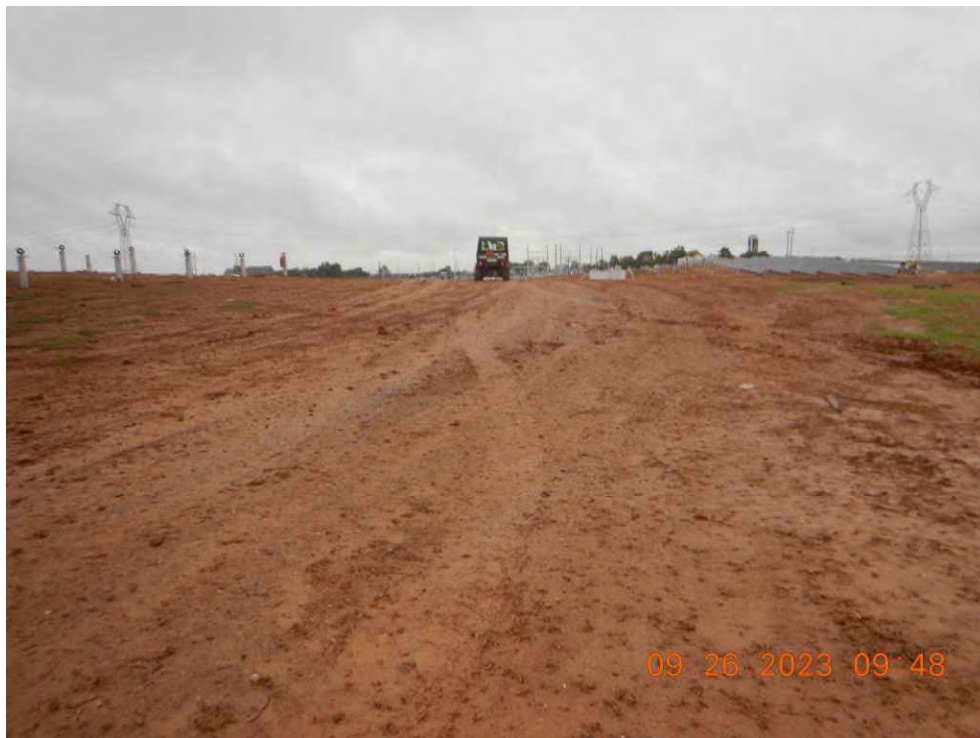
Unstabilized area of project. Temporary or permanent stabilization has not been started.

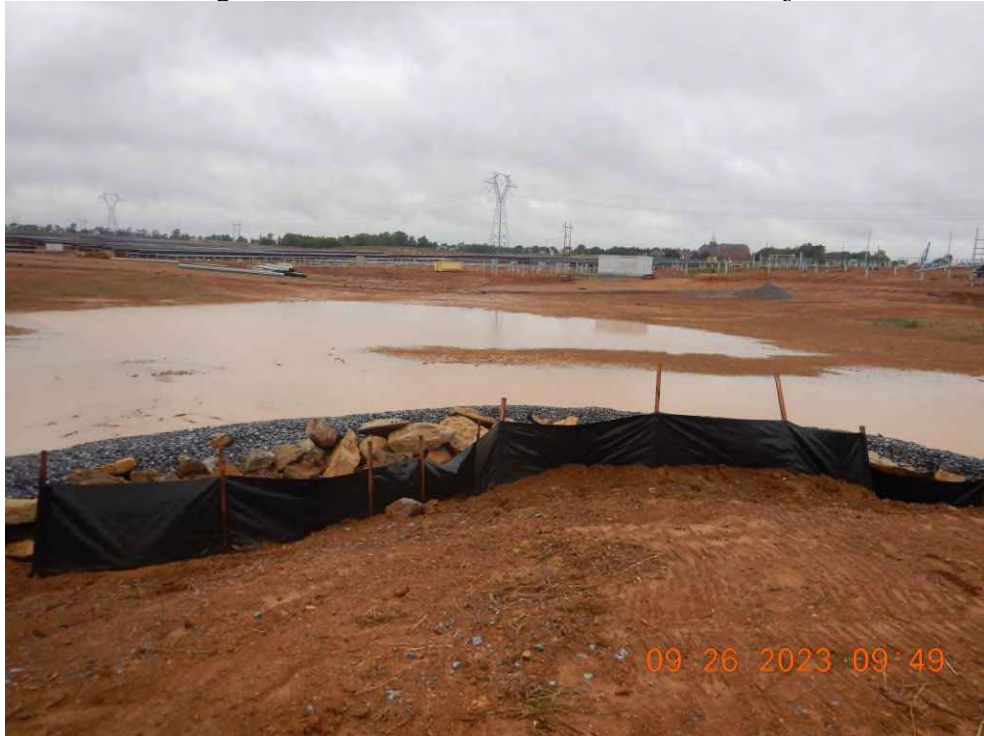
Sediment Pond 14 has been converted to a final stormwater management pond prior to all uphill disturbance being vegetated.

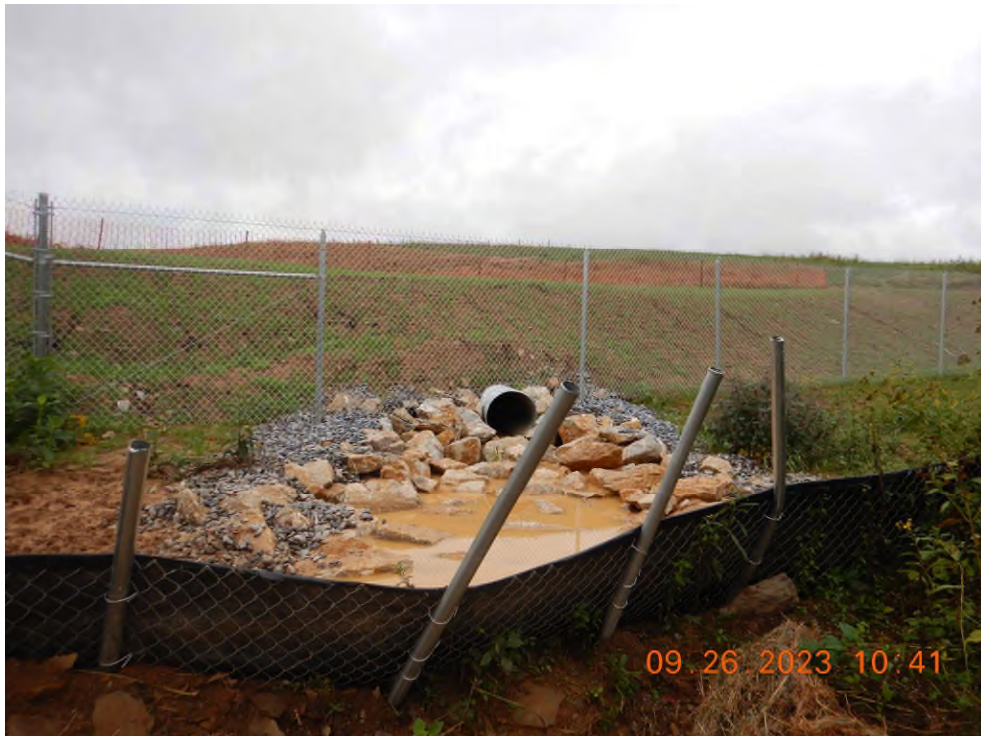
Sediment laden water leaving Sediment Basin 6. No outlet sign is visible.

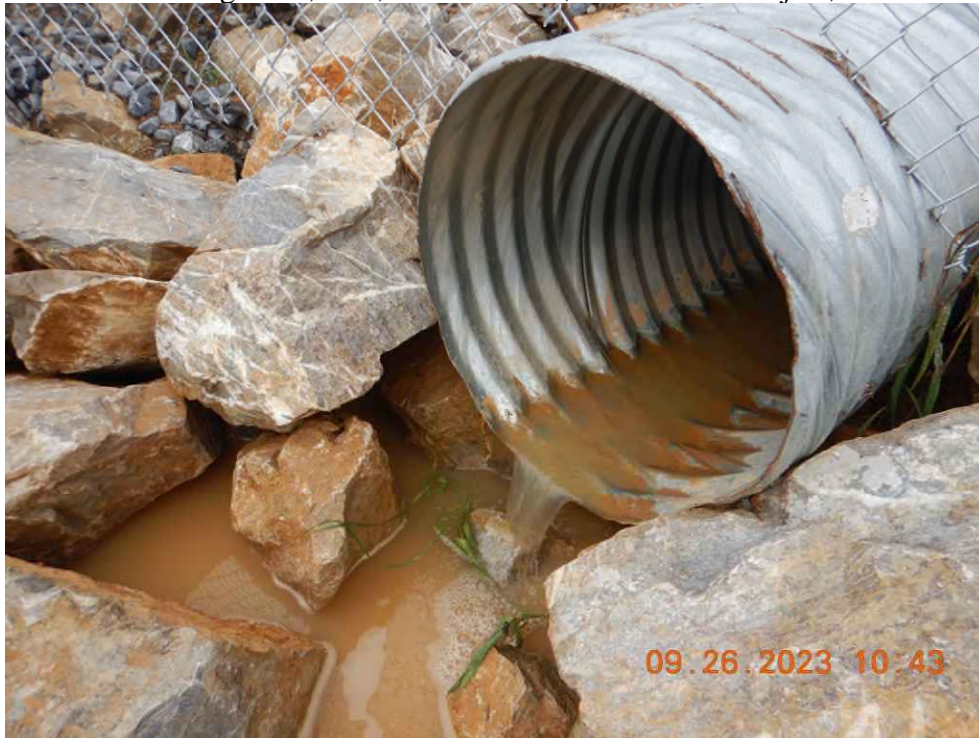
Sediment laden water discharging from Sediment Basin 6.

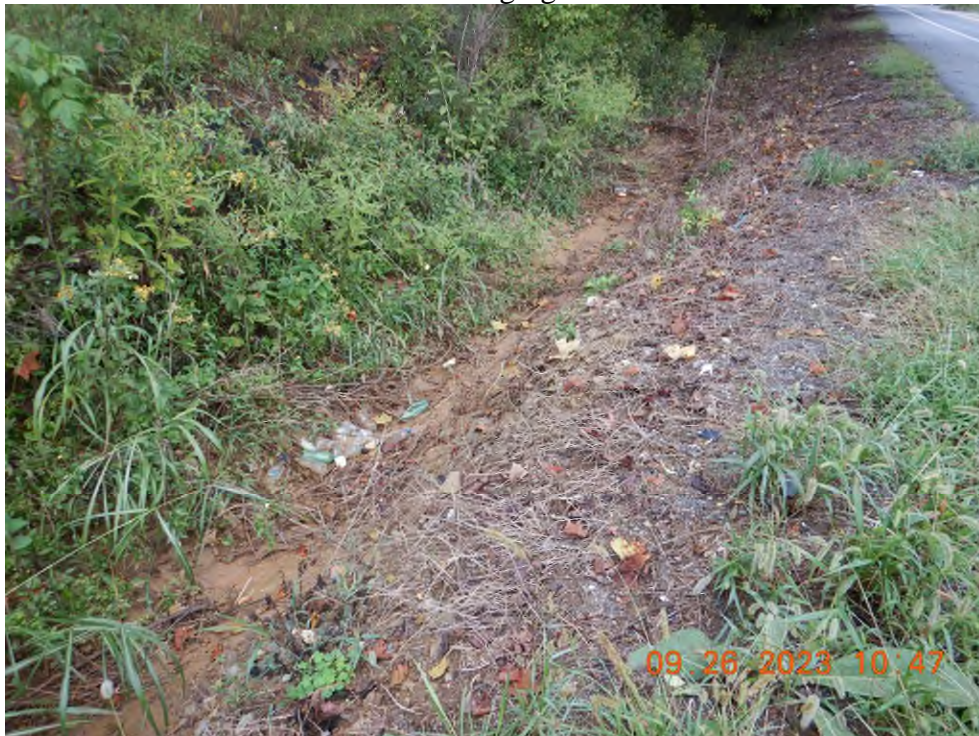
Sediment laden water from Sediment Basin 6 entering into an ephemeral UNT of Evitts Run (39° 15' 33.3189" X -77° 49' 30.6042").

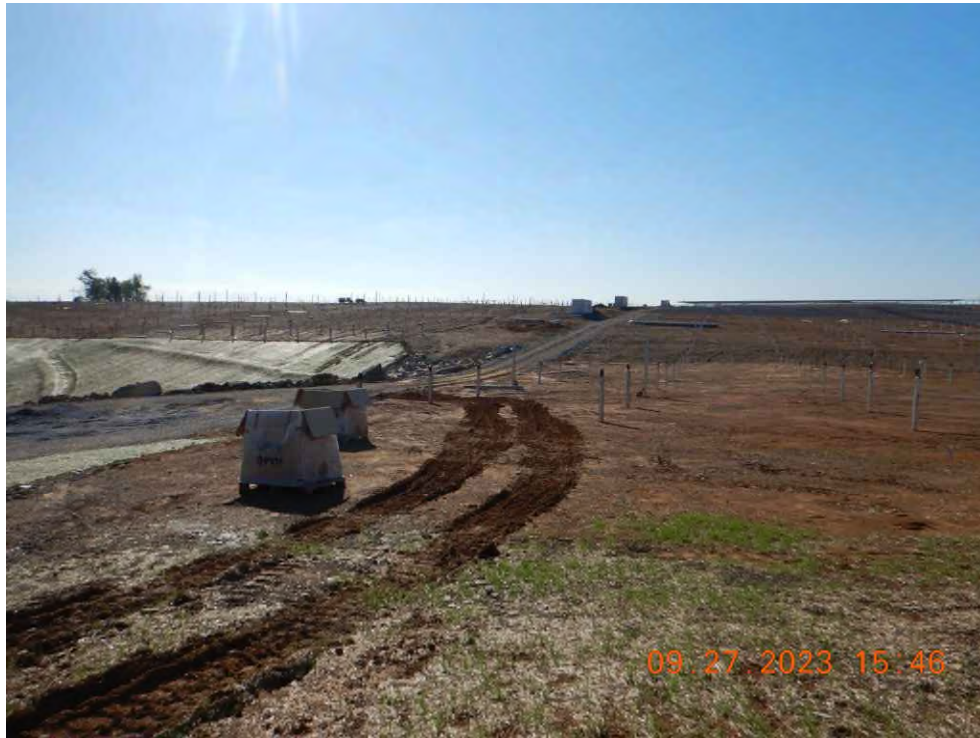
Unstabilized area of project. Temporary or permanent stabilization has not been started.
