**CONSENT ORDER
ISSUED UNDER THE
WATER POLLUTION CONTROL ACT
WEST VIRGINIA CODE CHAPTER 22, ARTICLE 11**

ORDER NO.: 10260

1. Horus West Virginia 1, LLC is conducting land disturbance activity associated with the Blake Solar Project in Jefferson County, West Virginia. Horus West Virginia 1, LLC was issued WV/NPDES Water Pollution Control Permit No. WV0115924, Registration No. WVR111837, on August 12, 2022.
2. On May 15, 2023, West Virginia Department of Environmental Protection (WVDEP) personnel conducted an inspection of the facility. During the inspection, violations of the following sections of the WV/NPDES permit were observed and documented:
 - a. Section II.H.1.d. – Horus West Virginia 1, LLC failed to provide an adequate stone access entrance/exit to reduce the tracking of sediment onto public or private roads.

Horus West Virginia 1, LLC, WVR111839, Blake Solar Project, 7/18/2023

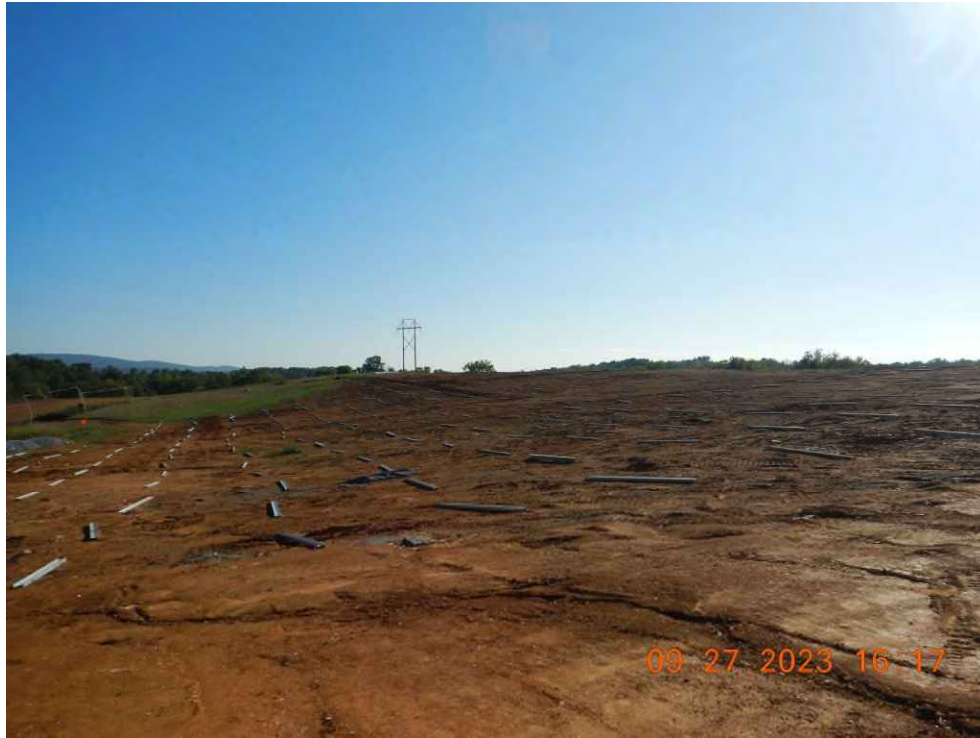
Unstabilized area of project. Temporary or permanent stabilization has not been started.

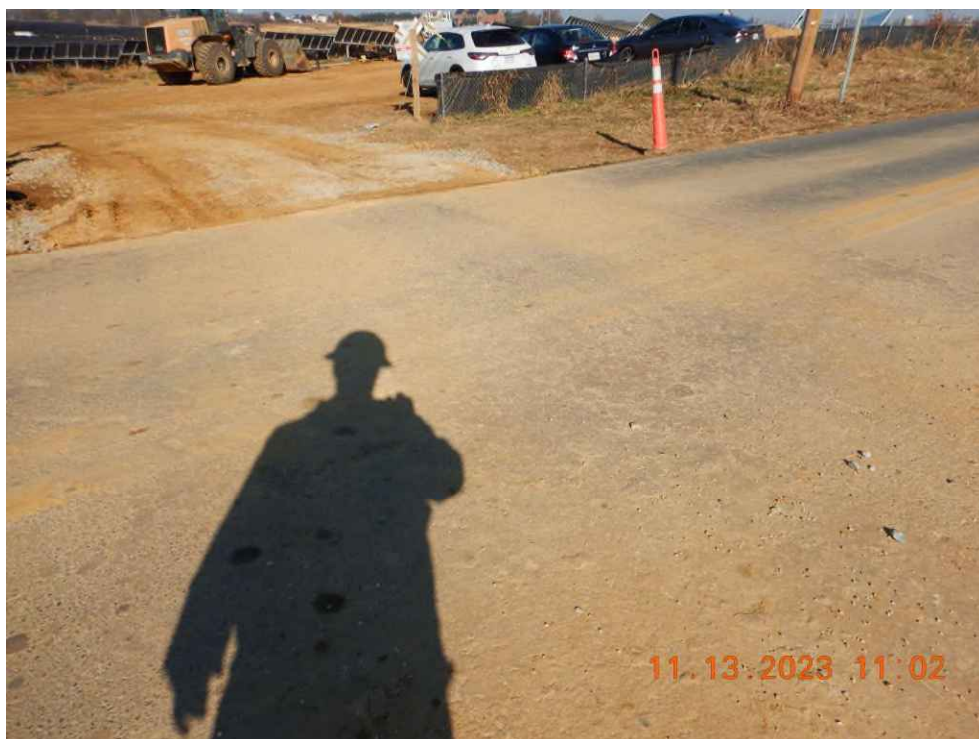
Unstabilized construction entrance.

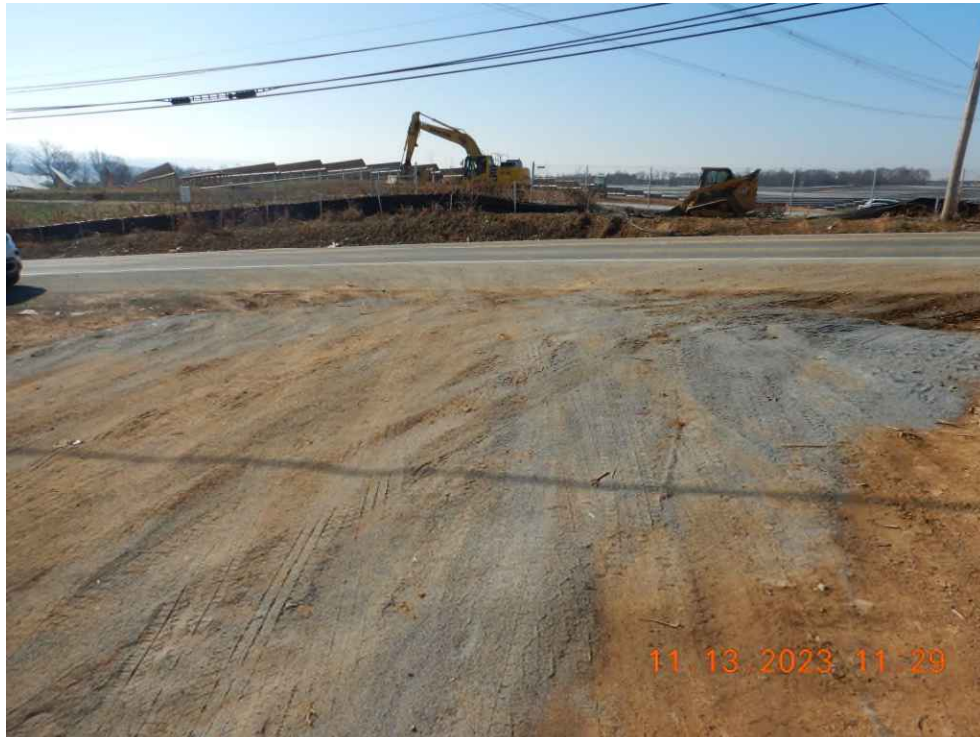
Unstabilized Construction Entrance.

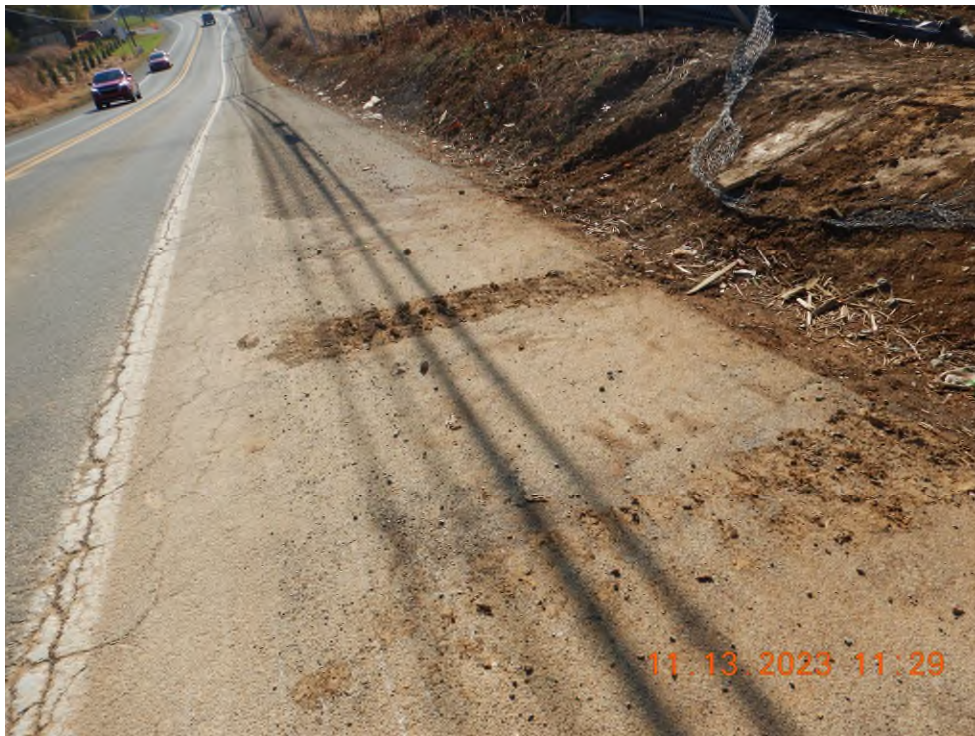
Track-out due to construction entrance not being stabilized.

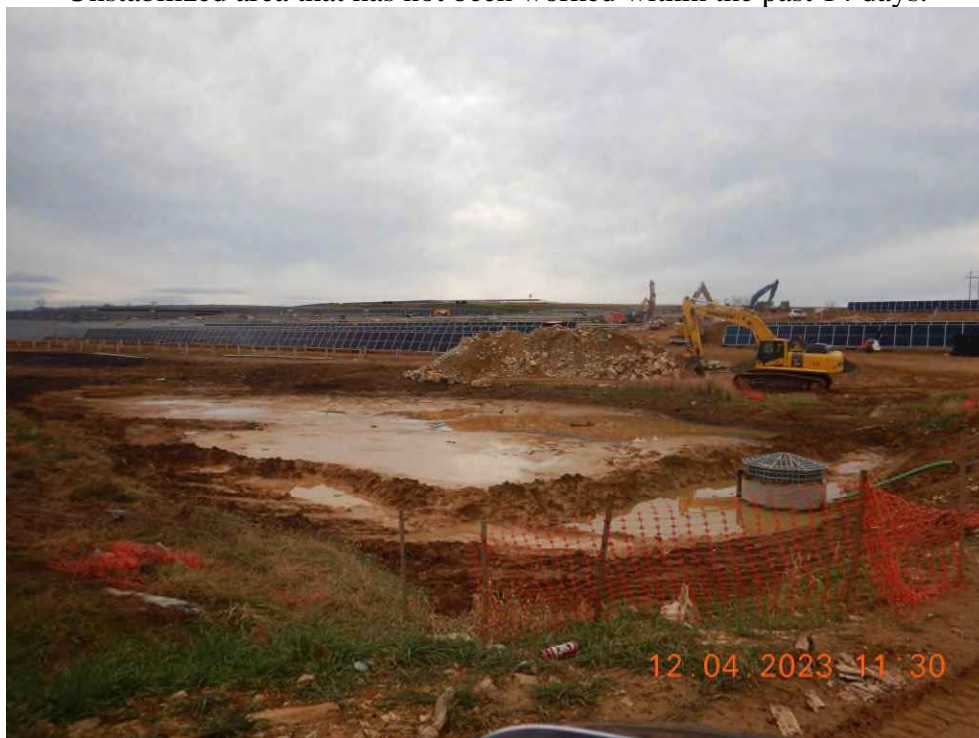
Sediment Basin 13 that has not been stabilized with outlet structure installed. Now known as Pond 2A on redline plan.

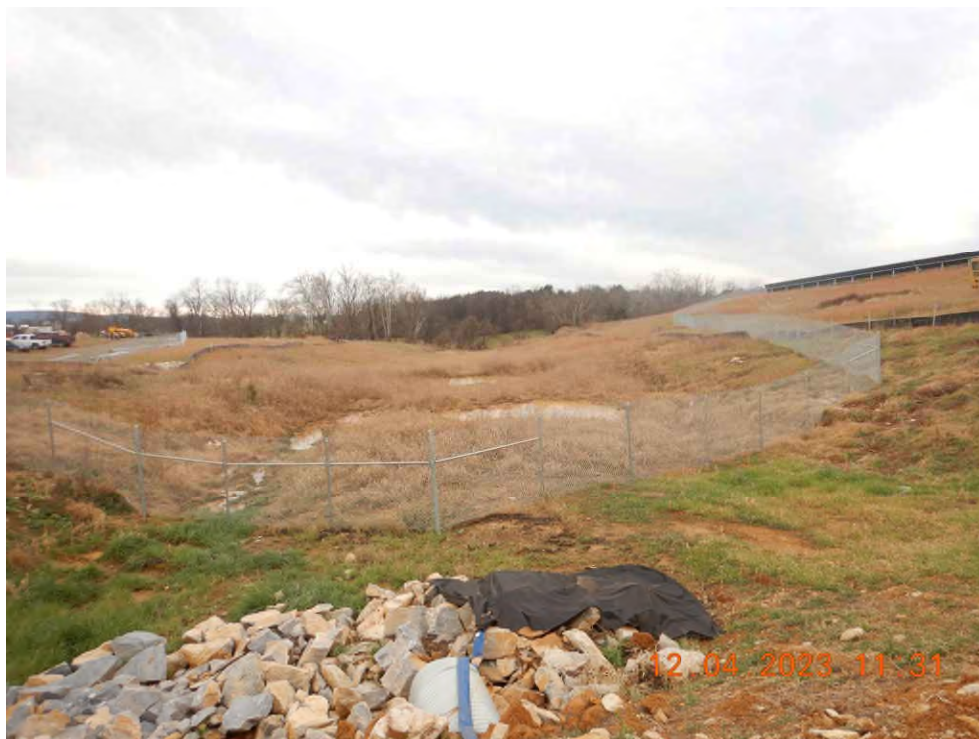
Sediment laden water leaving area Sediment Basin 13. Outlet structure has been installed prior to all uphill disturbance being vegetated.

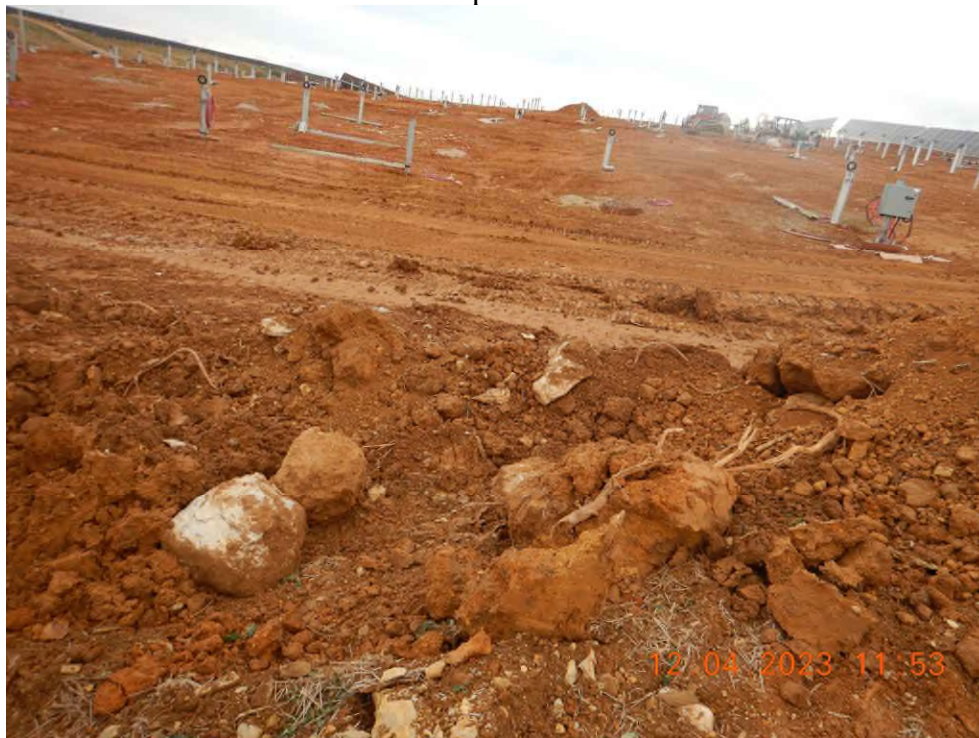
Unvegetated area that has not been excavated within the past 30 days

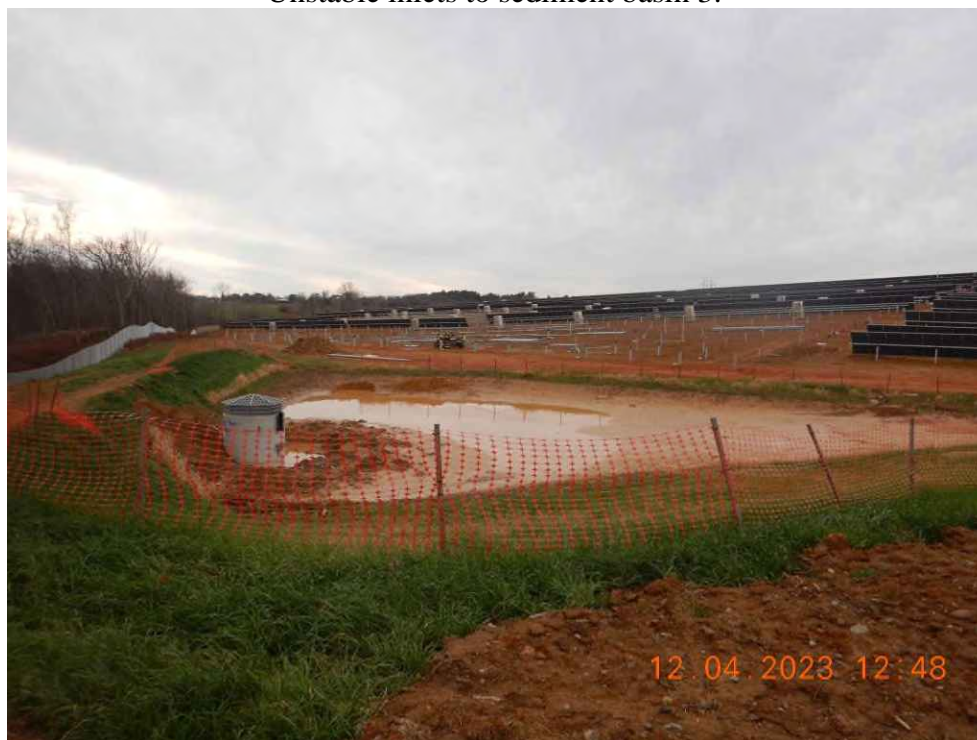
Sediment basin 3 (Pond 3B) converted prior to all uphill disturbance being vegetated.

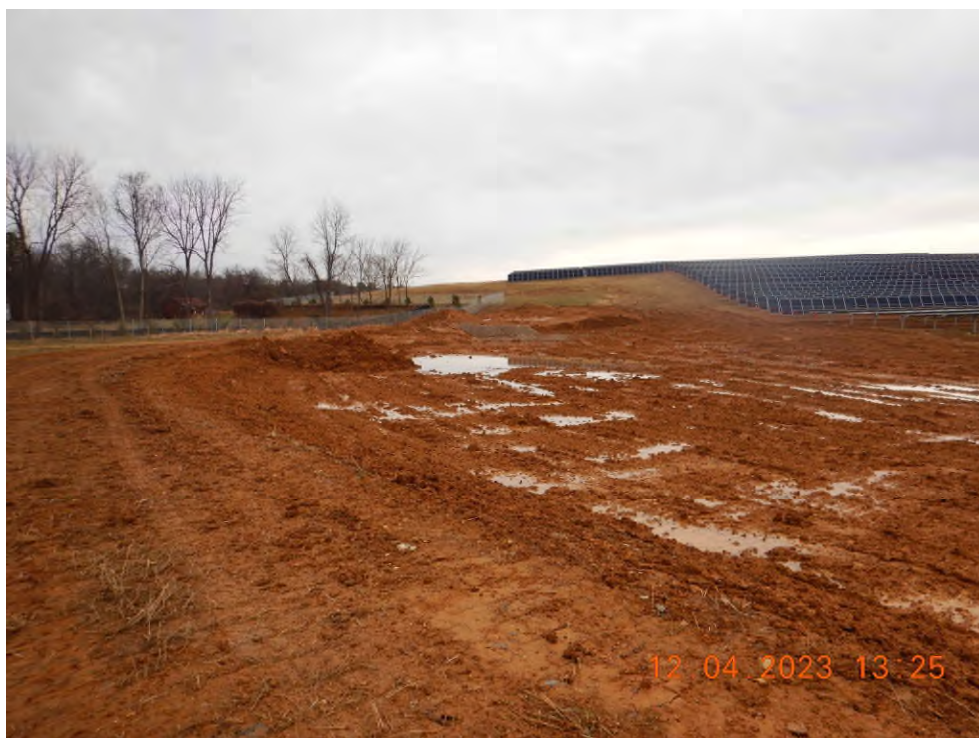
Sediment basin SB-11 (Pond 2B redline) that has been converted to stormwater retention prior to stabilization of the contributing area.

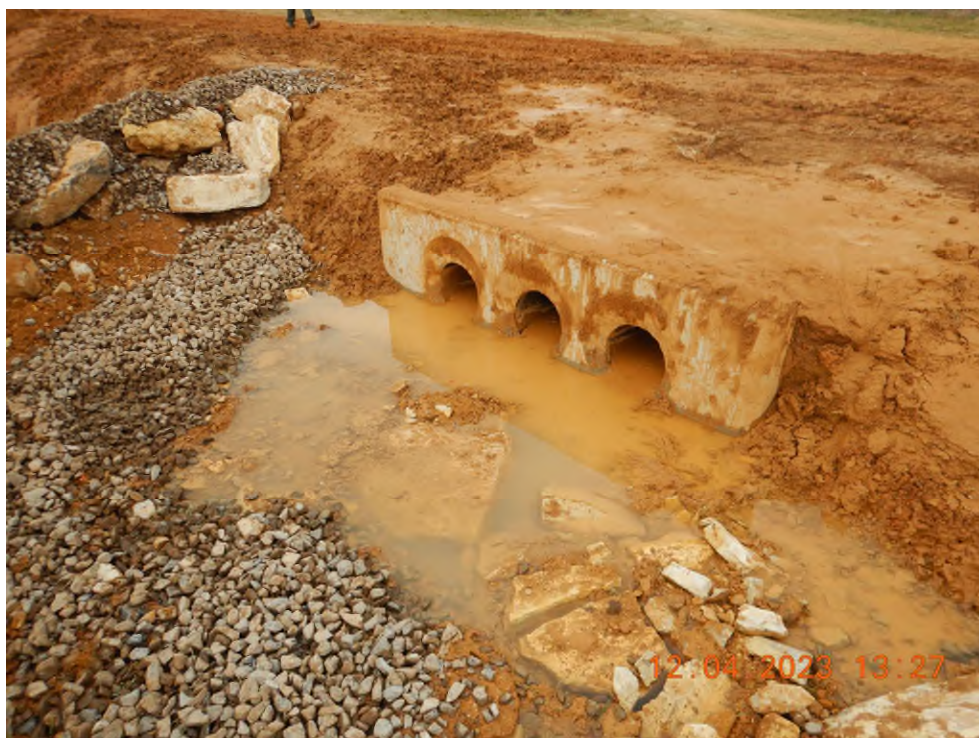
Sediment basin SB-11 (Pond 2B redline) that has been converted to stormwater retention prior to stabilization of the contributing area. Outlet pictured.

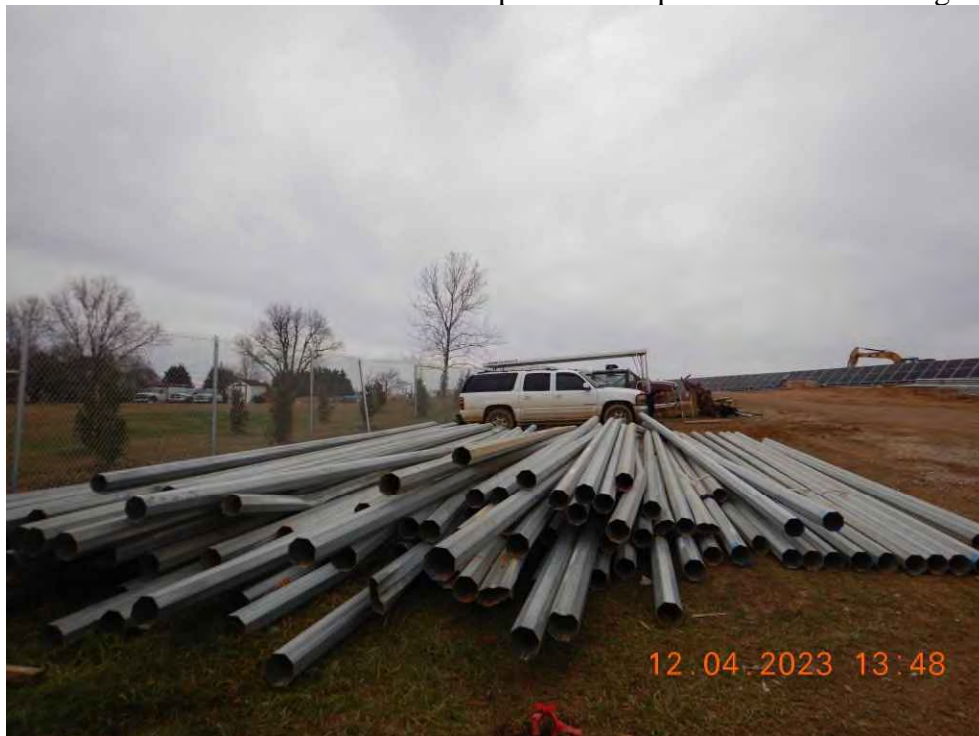
Area where Sediment Basin 12 should be installed.

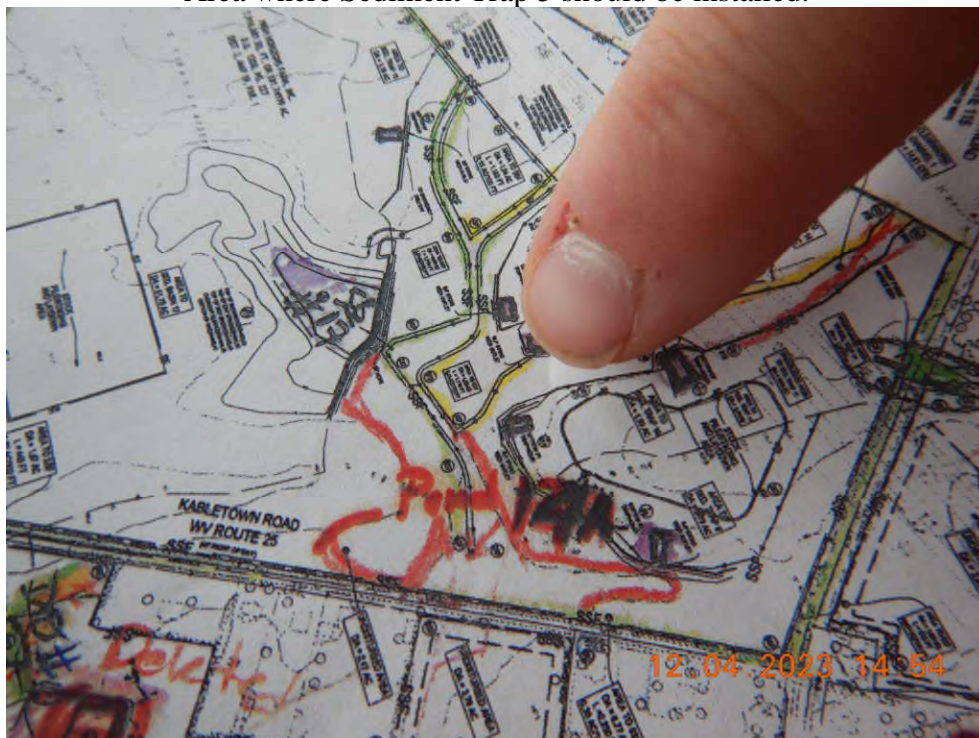
Pond 14A which is installed and not in the approved SWPPP.

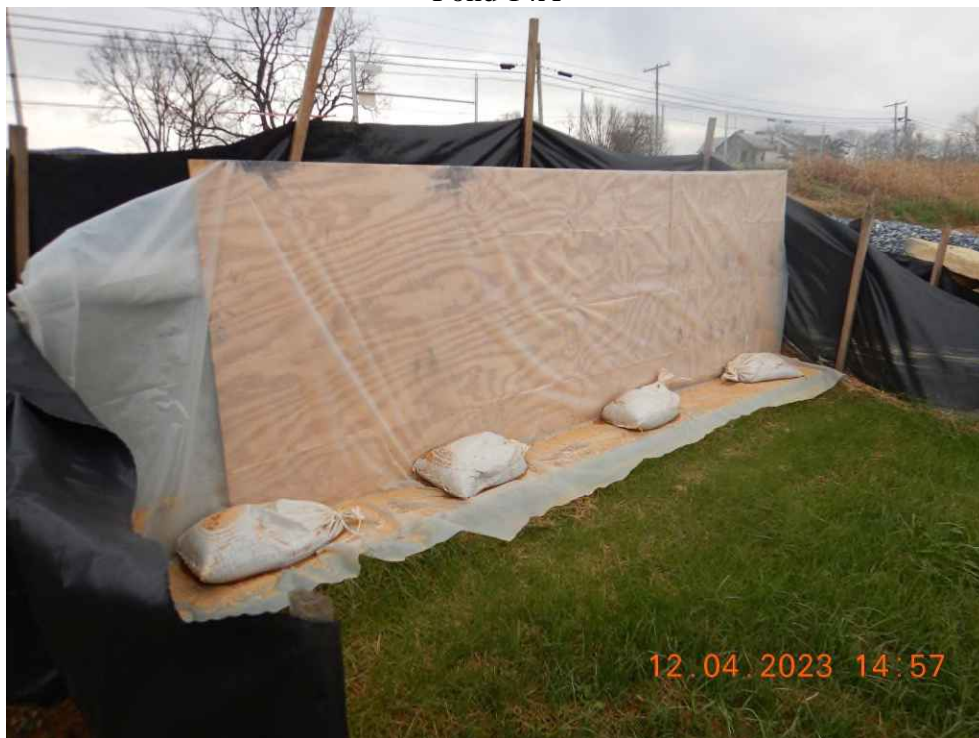
Outlet to Pond 14A. Still discharging on the other side.

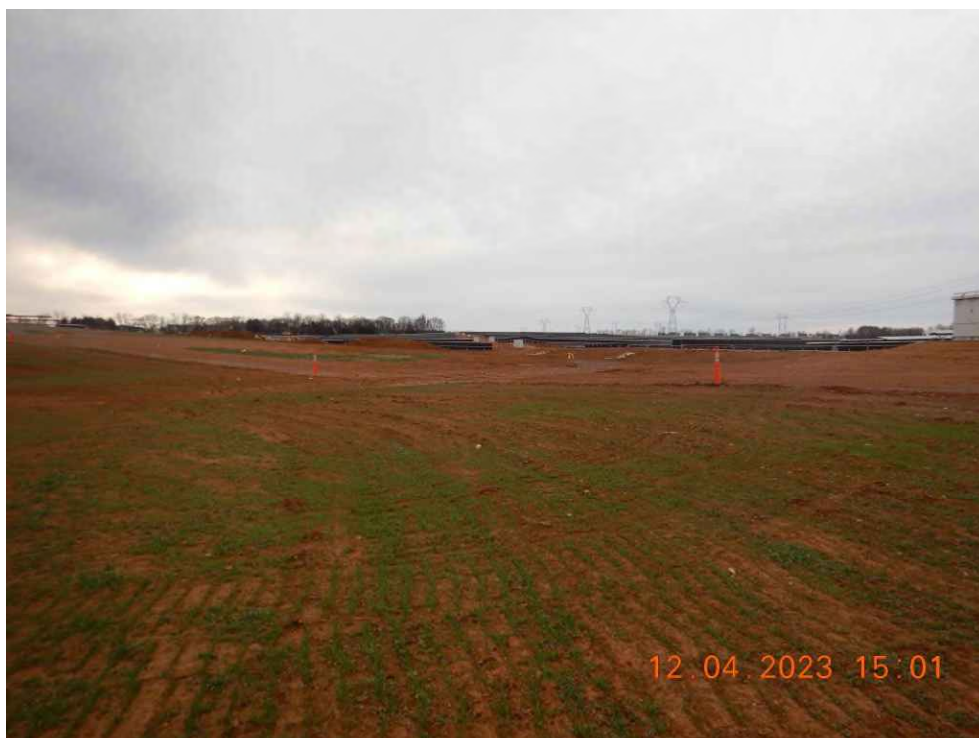
Area where sediment Basin 17 should be installed. Basin has been removed prior to all uphill disturbance being vegetated.

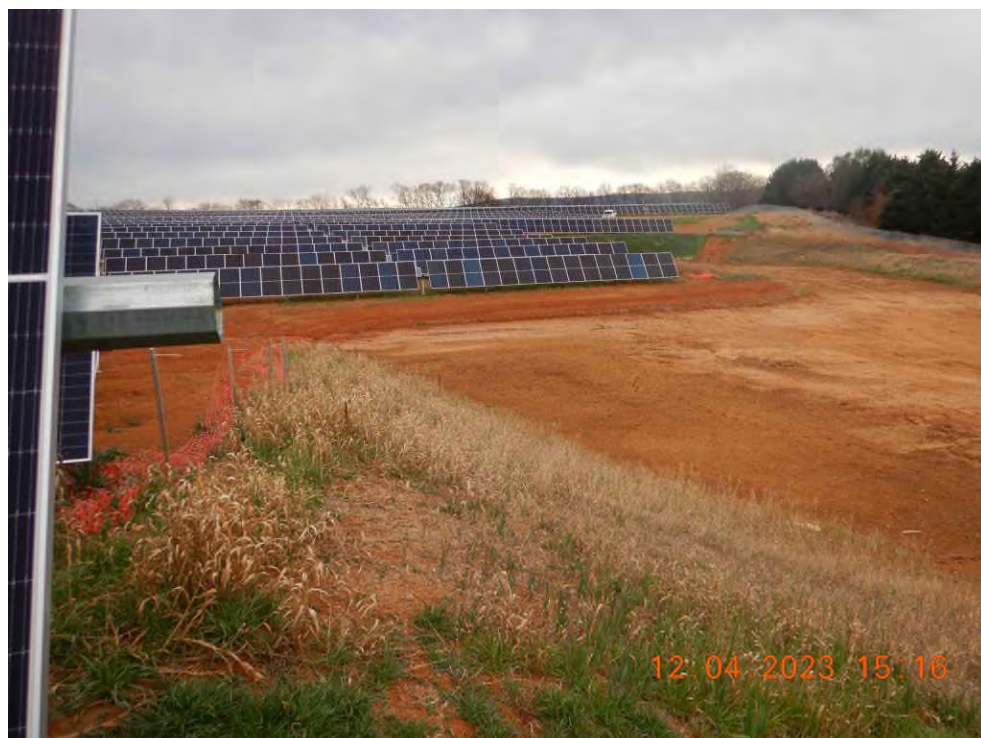
Sediment Basin 7 has been removed without all uphill disturbance being vegetated.

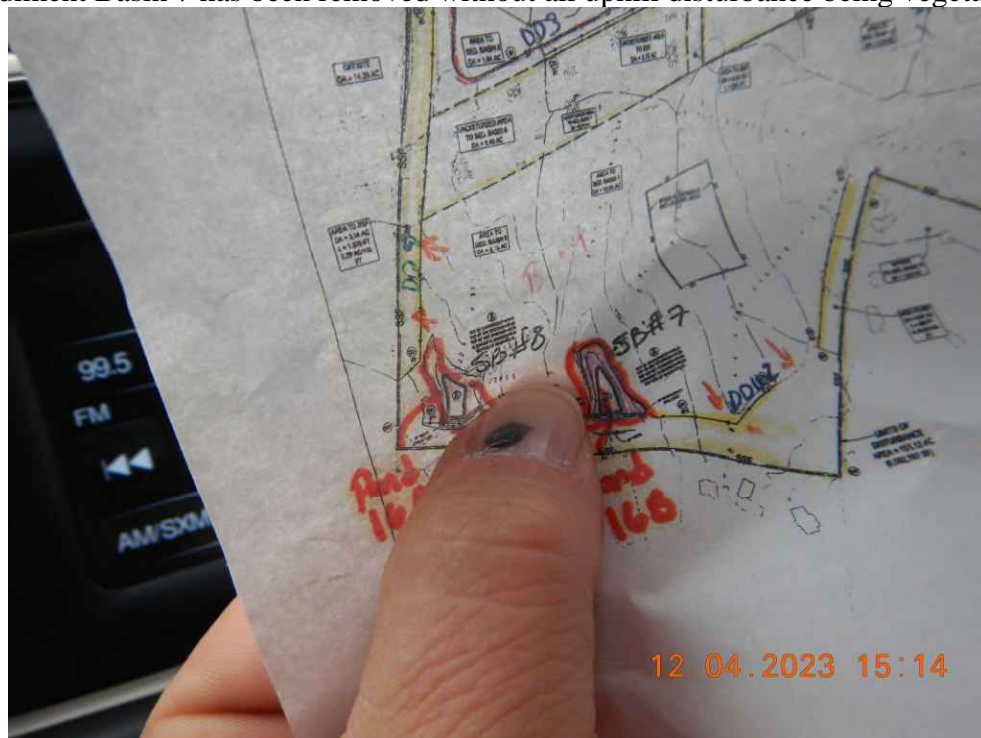
Map stating that Sediment Basin 7 has been converted into Pond 16B.

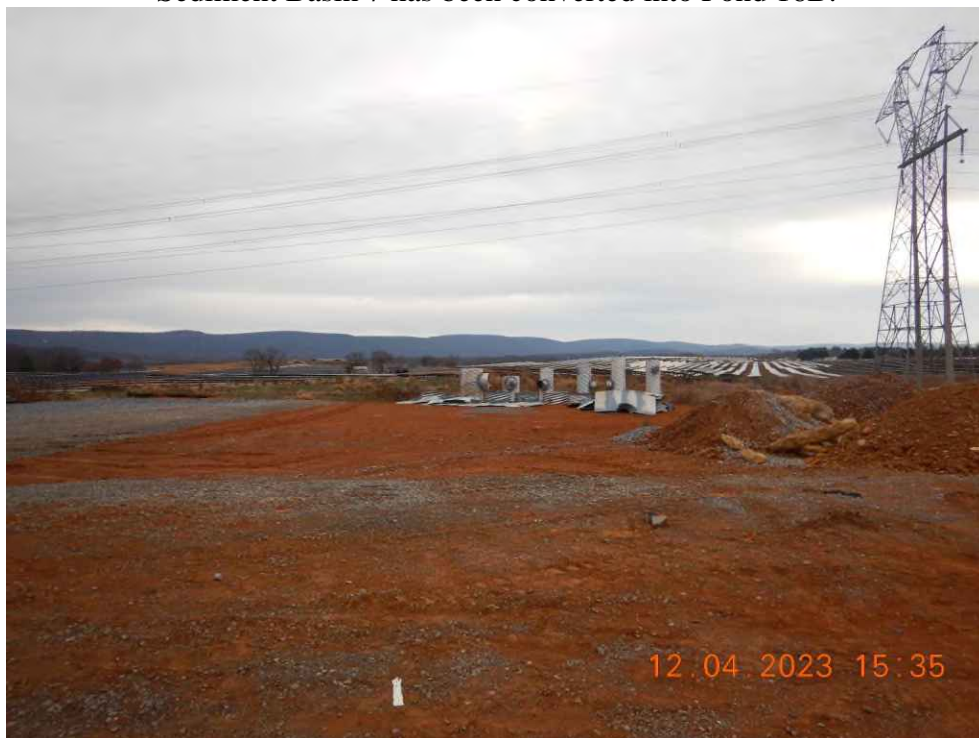
Sediment basin structures that have been removed prior to all uphill disturbance being vegetated.
Stockpiled riser structures from removed trapping structures pictured.

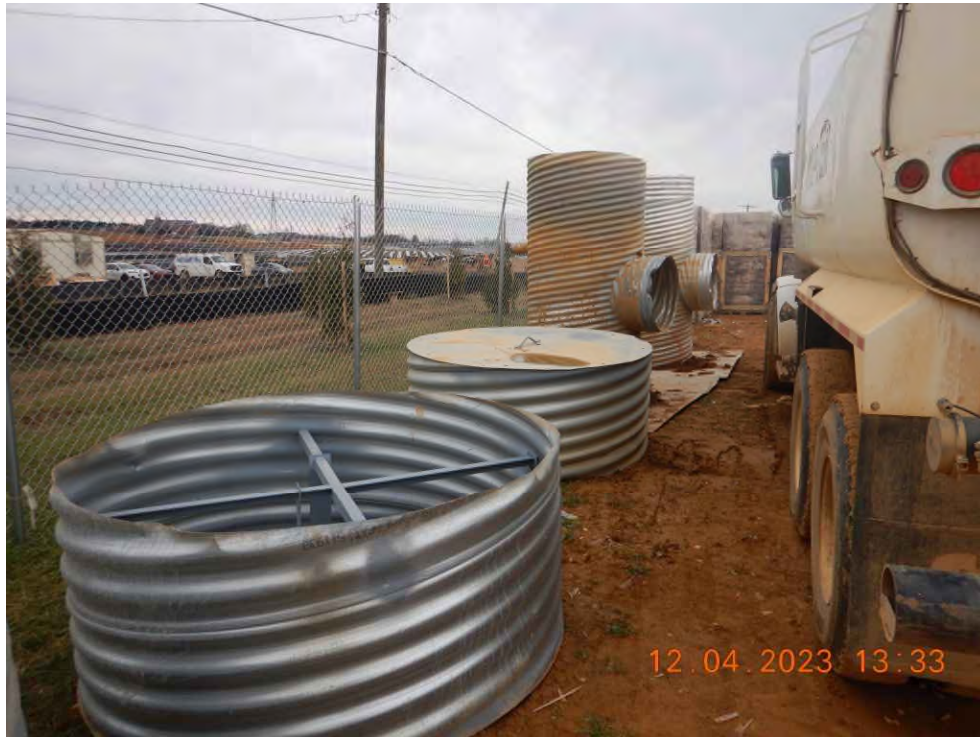
Sediment basin structures that have been removed prior to all uphill disturbance being vegetated.
Stockpiled riser structures from removed trapping structures pictured.

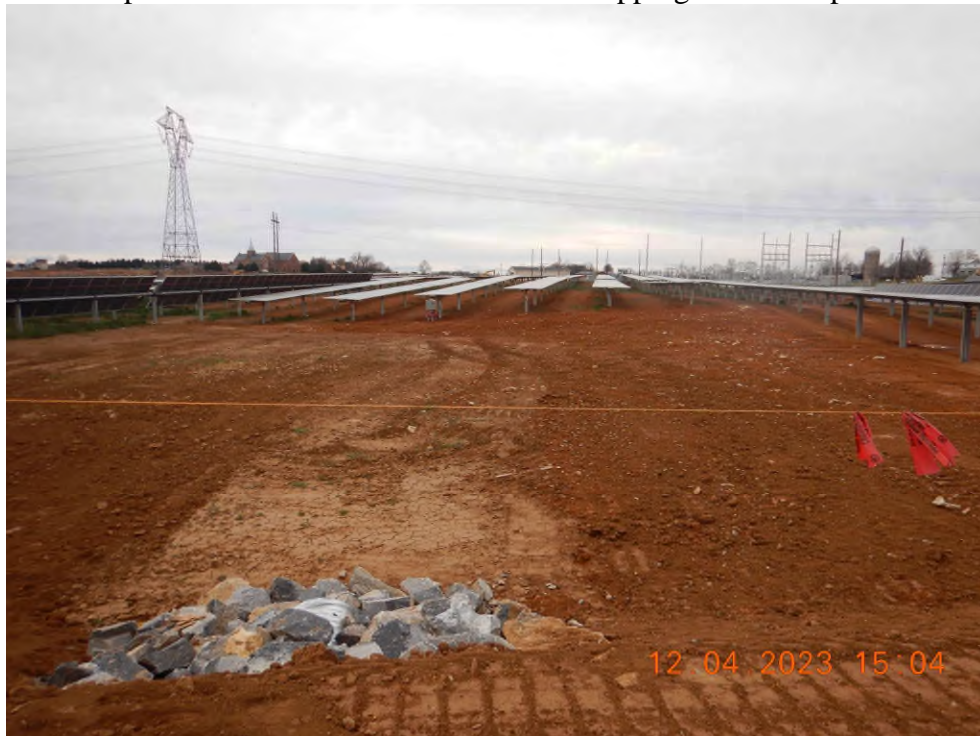
Area that has not been worked within the past 14 days and has not been stabilized. Area of proposed Sediment Trap ST-10 pictured, showing it as not in place with a disturbed contributing area.

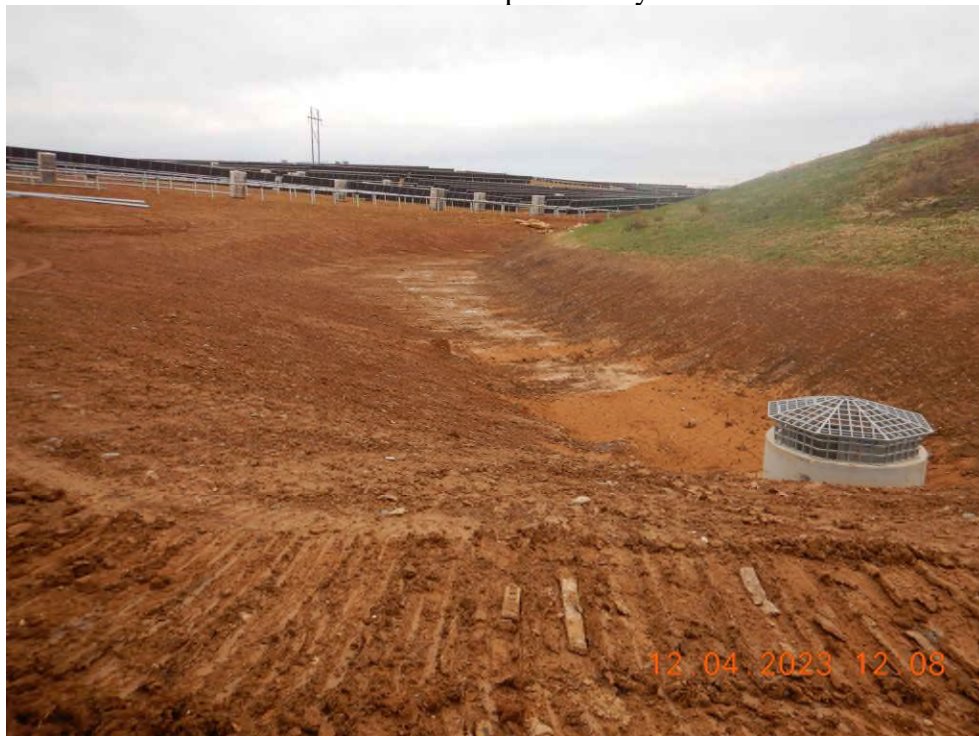
Sediment Basin 1 has been converted to Pond 3A prior to all upstream disturbance being vegetated.

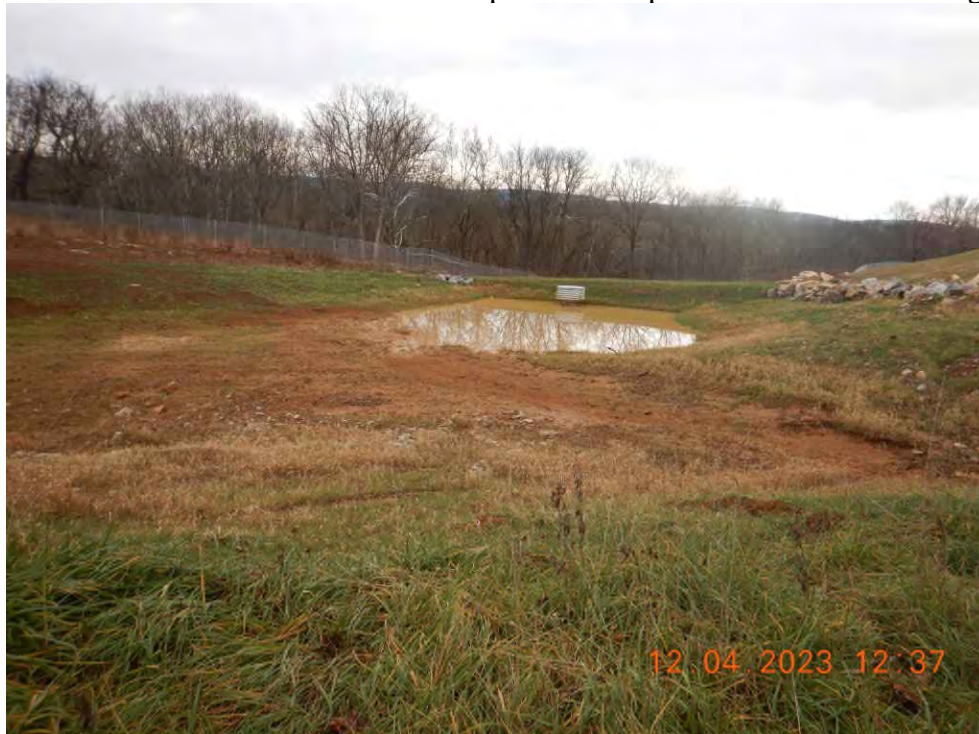
Sediment Basin 6 has been converted to Pond 4B prior to all upstream disturbance being vegetated.

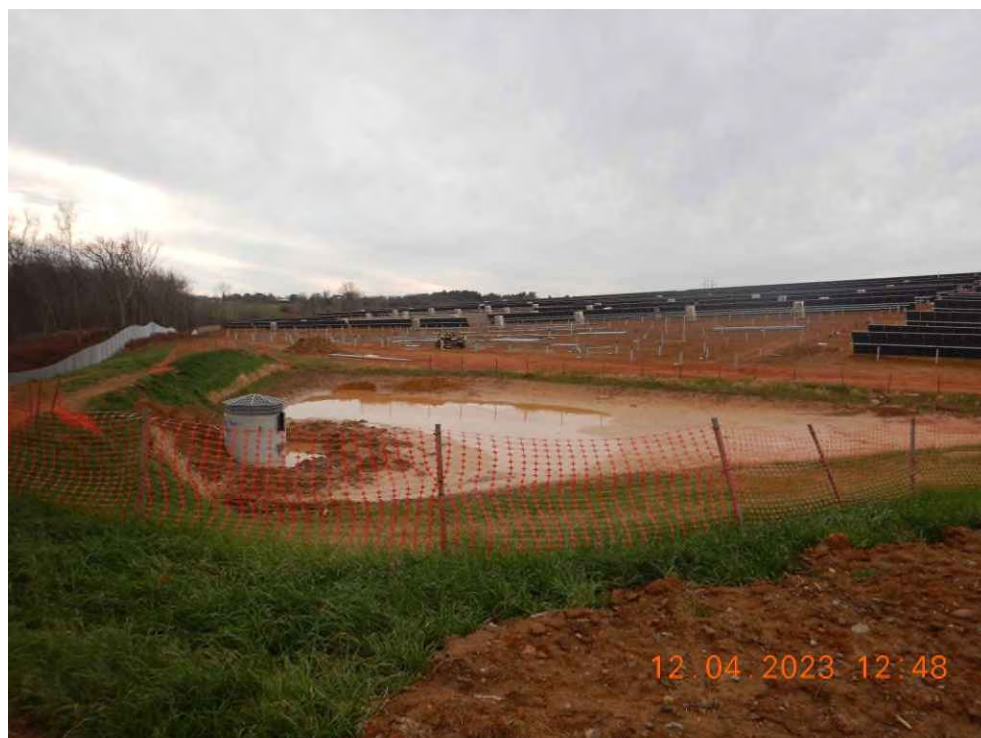
Sediment Basin 3 has been converted to Pond 3B prior to all upstream disturbance being vegetated.

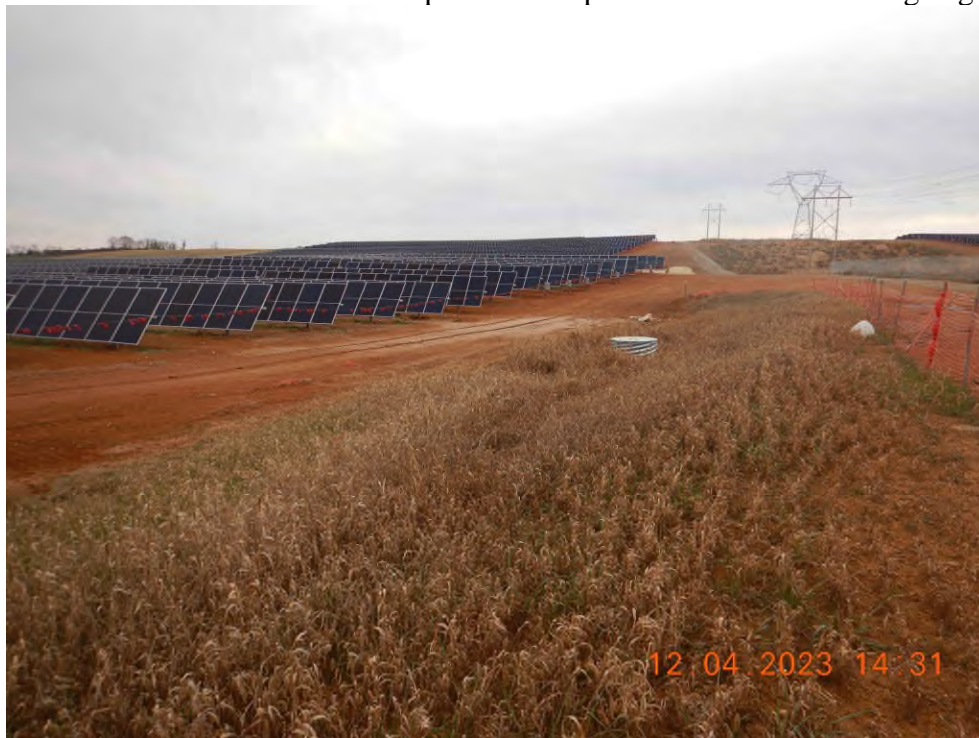
Sediment Basin 10 converted to Pond 8 prior to all upstream disturbance being vegetated.

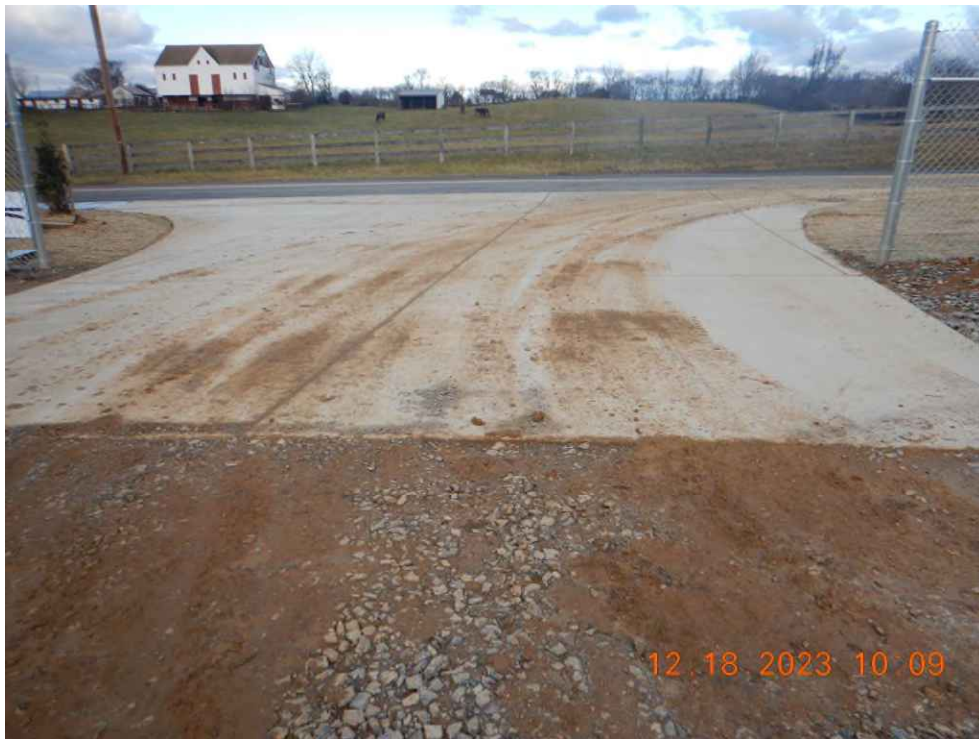
Track-out onto main road due to lack of stabilized construction entrance.

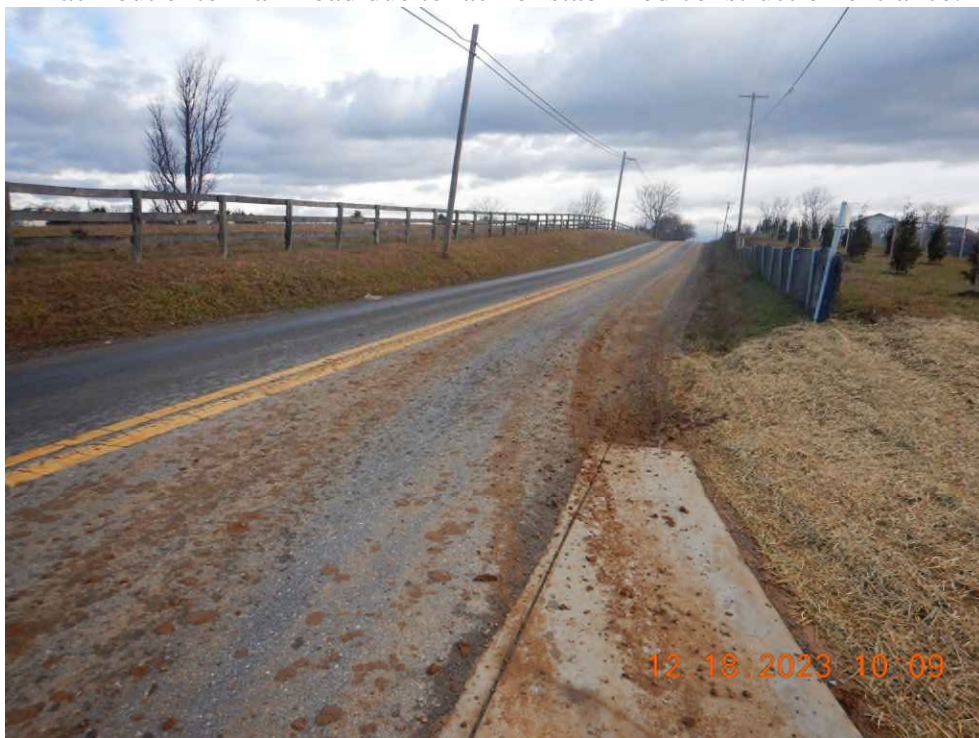
Track-out onto main road due to lack of stabilized construction entrance.

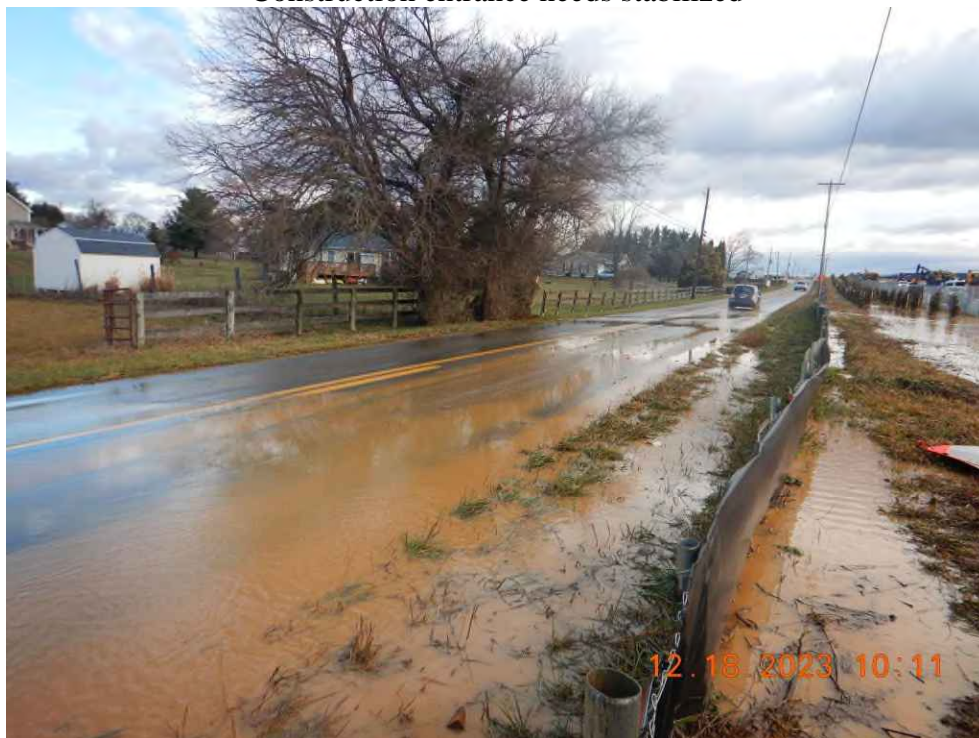
Sediment laden water leaving the site onto Kabletown Road.

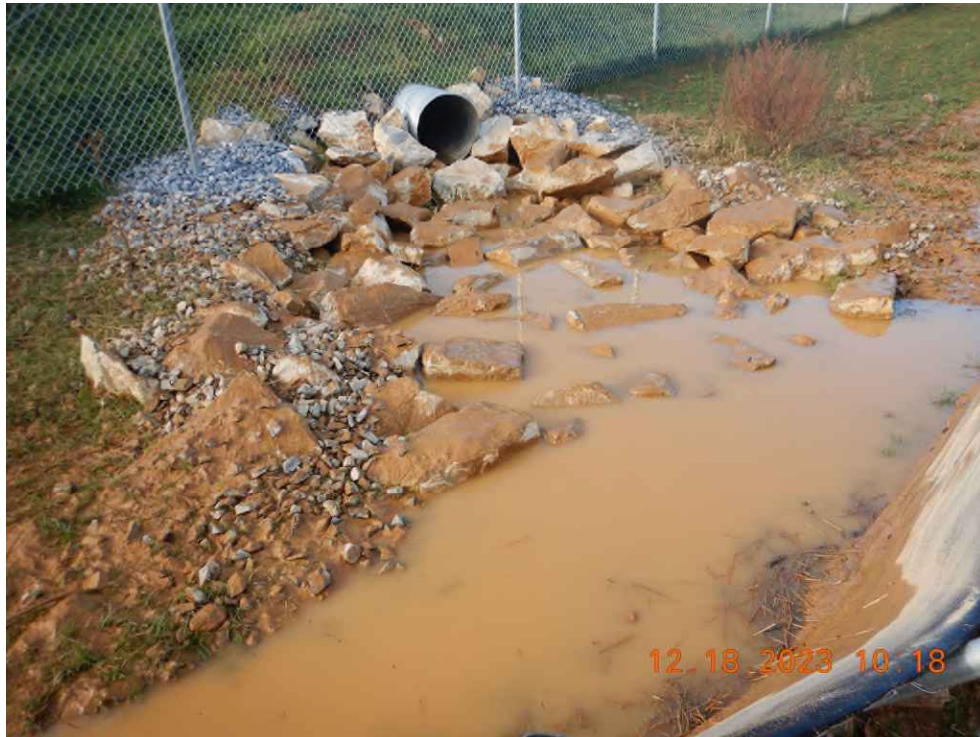
Sediment laden water leaving site via outlet of Sediment Basin 6.

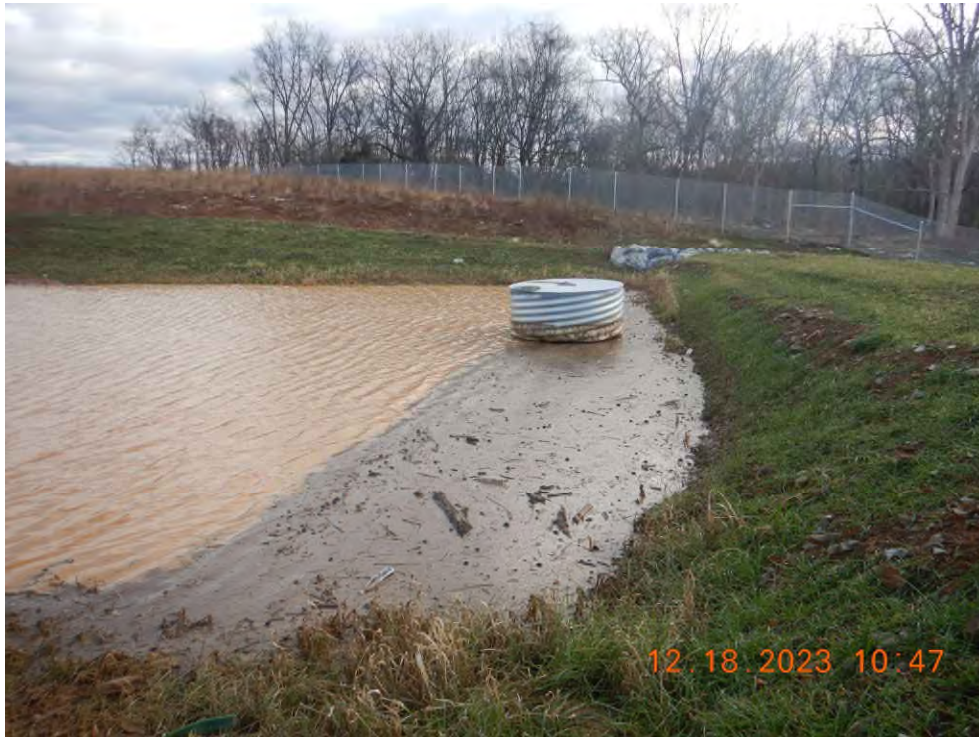
Sediment Basin 5 has been converted to final stormwater management Pond 4B. Discharging sediment laden water into Evitts Run.

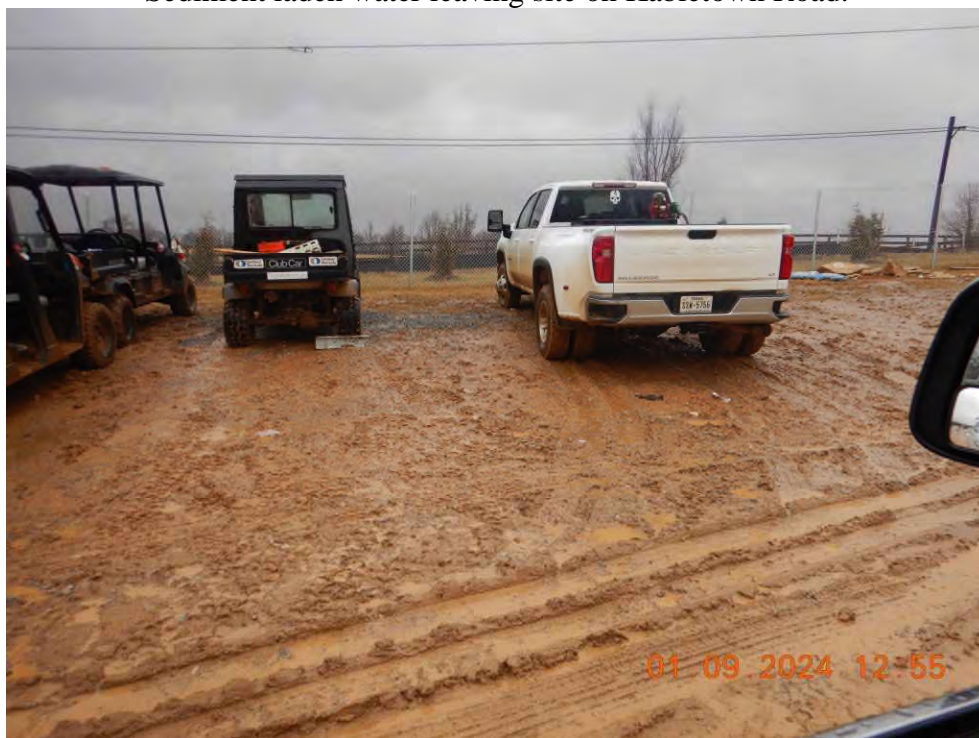
Unstabilized construction entrance by Entrance 2 Kabletown Road

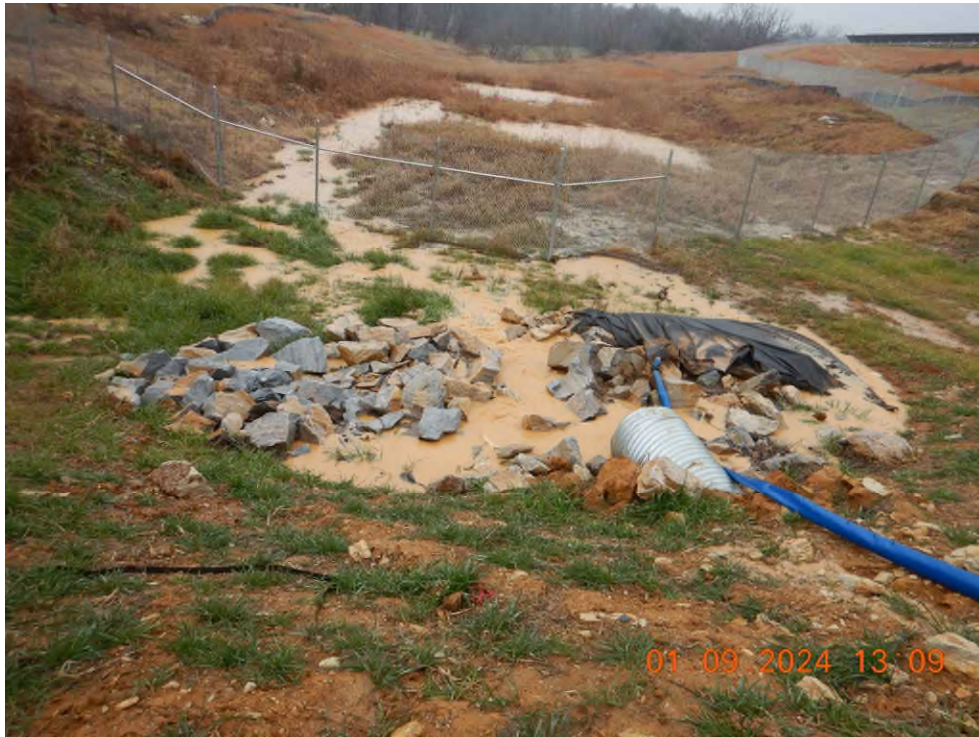
Sediment Basin 13 discharging into Evitts Run.
