**CONSENT ORDER
ISSUED UNDER THE
WATER POLLUTION CONTROL ACT
WEST VIRGINIA CODE CHAPTER 22, ARTICLE 11**

ORDER NO.: 10260

1. Horus West Virginia 1, LLC is conducting land disturbance activity associated with the Blake Solar Project in Jefferson County, West Virginia. Horus West Virginia 1, LLC was issued WV/NPDES Water Pollution Control Permit No. WV0115924, Registration No. WVR111837, on August 12, 2022.
2. On May 15, 2023, West Virginia Department of Environmental Protection (WVDEP) personnel conducted an inspection of the facility. During the inspection, violations of the following sections of the WV/NPDES permit were observed and documented:
 - a. Section II.H.1.d. – Horus West Virginia 1, LLC failed to provide an adequate stone access entrance/exit to reduce the tracking of sediment onto public or private roads.

Horus West Virginia 1, LLC, WVR111839, Blake Solar Project, 7/18/2023

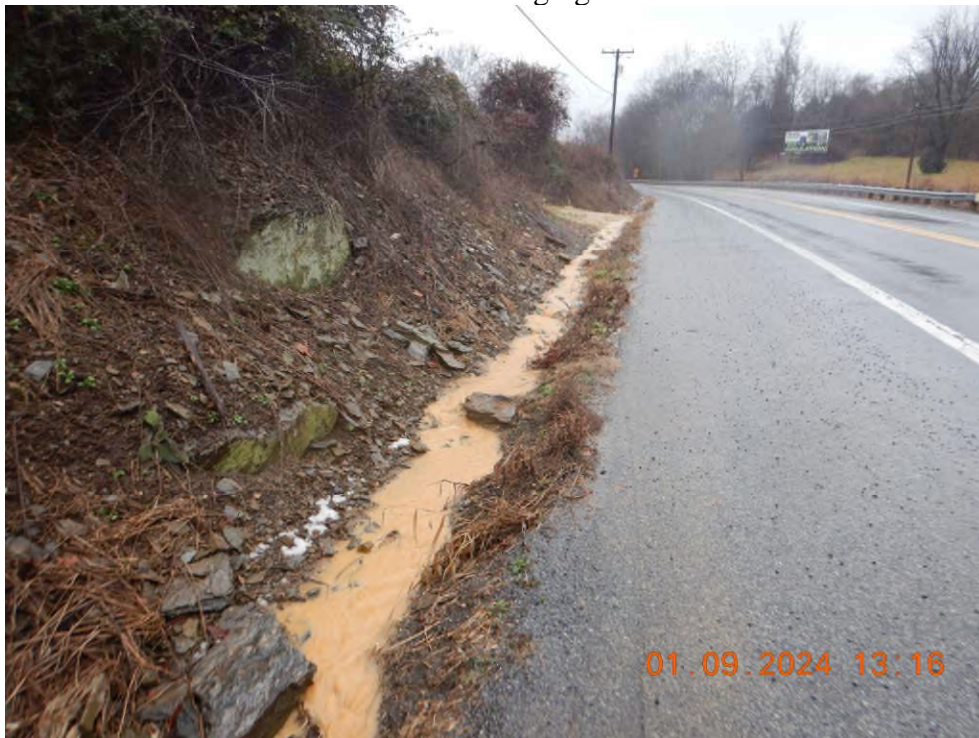
Sediment Basin 6 Discharging into WVDOT ditchline and discharging into WVDOT right of way leading to Shenandoah River.

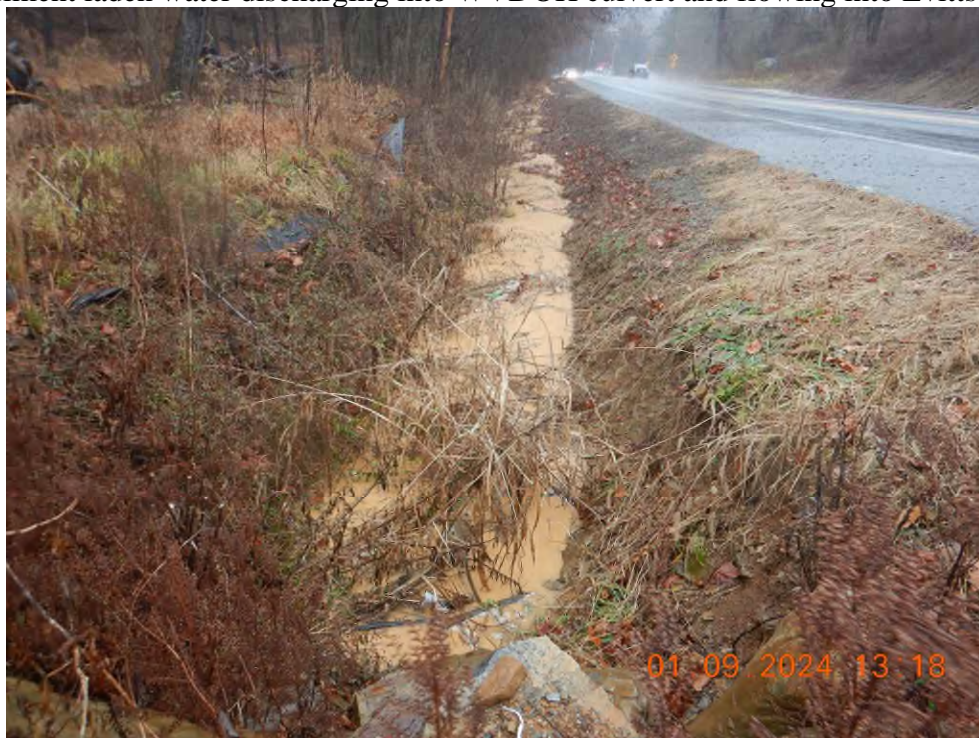
Sediment laden water following WVDOT ditchline into Evitts Run

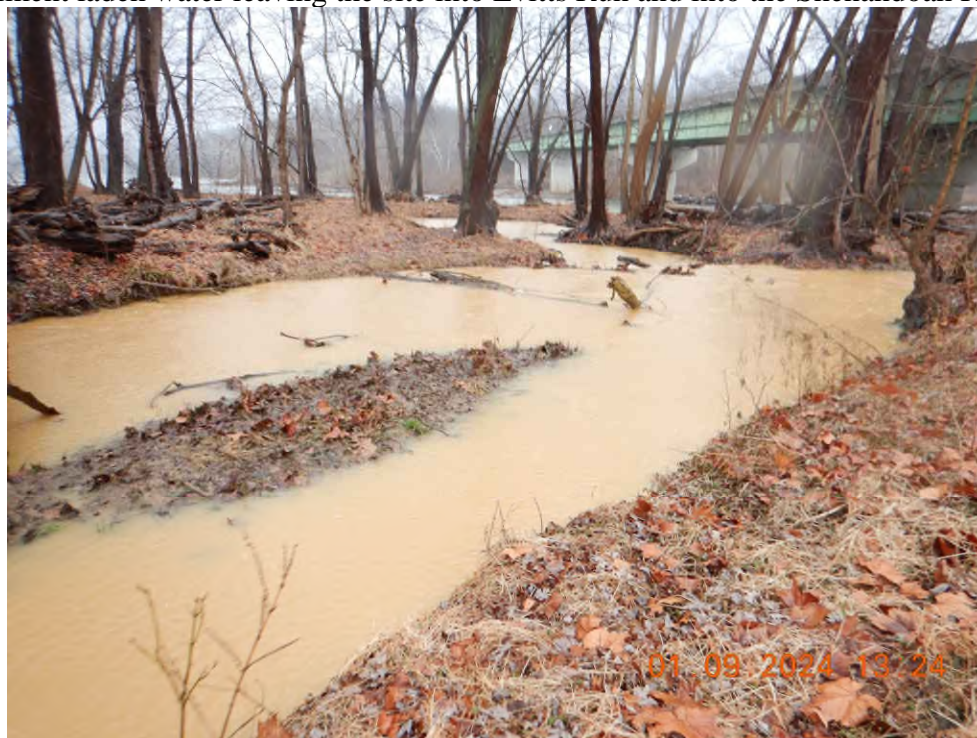
Evitts Run into the Shenandoah River.

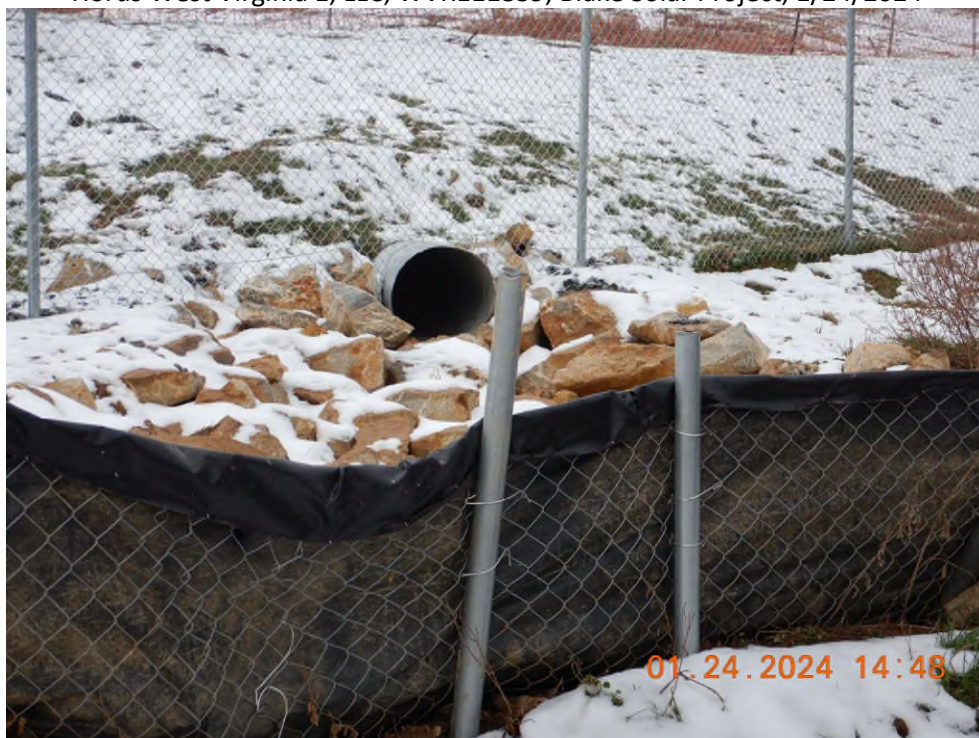
No outlet marker at Pond 6

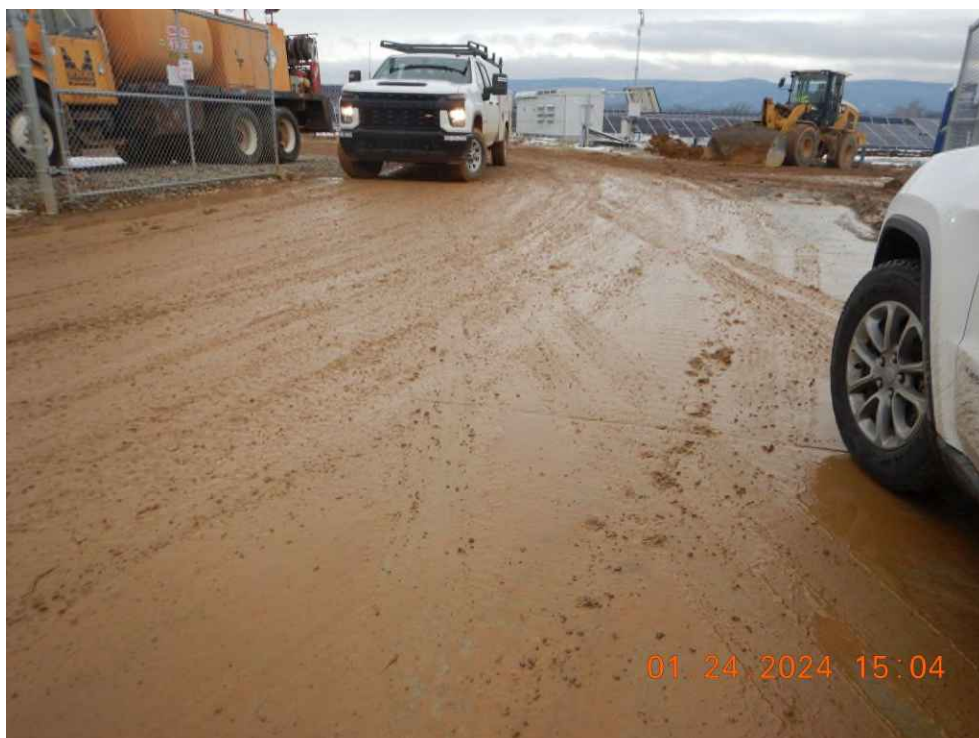
Track-out from Construction Entrance 2 that was not being cleaned during inspection.

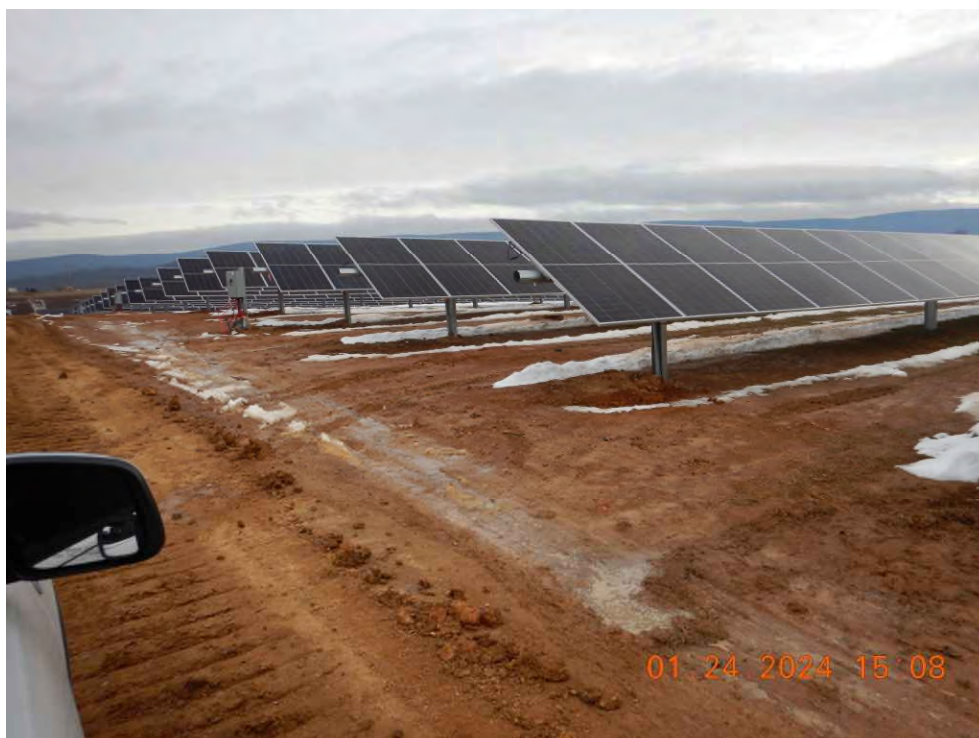
Unstabilized area that has not been worked within the past 14 days.

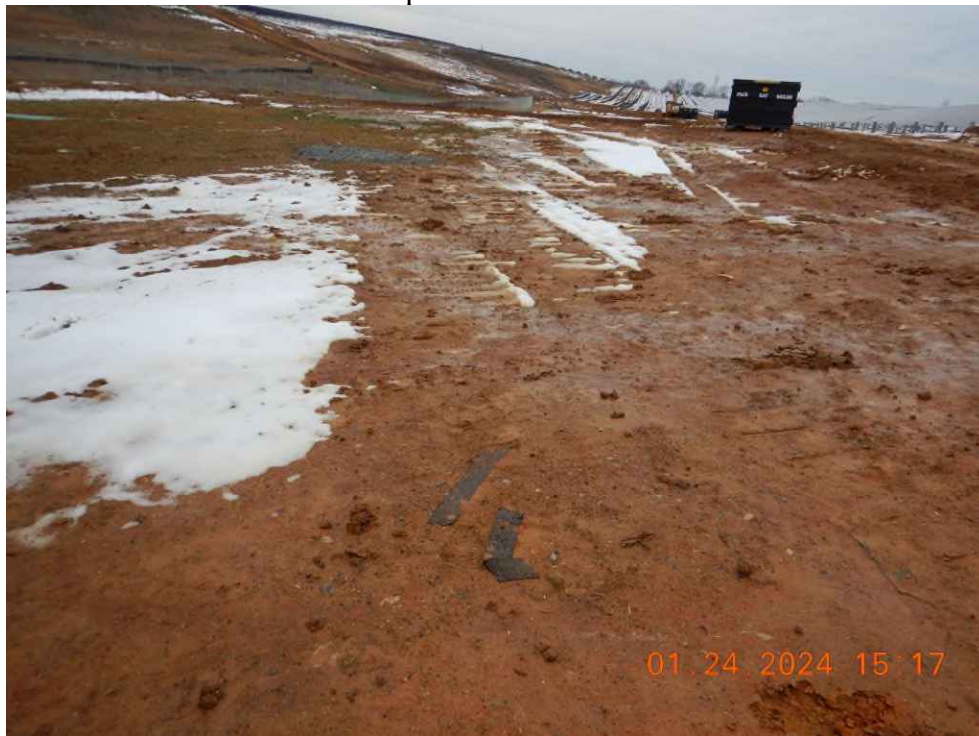
Area that has not been worked within the past 14 days.

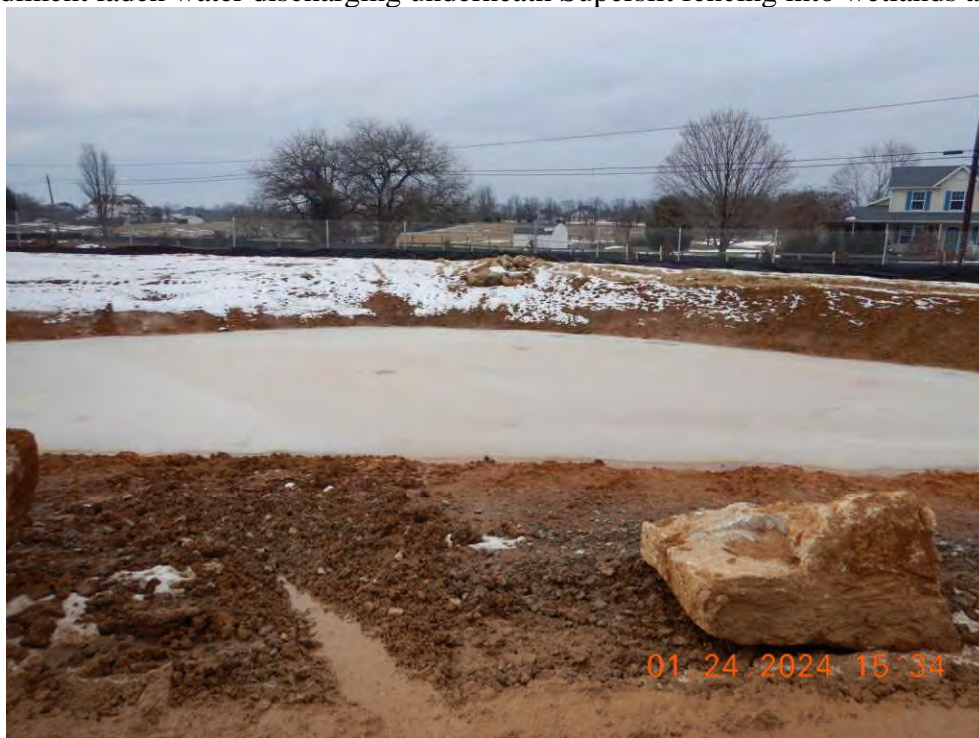
New pond that has been installed to prevent sediment laden water from leaving the site. SWPPP needs to be modified to include pond.

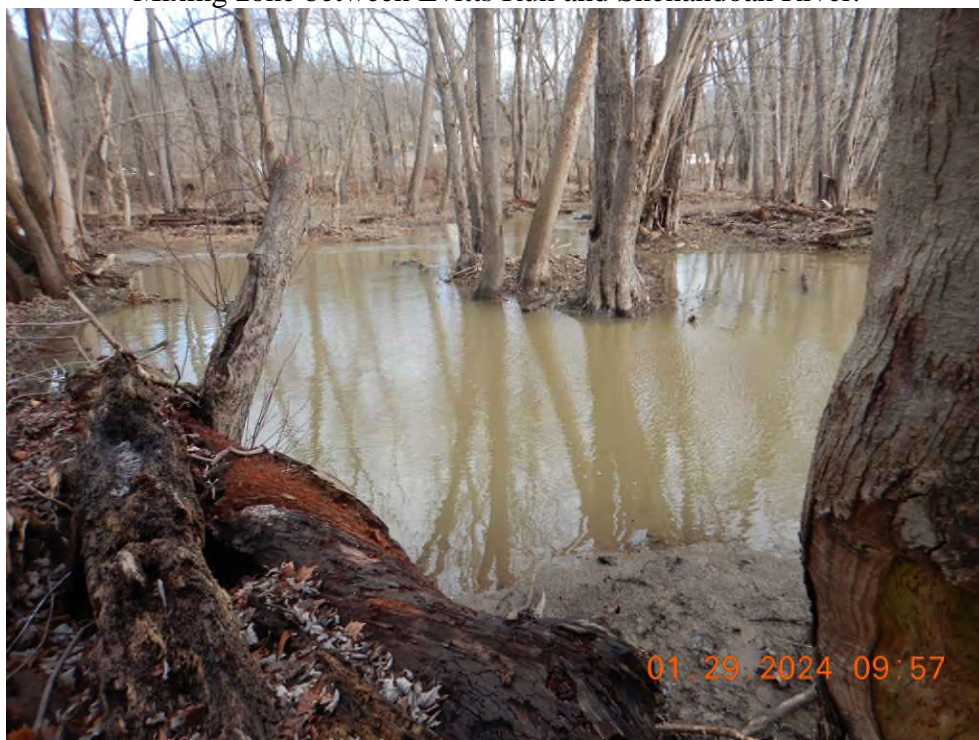
Evitts Run downstream of the construction site.

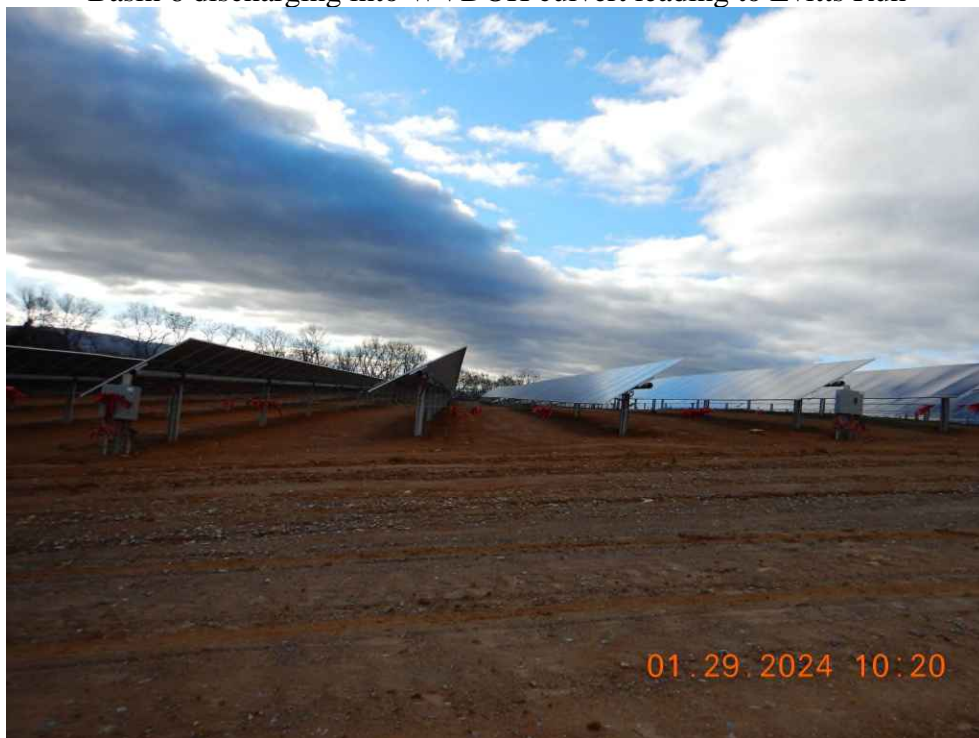
Area that has not been worked in the past 14 days and lacks stabilization.

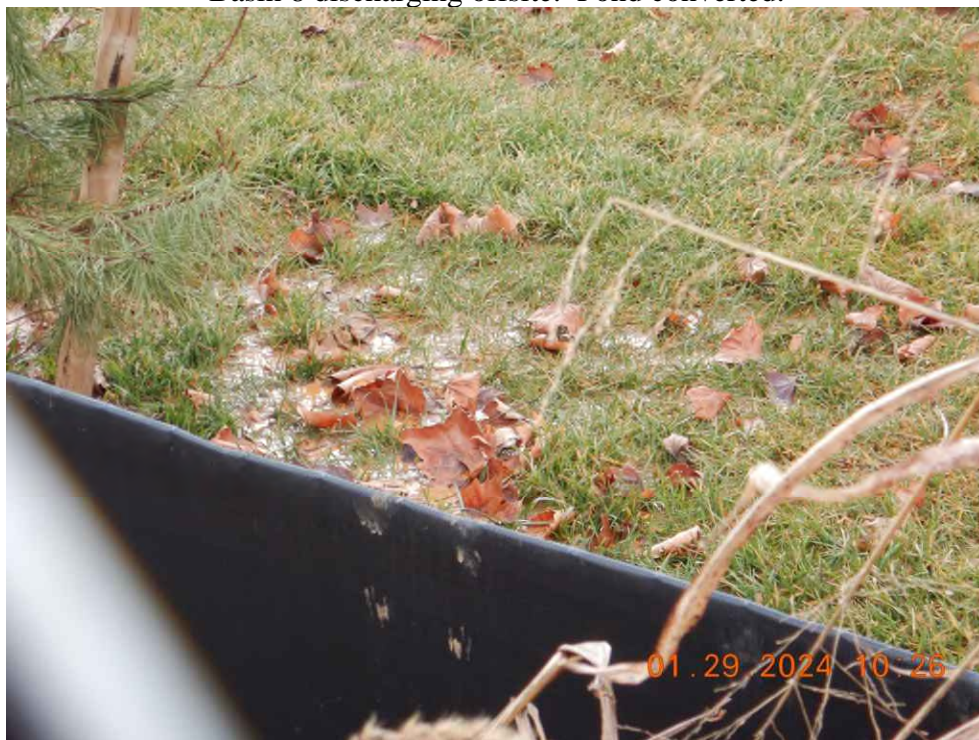
Basin 8 discharging offsite.

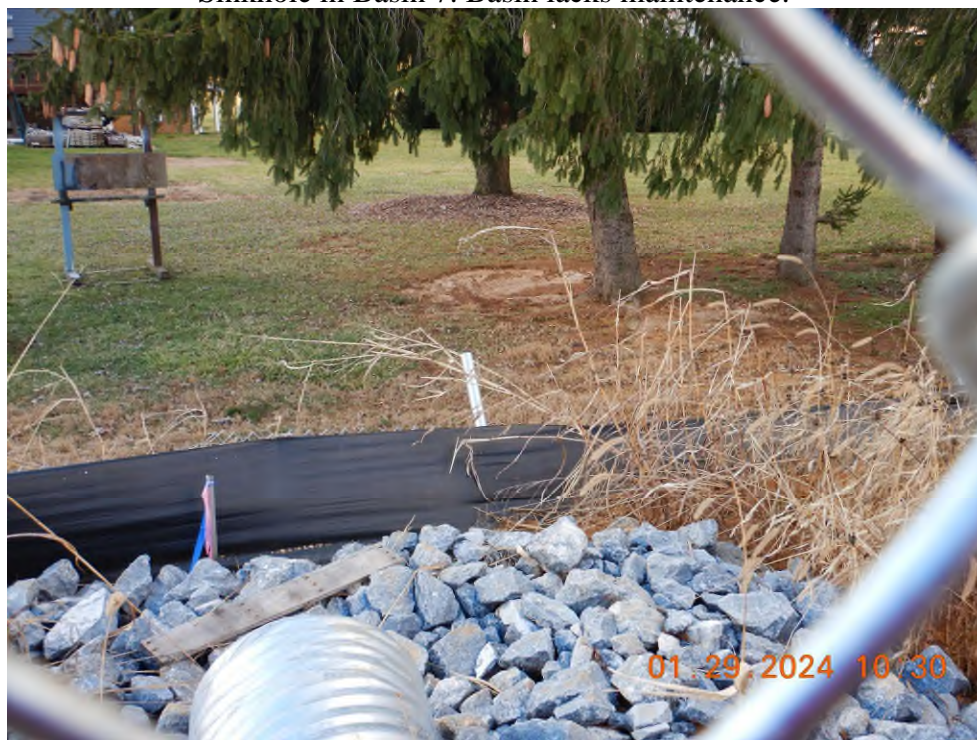
Basin 7 discharging offsite.

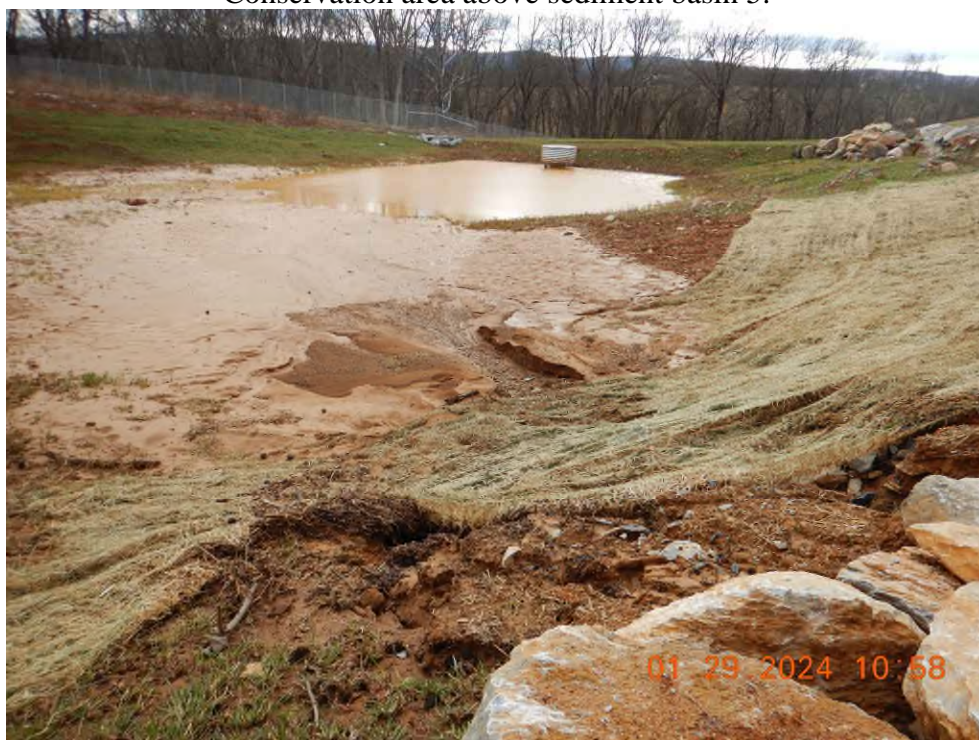
Basin 5 is in need of maintenance.

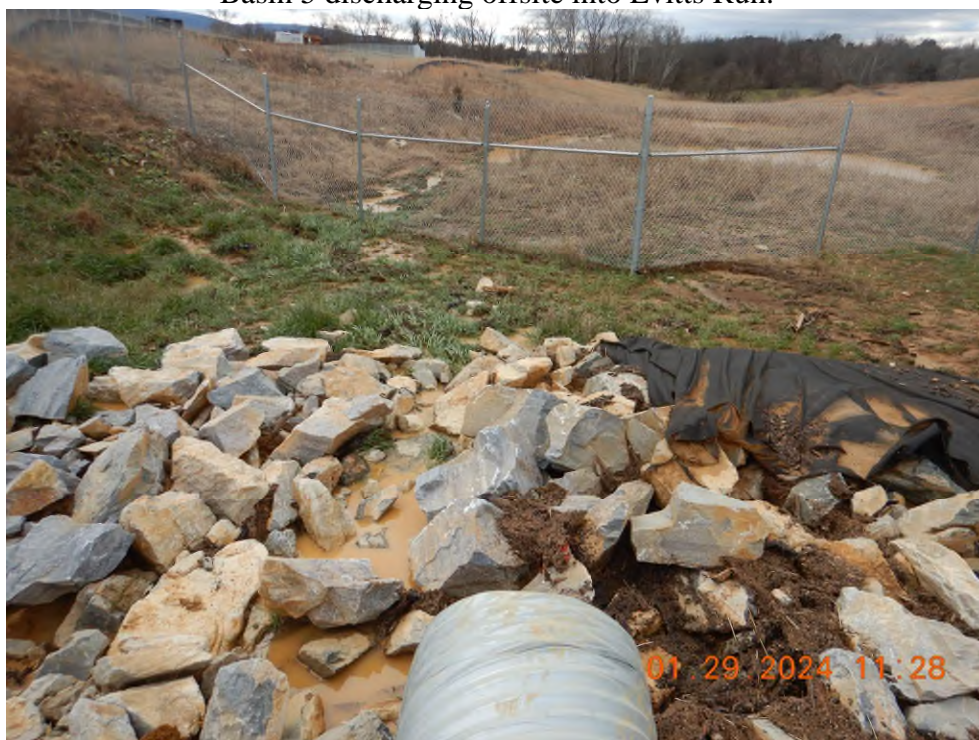
Basin 13 discharging into Evitts Run.

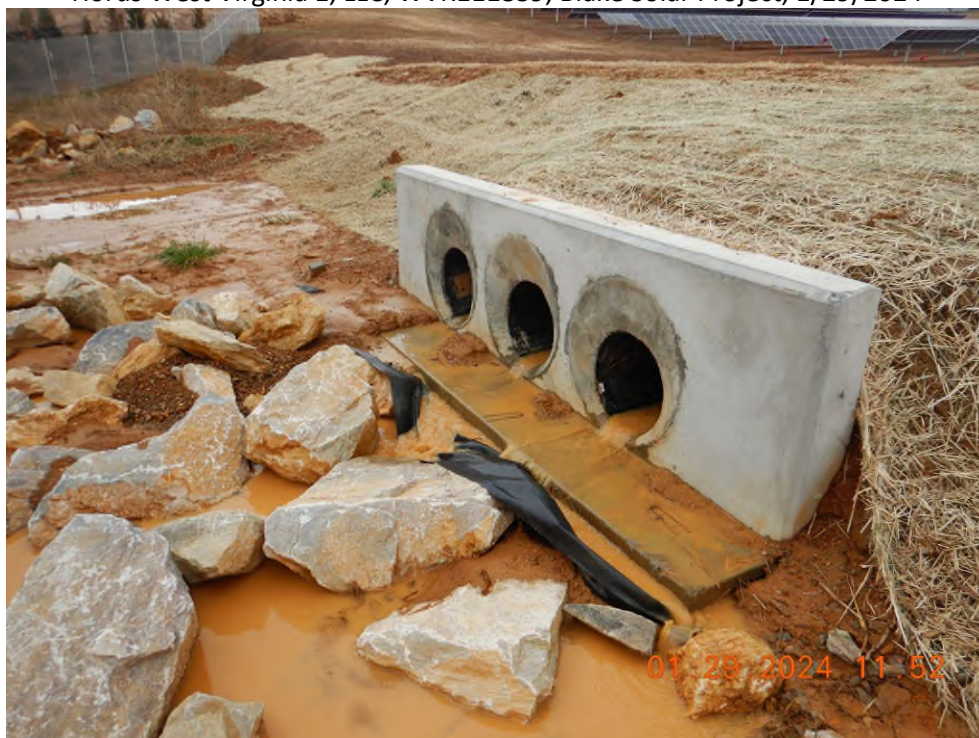
Basin 11 discharging offsite.

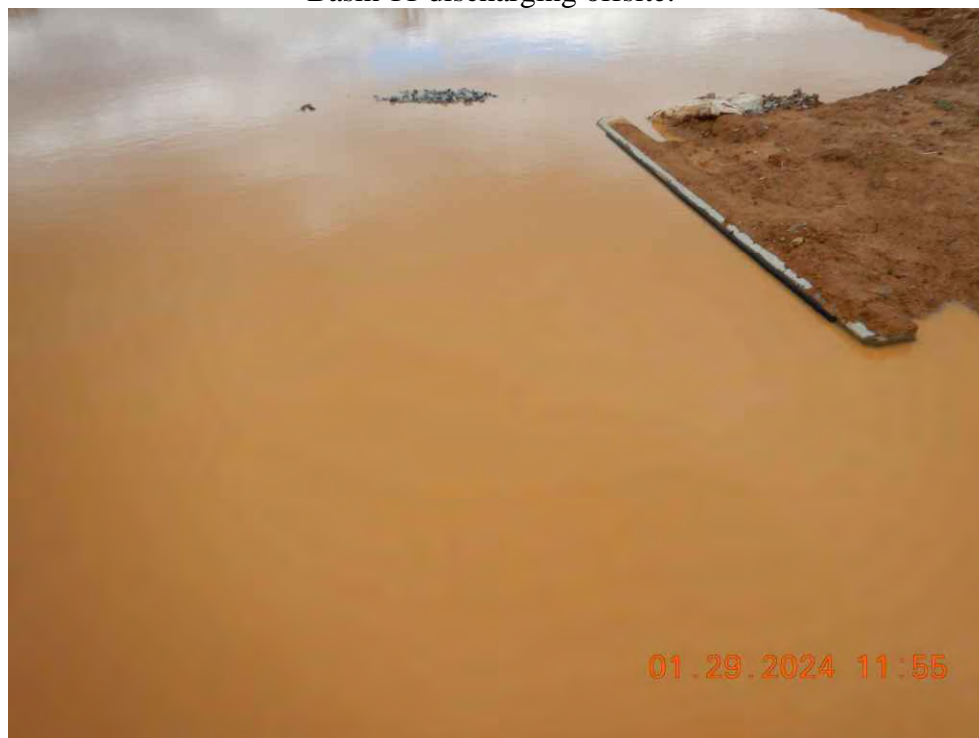
Basin 11 converted to stormwater management.

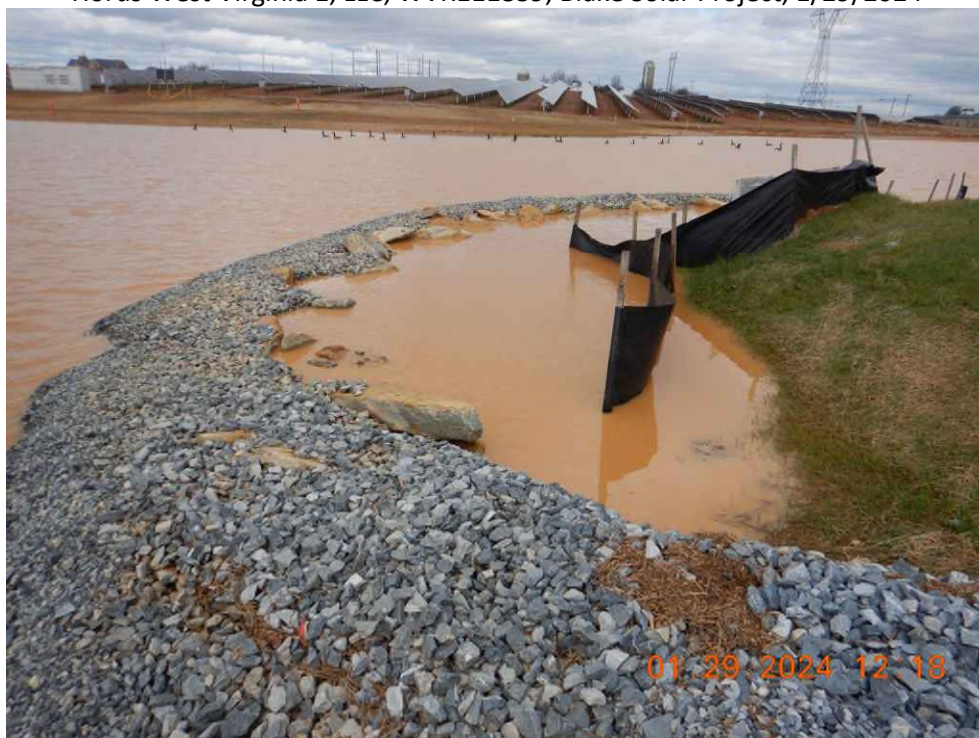
Redlined Pond 14A. Note the unstabilized area above the pond.

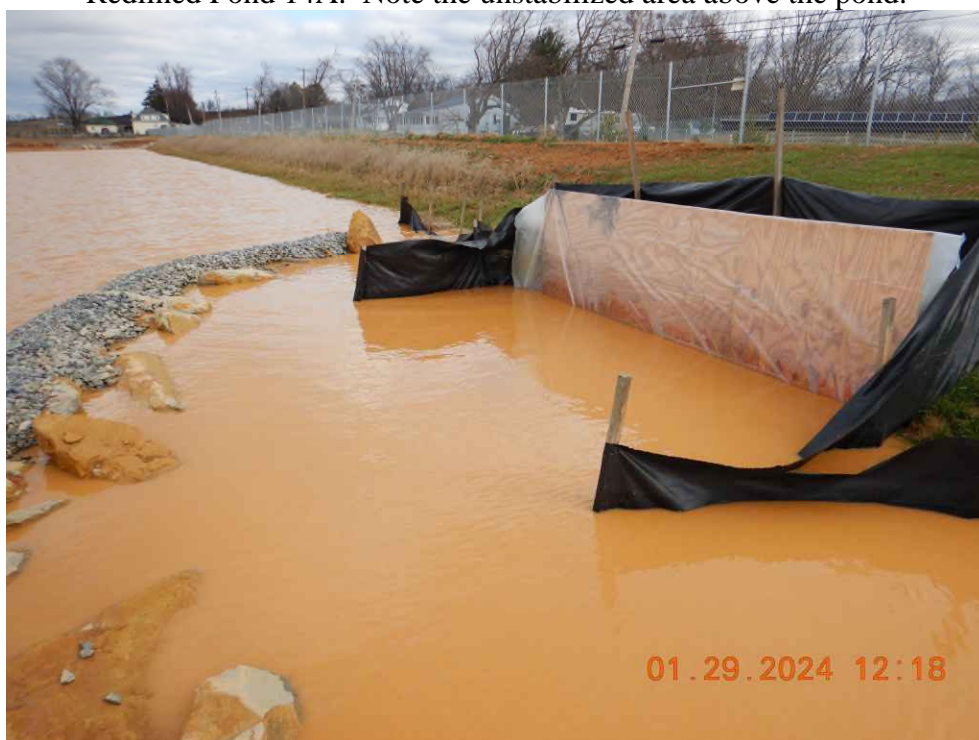
Outlet of pond 14A discharging offsite.

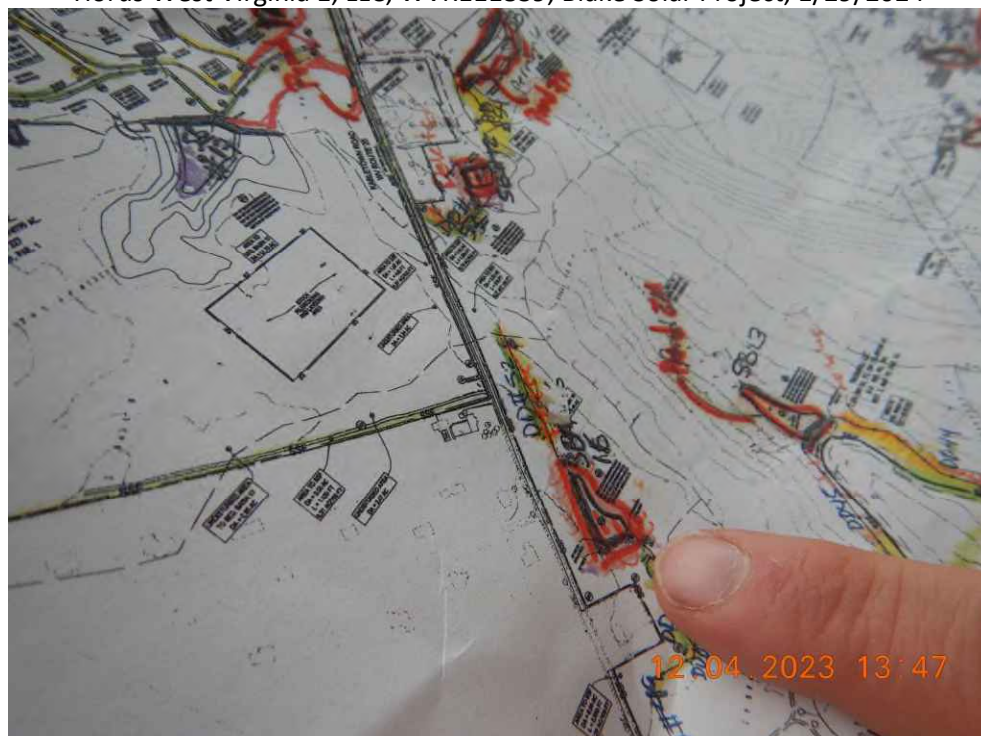
Sediment Basins 12 and 15 have been deleted prior to all uphill disturbance being vegetated.

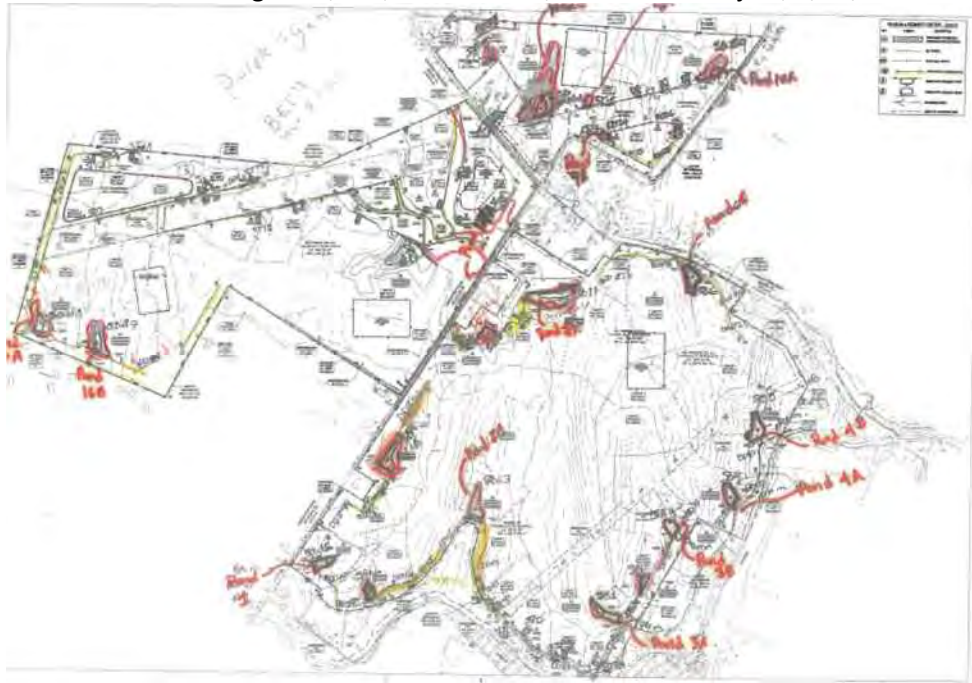
Copy of map that shows deleted Sediment Traps/Basins. Map also shows all ponds that have been converted to stormwater management.

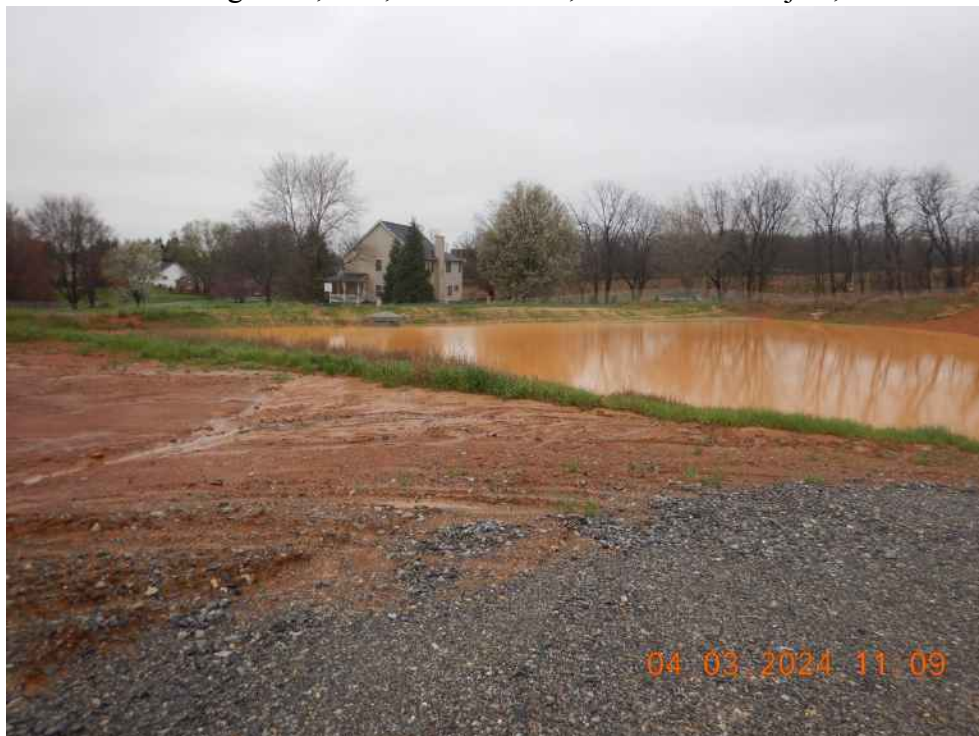
Area above Pond 16A that has not been stabilized.

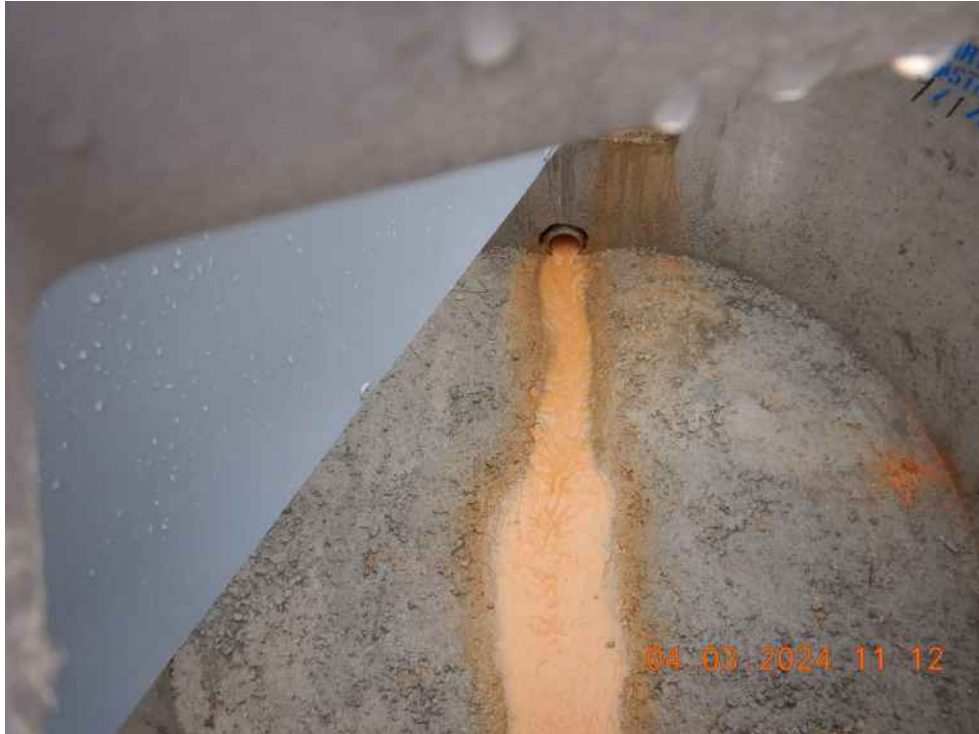
Structure for Pond 16A discharging sediment laden water.

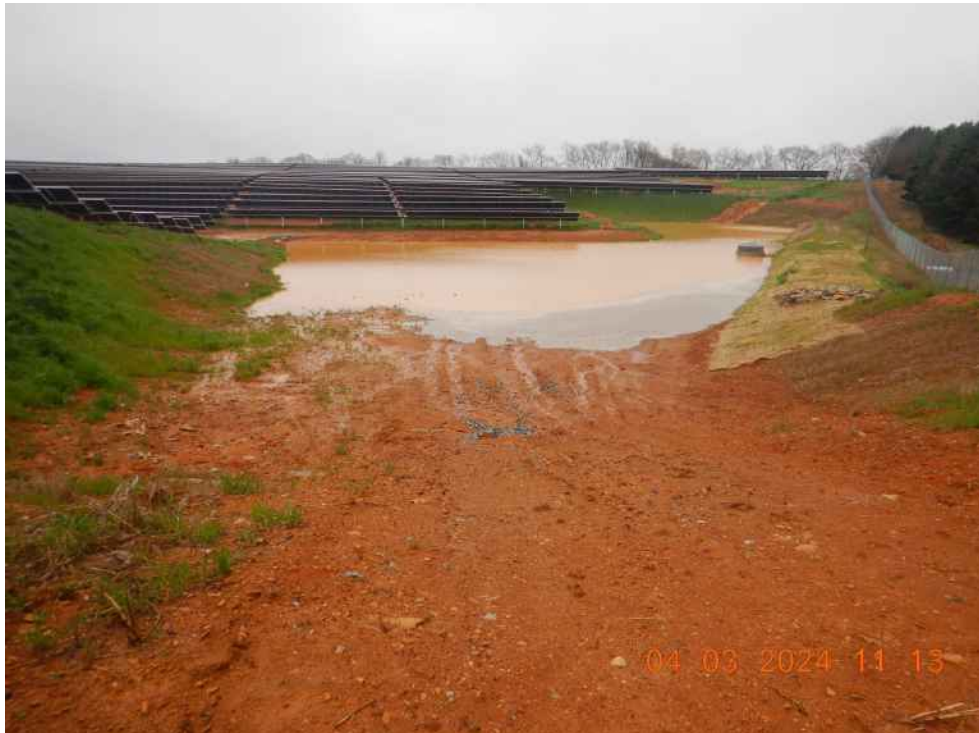
Area that has not been worked in the past 14 days and lacks stabilization above Pond 16B.

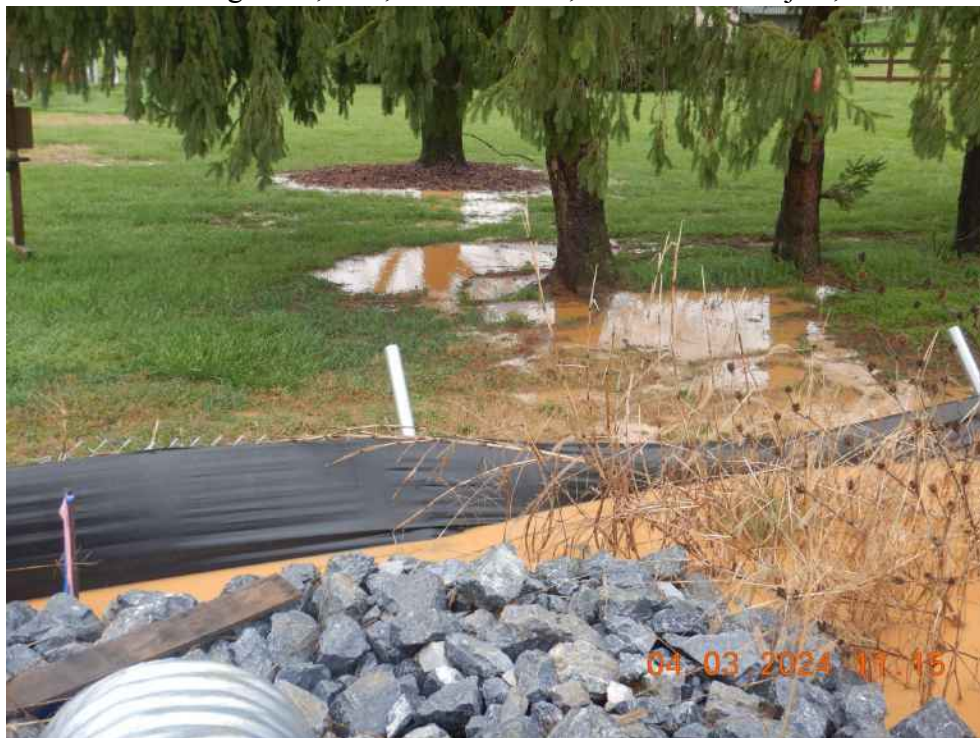
Pond 16B discharging offsite.

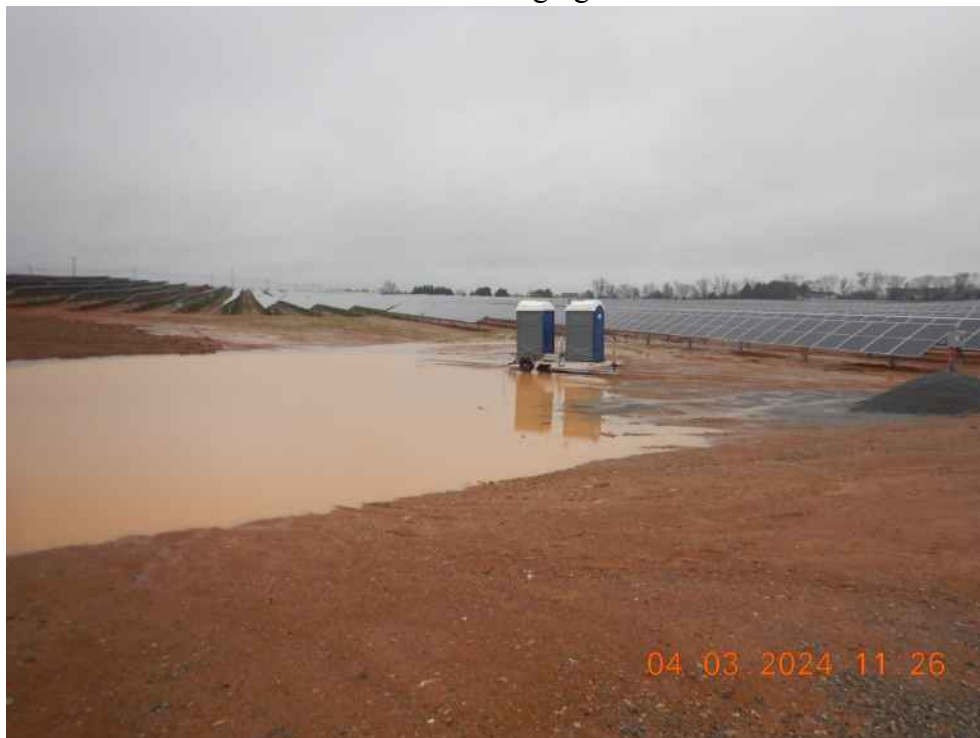
Unstabilized area that has not been excavated in the past 14 days.

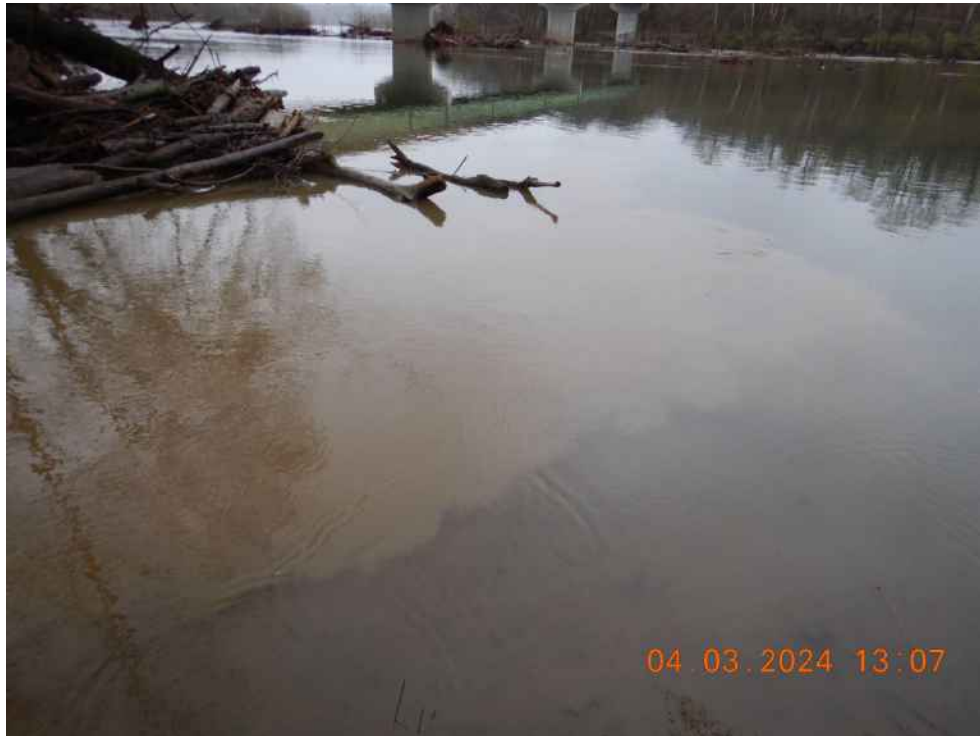
Mixing zone between Evitts Run and Shenandoah River.

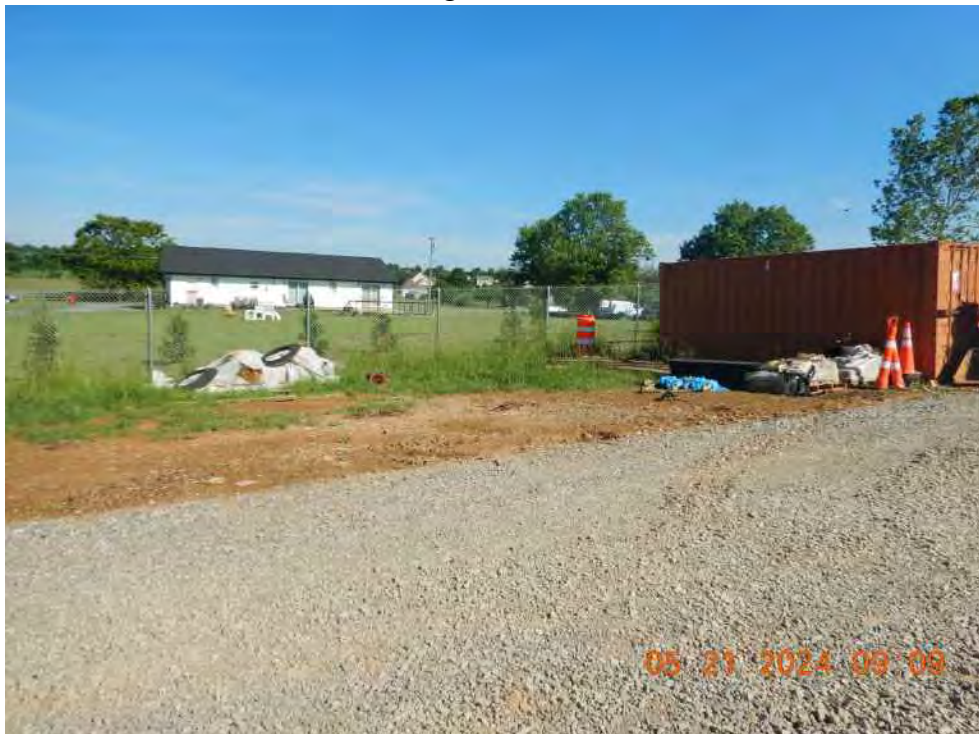
Unstabilized area where sediment basin 12 is supposed to be installed.

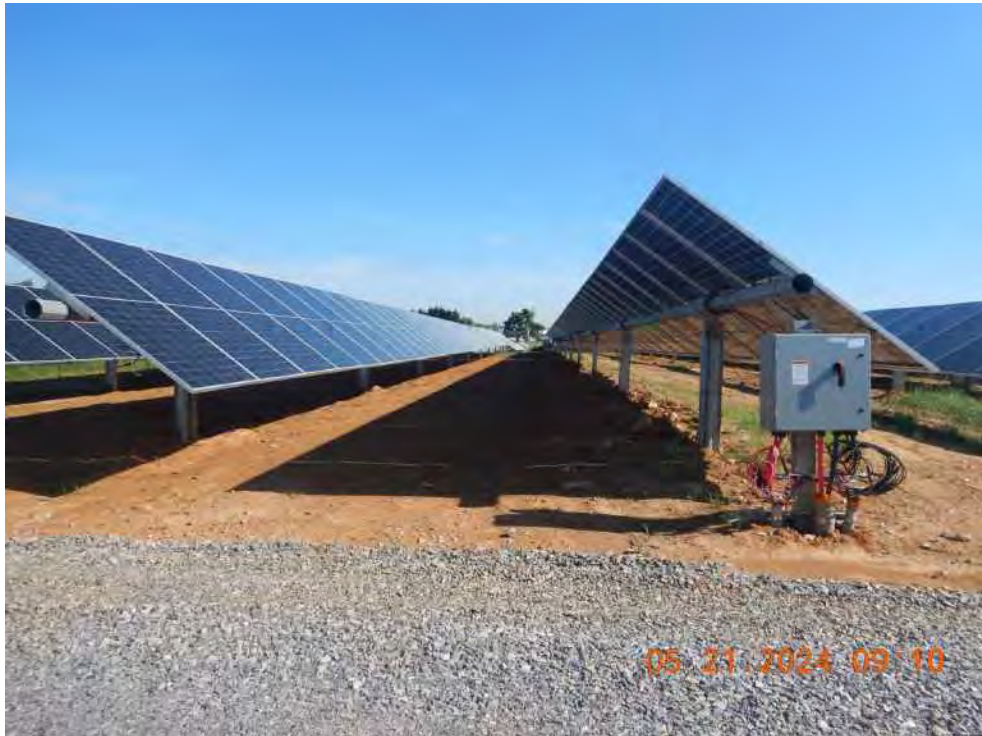
Area that has not been worked in the past 14 days and lacks stabilization

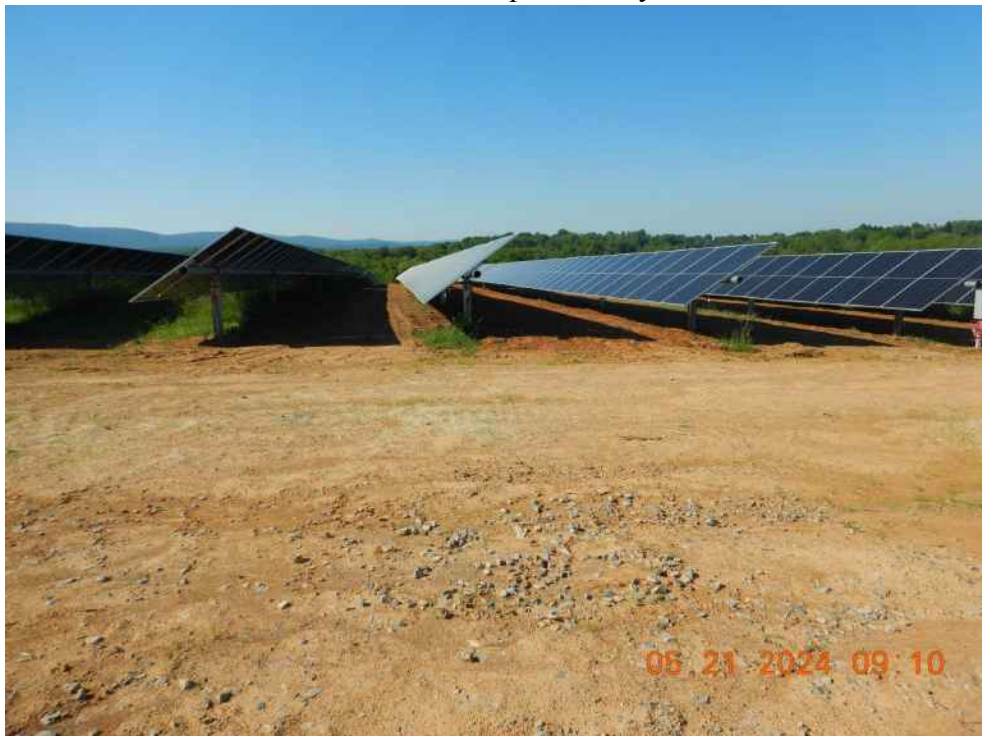
Area that has not been worked in the past 14 days and lacks stabilization.

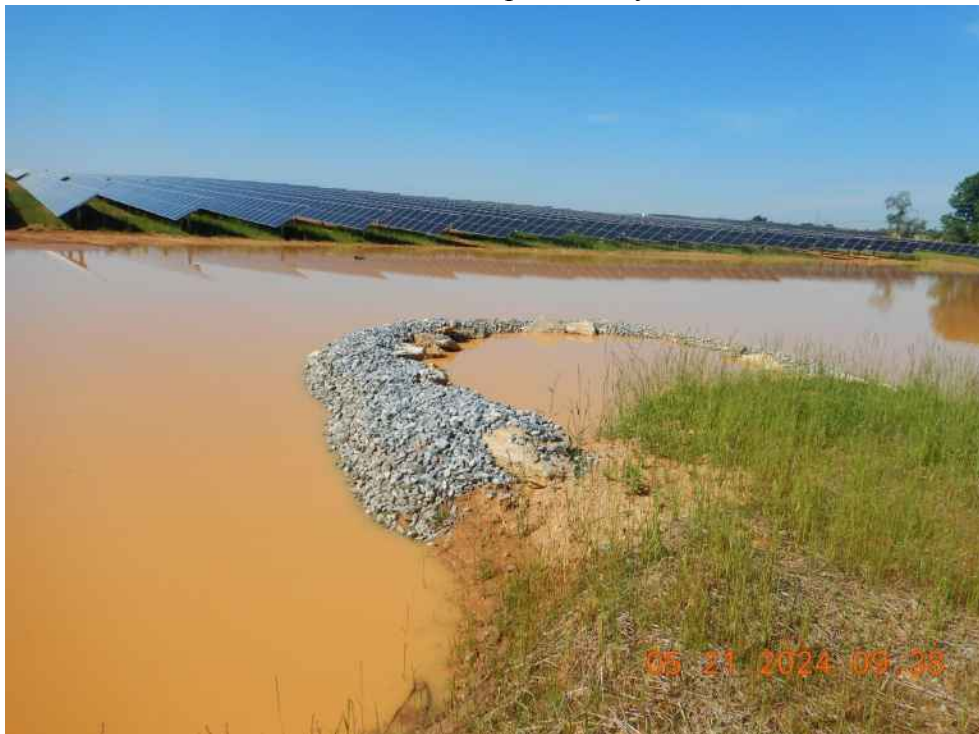
Sediment Basin 11 discharging offsite.

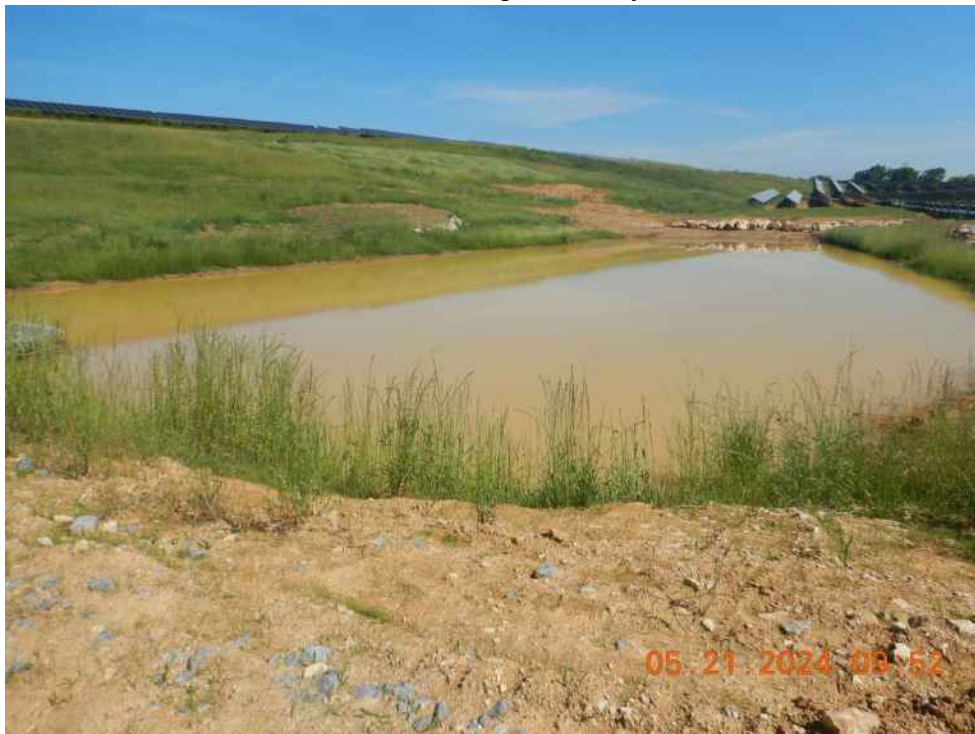
Sediment Basin 13 discharging off site directly into Evitts Run.
Sediment Laden Water Leaving Site
