**CONSENT ORDER
ISSUED UNDER THE
WATER POLLUTION CONTROL ACT
WEST VIRGINIA CODE CHAPTER 22, ARTICLE 11**

ORDER NO.: 10260

1. Horus West Virginia 1, LLC is conducting land disturbance activity associated with the Blake Solar Project in Jefferson County, West Virginia. Horus West Virginia 1, LLC was issued WV/NPDES Water Pollution Control Permit No. WV0115924, Registration No. WVR111837, on August 12, 2022.
2. On May 15, 2023, West Virginia Department of Environmental Protection (WVDEP) personnel conducted an inspection of the facility. During the inspection, violations of the following sections of the WV/NPDES permit were observed and documented:
 - a. Section II.H.1.d. – Horus West Virginia 1, LLC failed to provide an adequate stone access entrance/exit to reduce the tracking of sediment onto public or private roads.

Horus West Virginia 1, LLC, WVR111839, Blake Solar Project, 7/18/2023

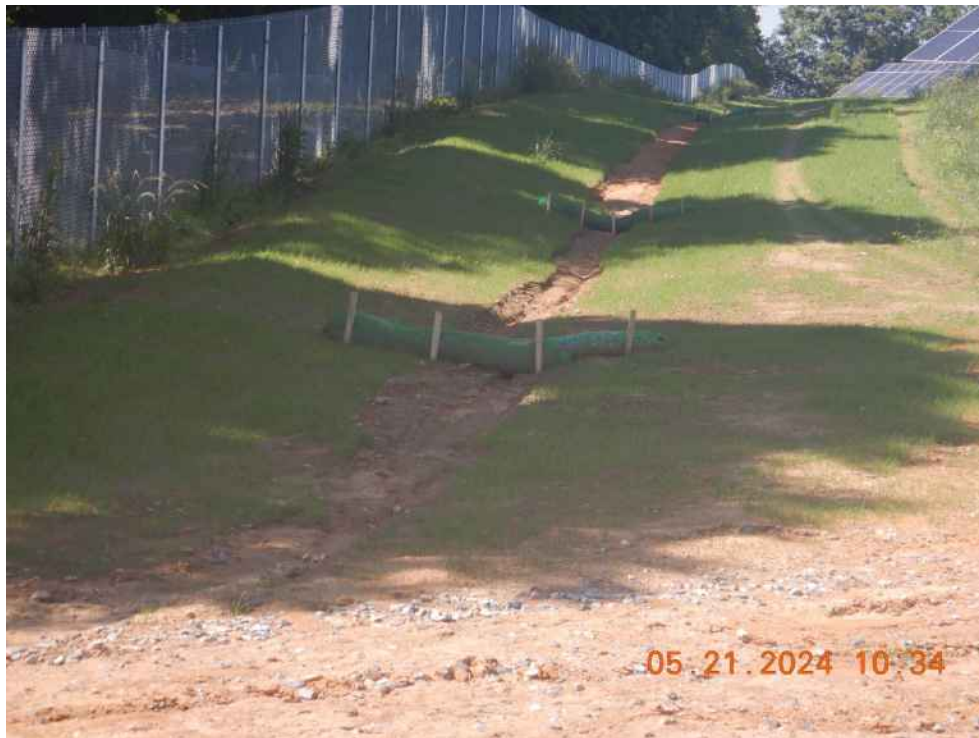
Installed diversion that has been installed and eroded and lacks maintenance.

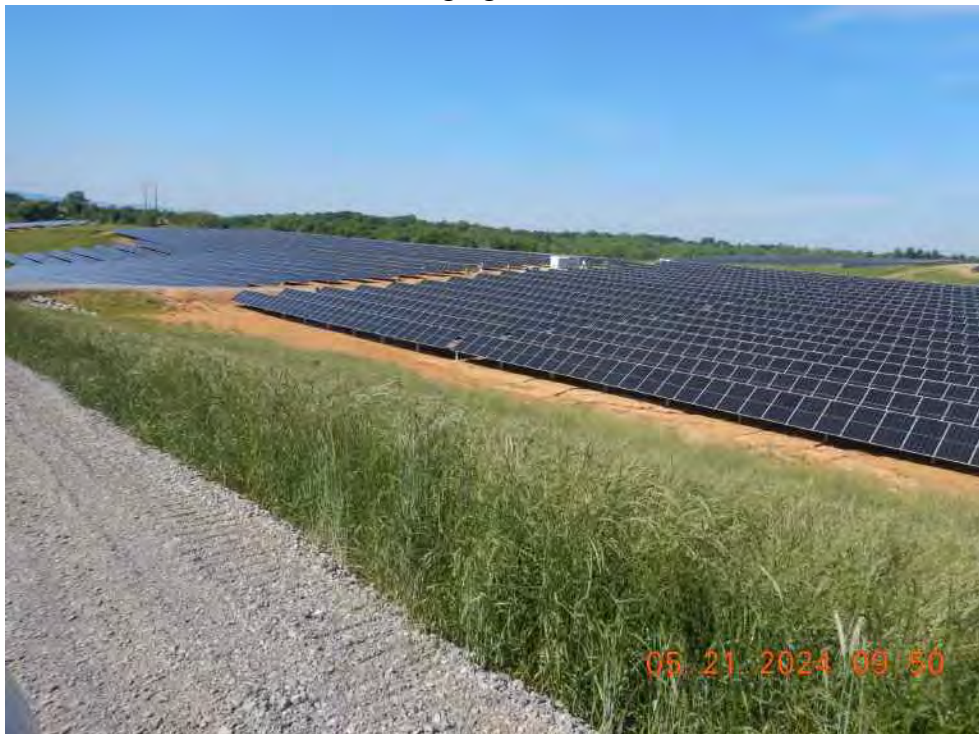
Unstabilized area that has not been stabilized or worked within 14 days.

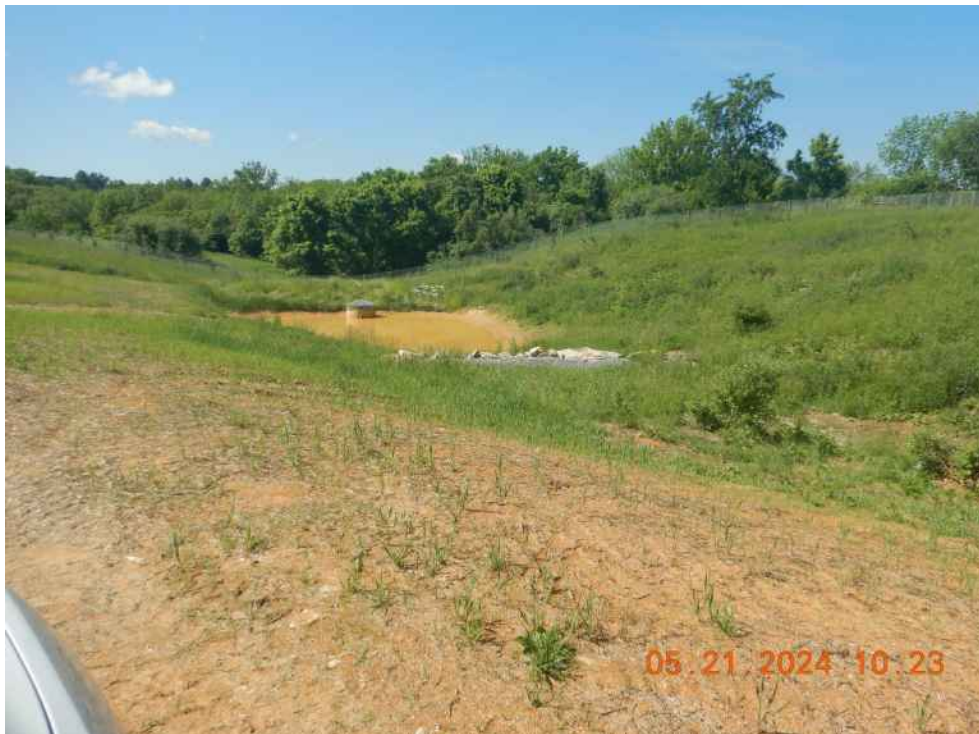
Unstabilized area above Sediment Basin 14.

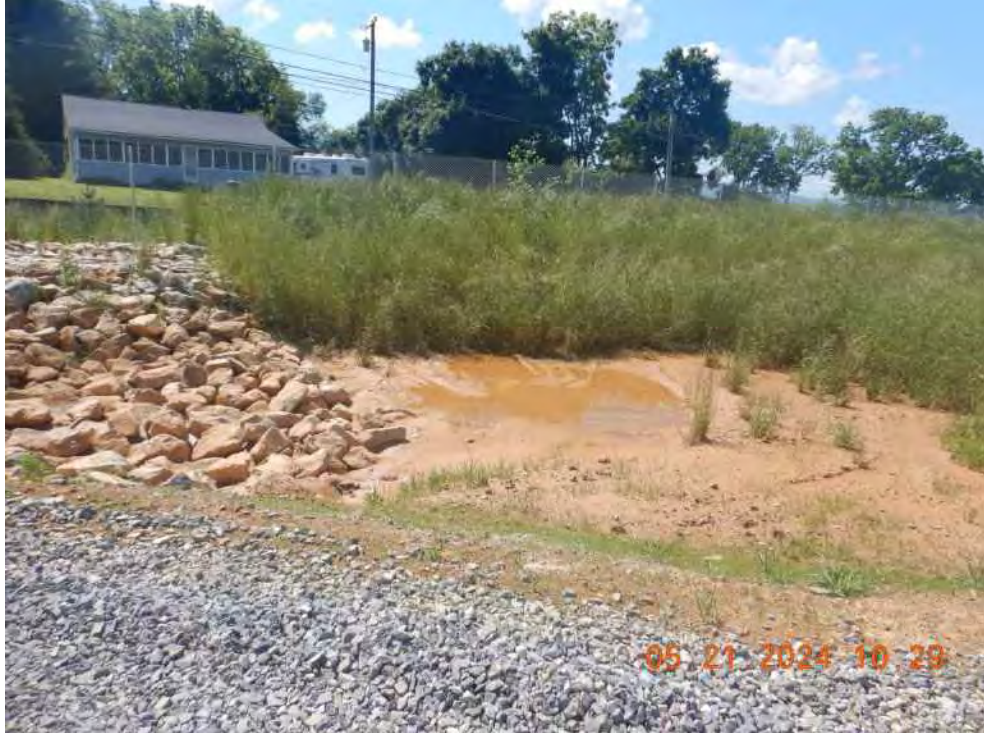
Unstabilized area above Pond 14A.

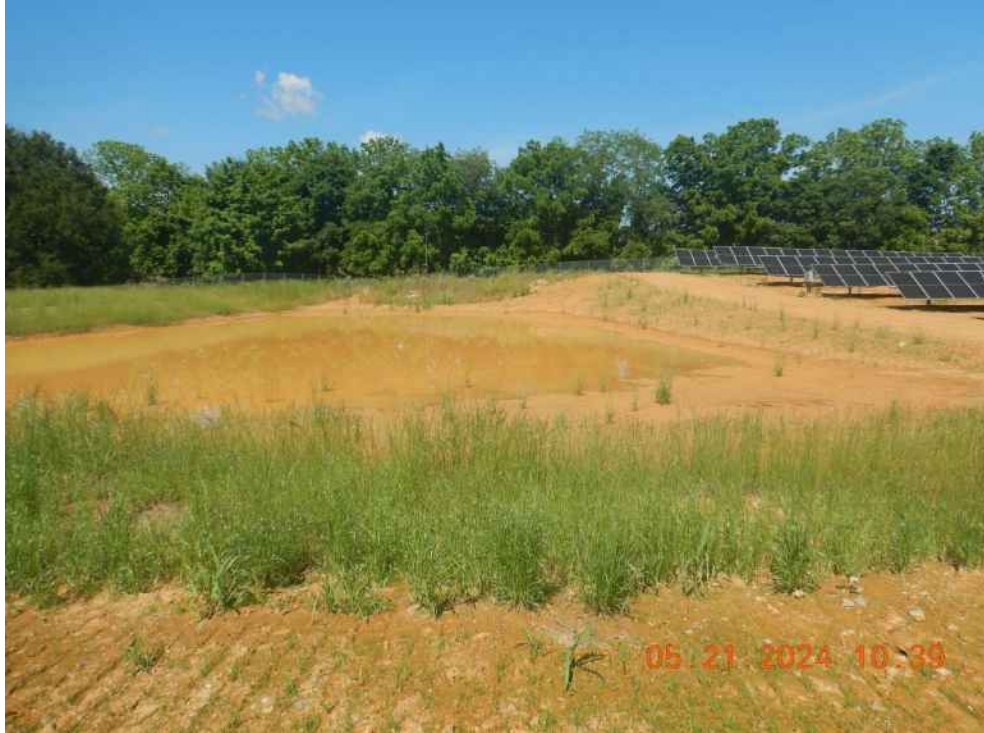
Unstabilized area above Sediment Basin 8.

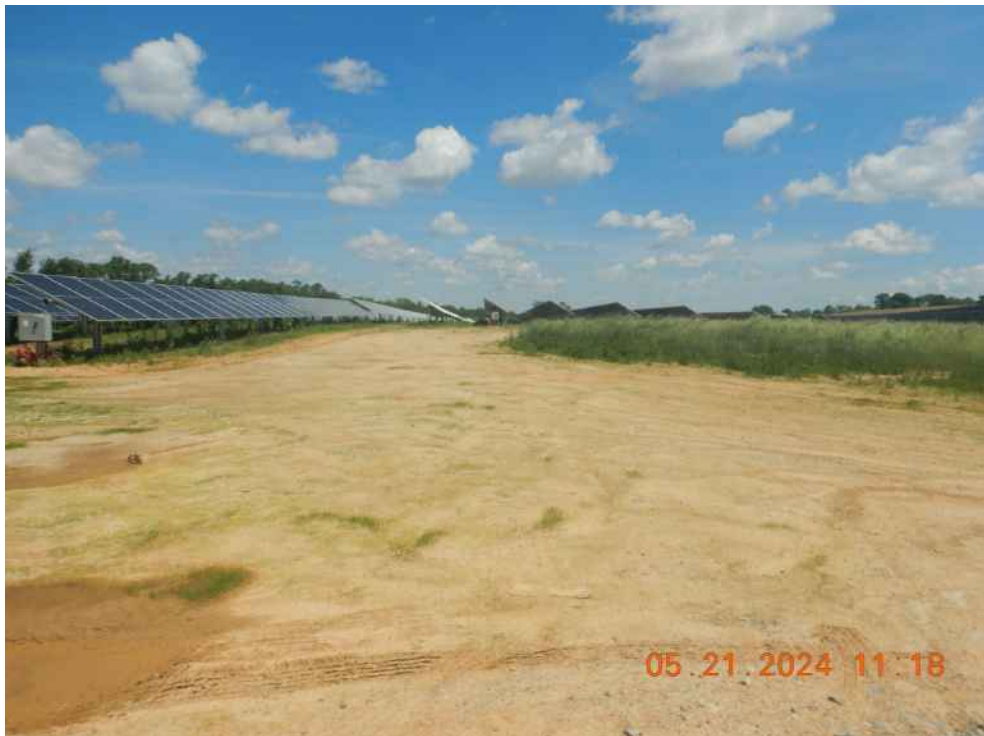
Unstabilized area above Sediment Basin 10.

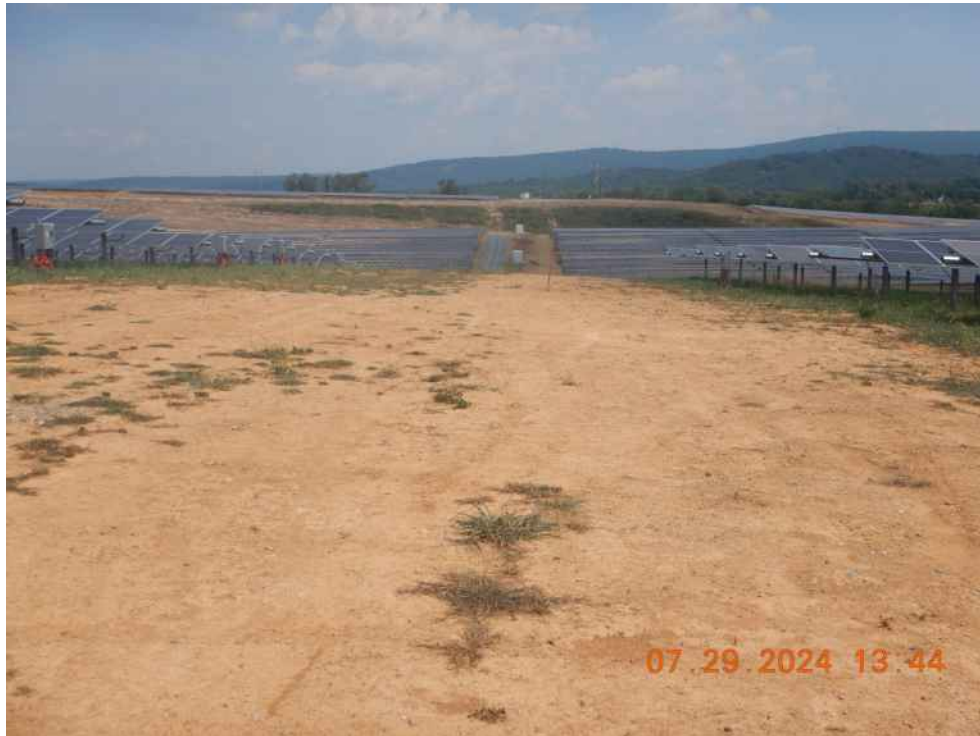
An unstabilized area that has not been actively worked. Sediment basin 13 drainage area.

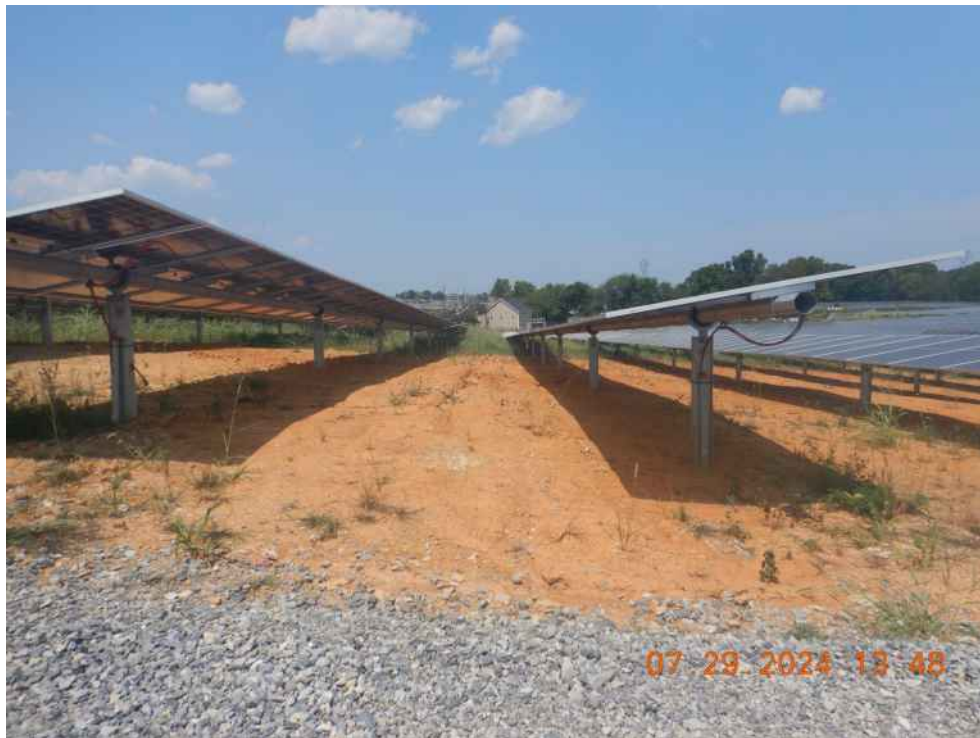
An unstabilized area that has not been actively worked. Sediment basin 17 drainage area.

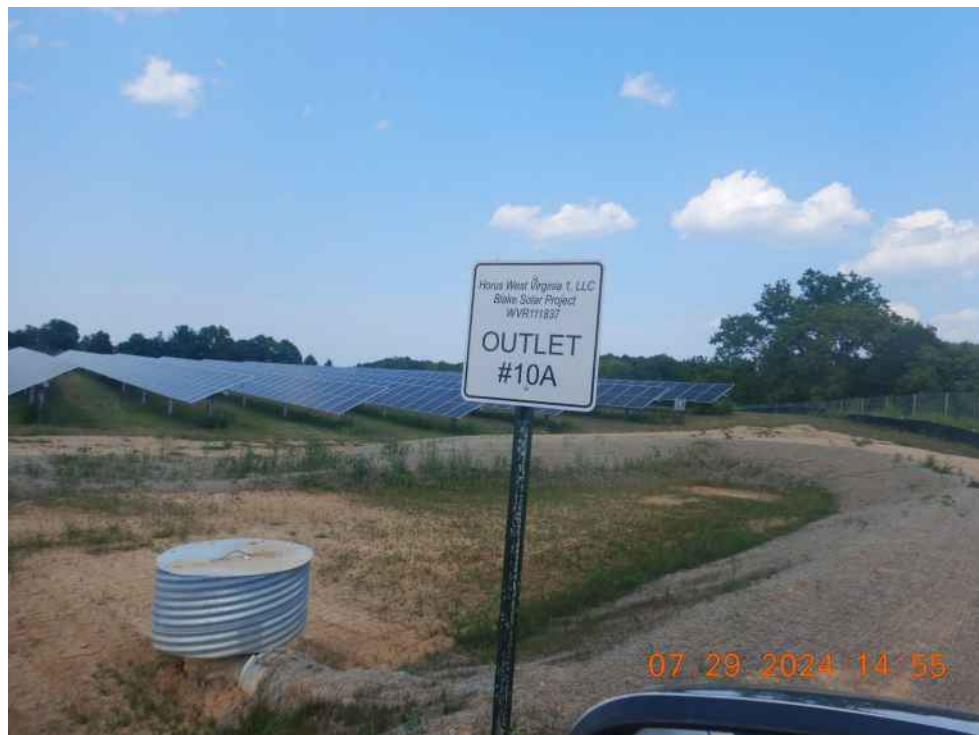
Sediment basin 9, that has been converted prior to all uphill disturbance being stabilized.

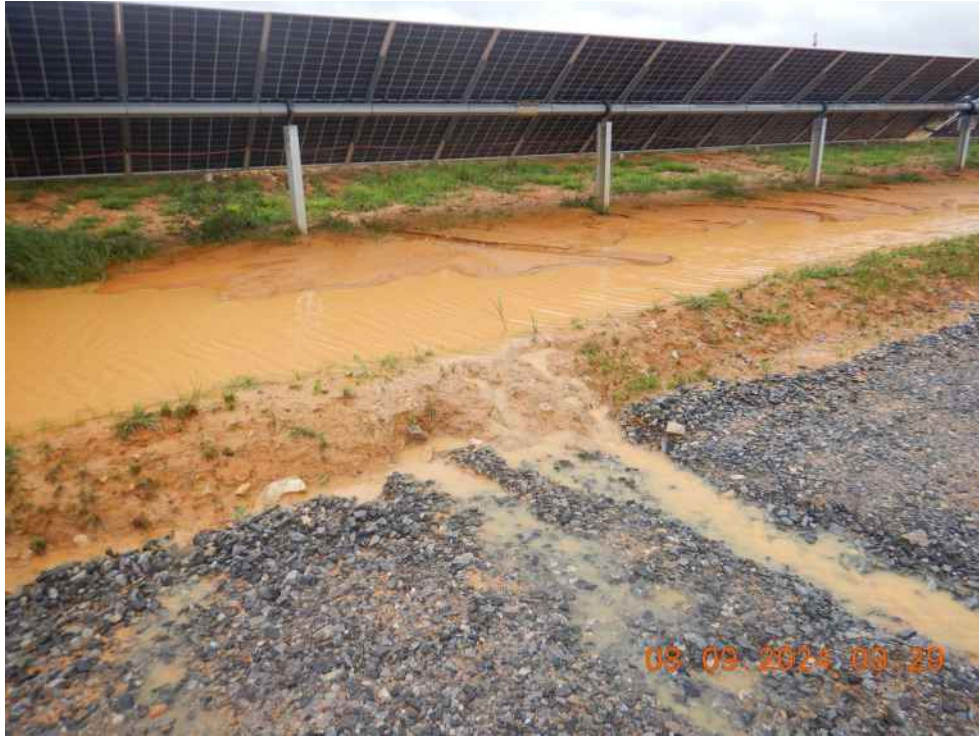
An unstabilized area that has not been actively worked. Sediment basin 13 drainage area.

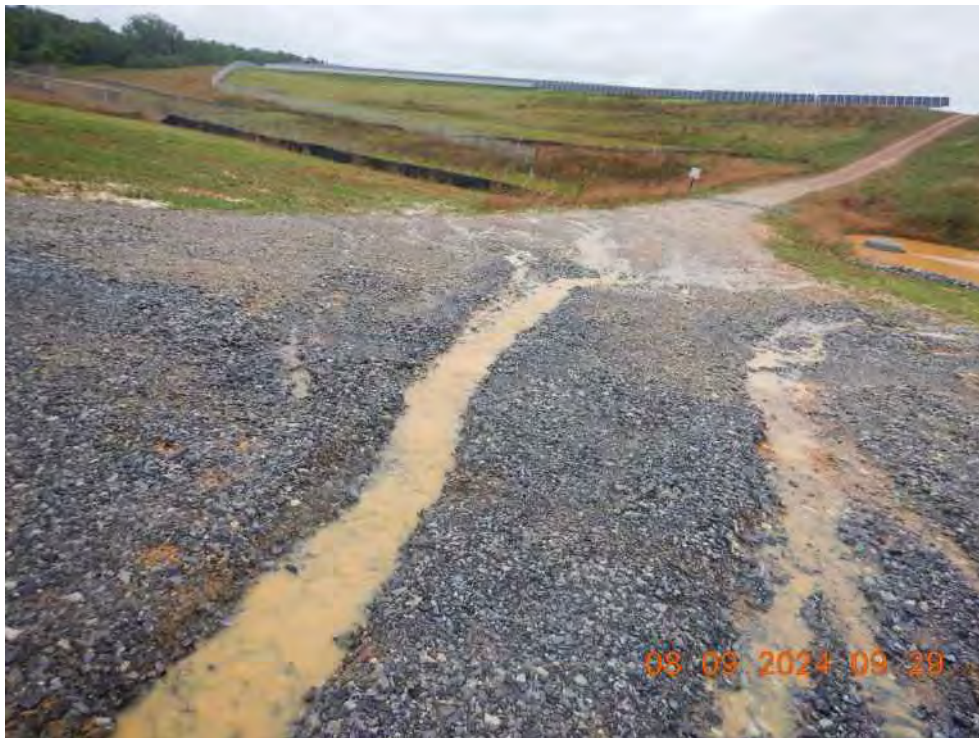
An unstabilized area that has not been actively worked. Sediment basin 13 drainage area.

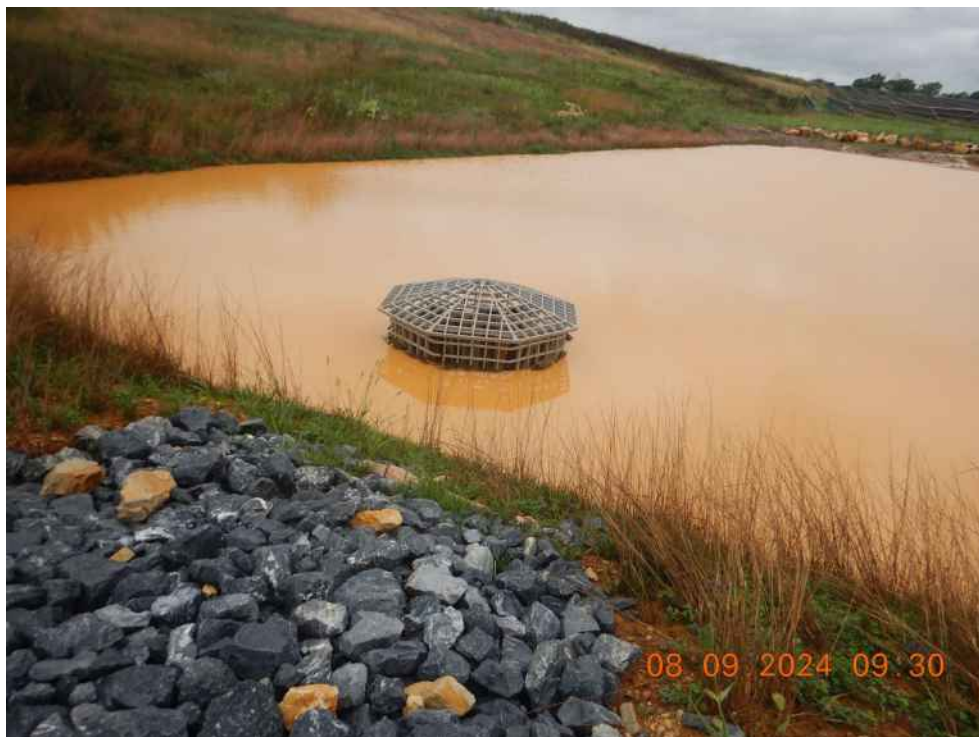
Sediment basin 12 drainage area discharging into Evitts Run.

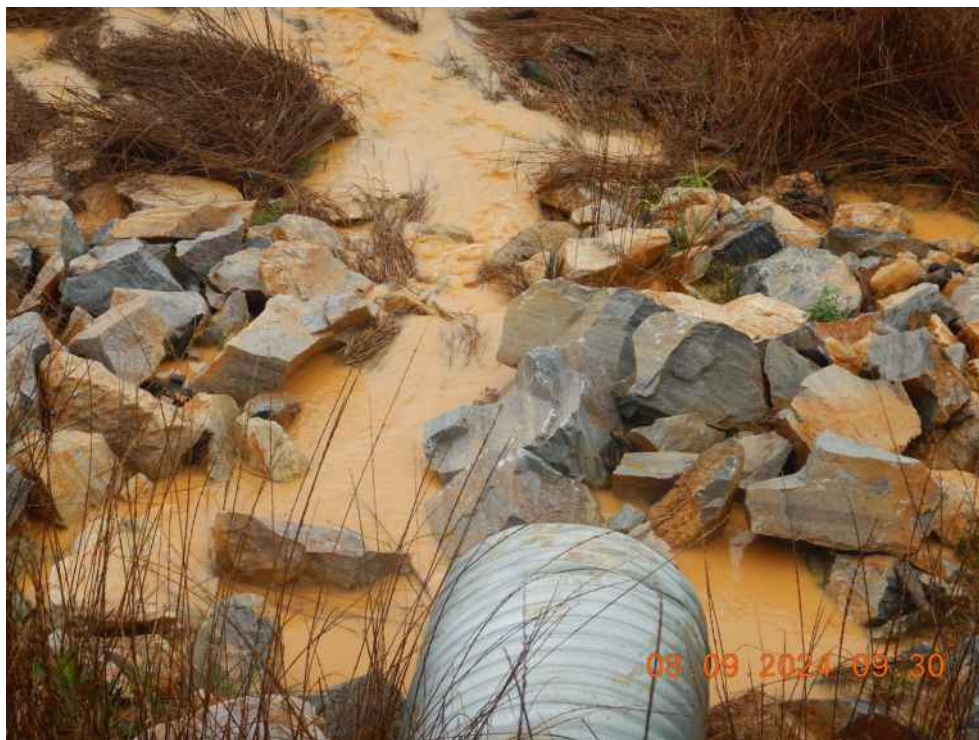
Sediment basin 12 discharging sediment-laden water into Evitts Run.

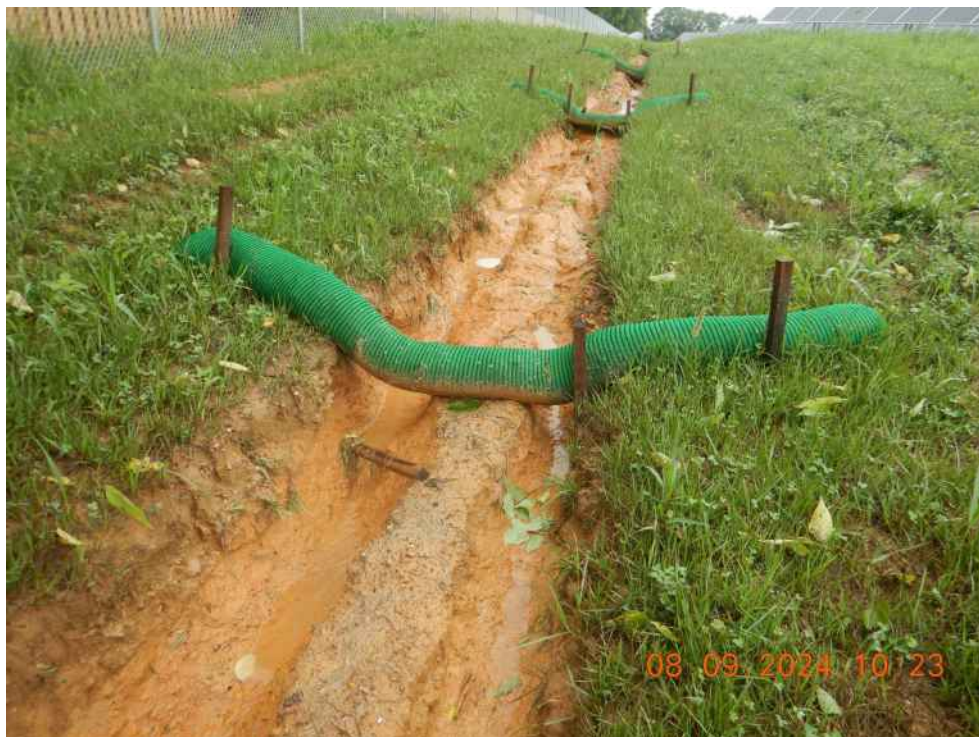
Ditch checks lack maintenance and have been undermined.

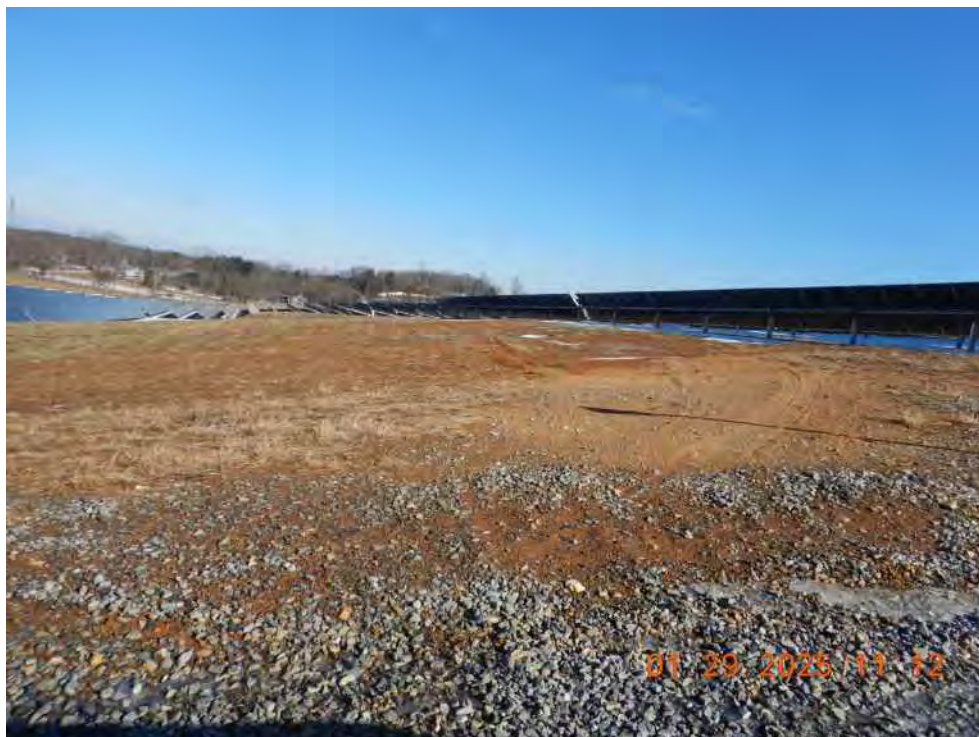
An unstabilized area of the project.

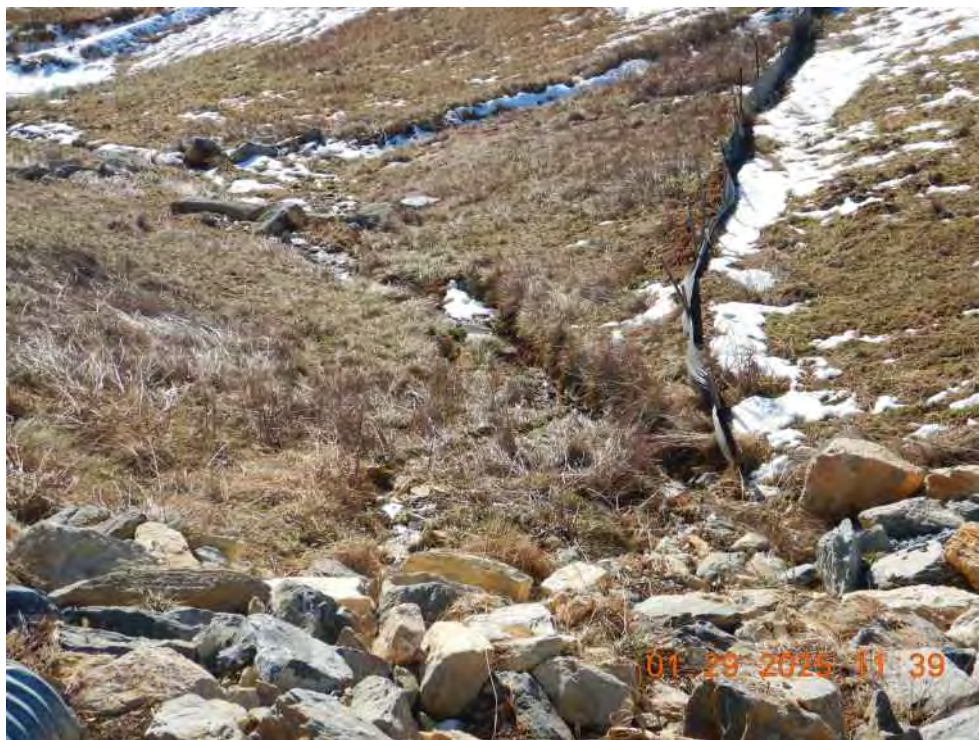
An unstabilized channel that has eroded due to lack of vegetation.

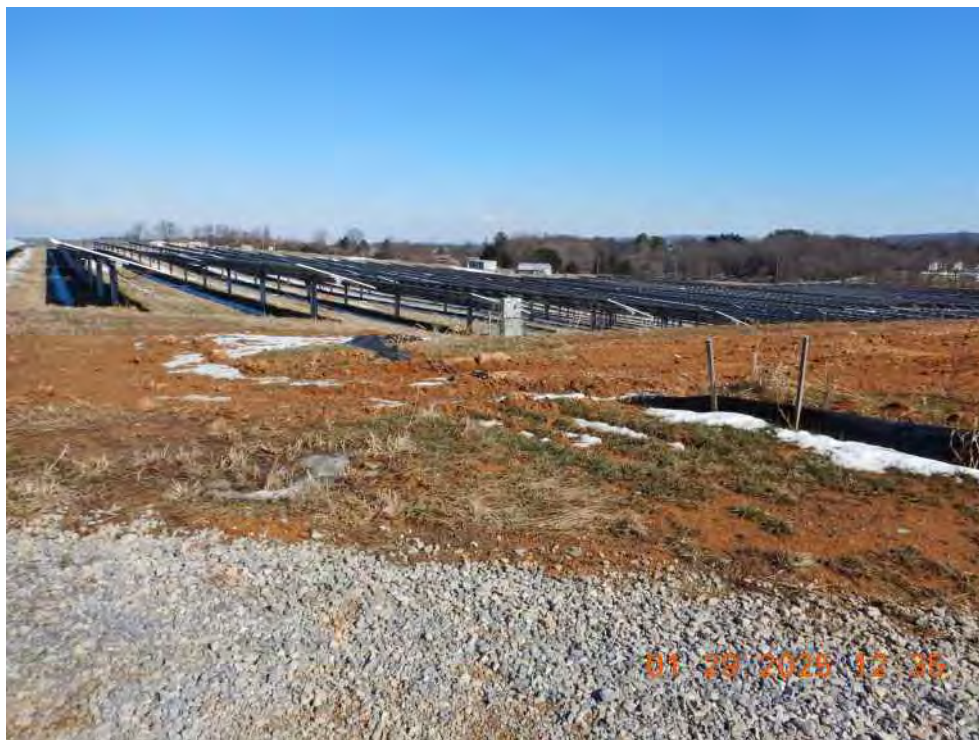
An unstabilized area of the project.
